Suomenlinna

Conservation and Reuse

GOVERNING BODY OF SUOMENLINNA

Publisher: Governing Body of Suomenlinna

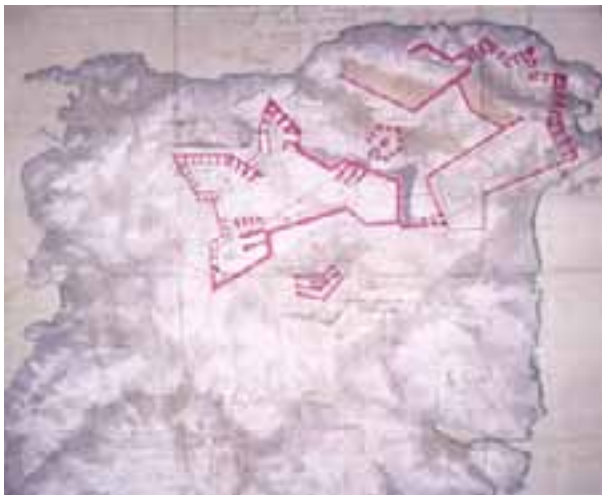
The Kustaanmiekka fortifications in an explanatory drawing dating from 1751. KrA

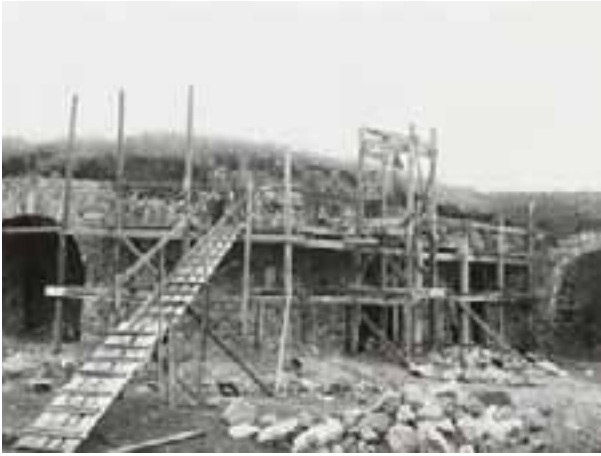
Repairs being made to the inside wall of the Kustaanmiekka shore fortifications in 1928. OE

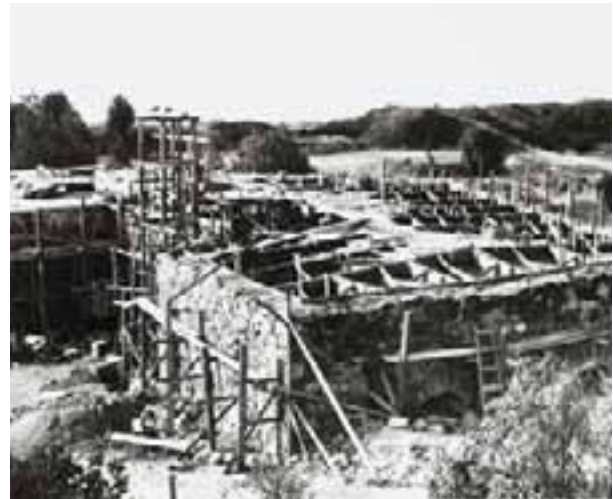
In 1956–1957, caponniere Coyet on Kustaanmiekka was excavated from under a Russian-era sand embankment, and its walls were raised to their original Swedish-era height. MV

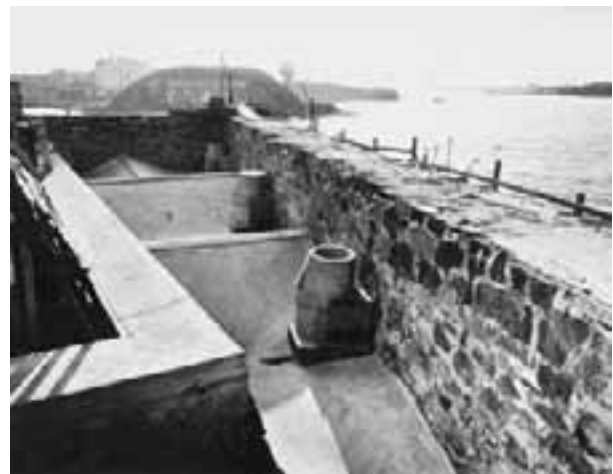
A photo from 1962, with the caption: “Restoration of bastion Stiernroos”. FR

In the following decades, structural improvements were introduced in repair work on the monument. A case in point is the repair work done on bastion Stiernroos on Pikku Mustasaari island, which is still occupied by the Naval Academy. The soil was completely removed from the tops of the casemates so that a concrete slab and modern rainwater drains could be installed to lead water

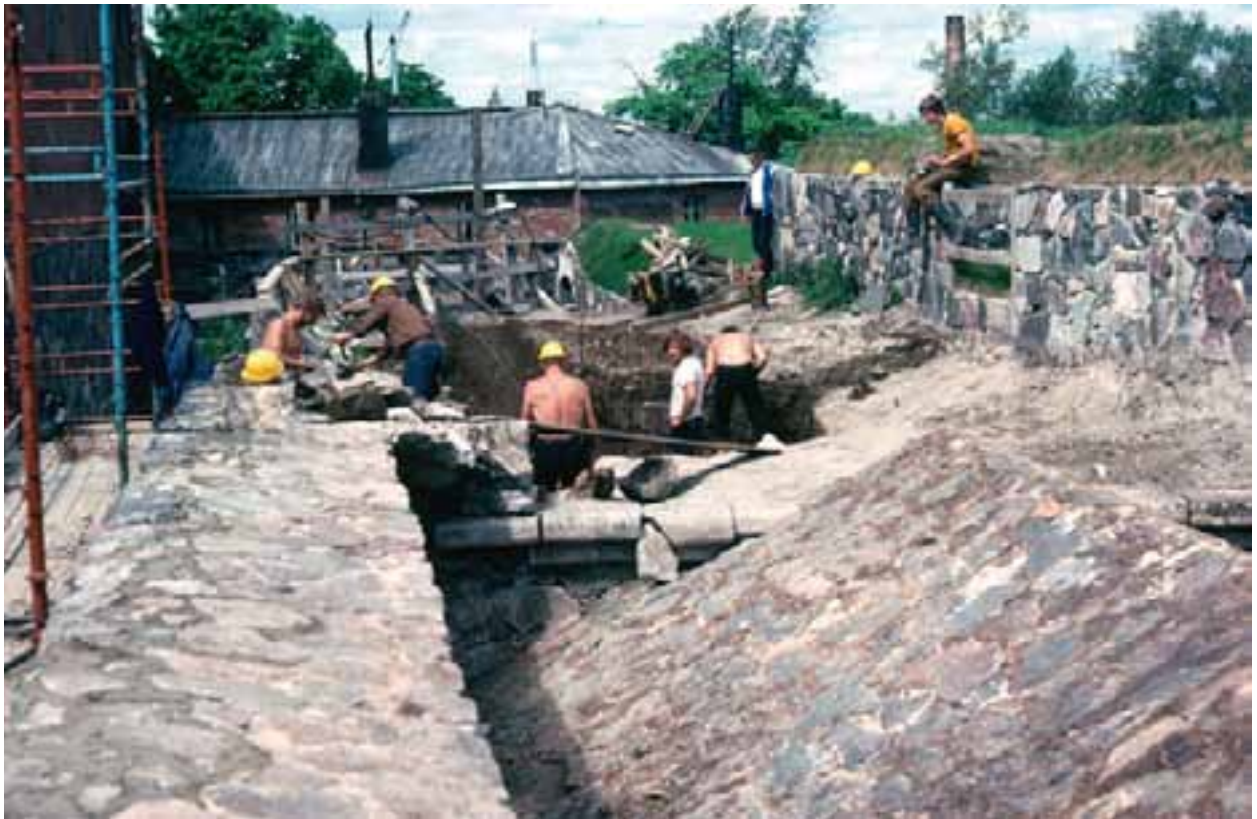
The soil layers covering the 'rifle gallery' between bastions Wrede and Hyve were removed in an exploratory dig carried out by the National Board of Antiquities in 1977.

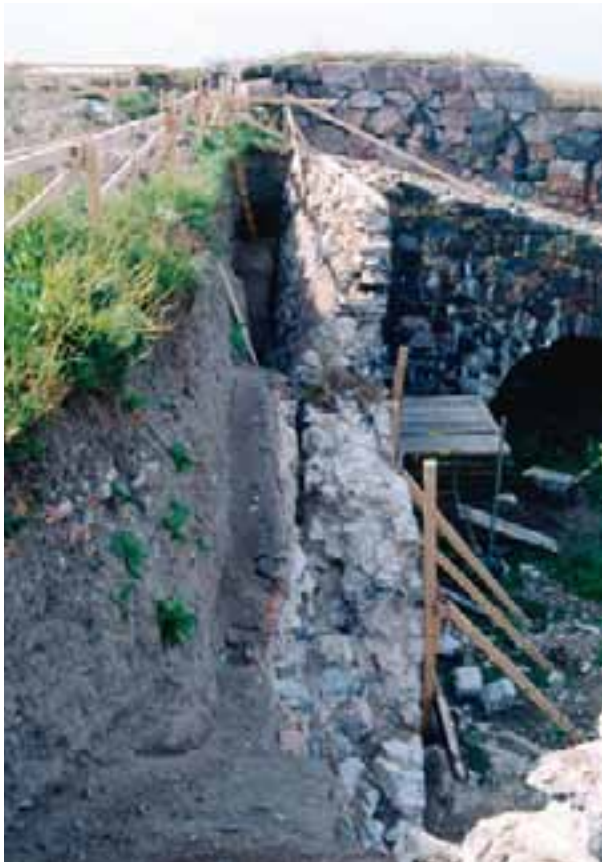
In 1992, soil was removed from the top of the Kustanmiekkä shore fortifications only to the extent required by the wall repairs. MV

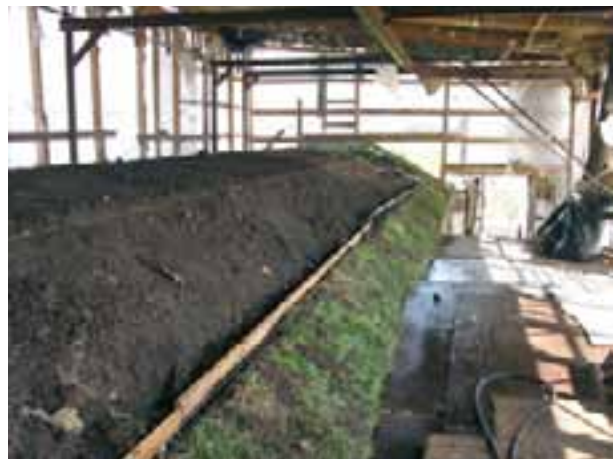
Over the birch bark, clay and soil covering of the tops of the fortifications, slabs of turf cut from grassy areas on the island (known as 'turf tiles') were laid. A view of the winter tent over bastion Hårleman in 2003. PM

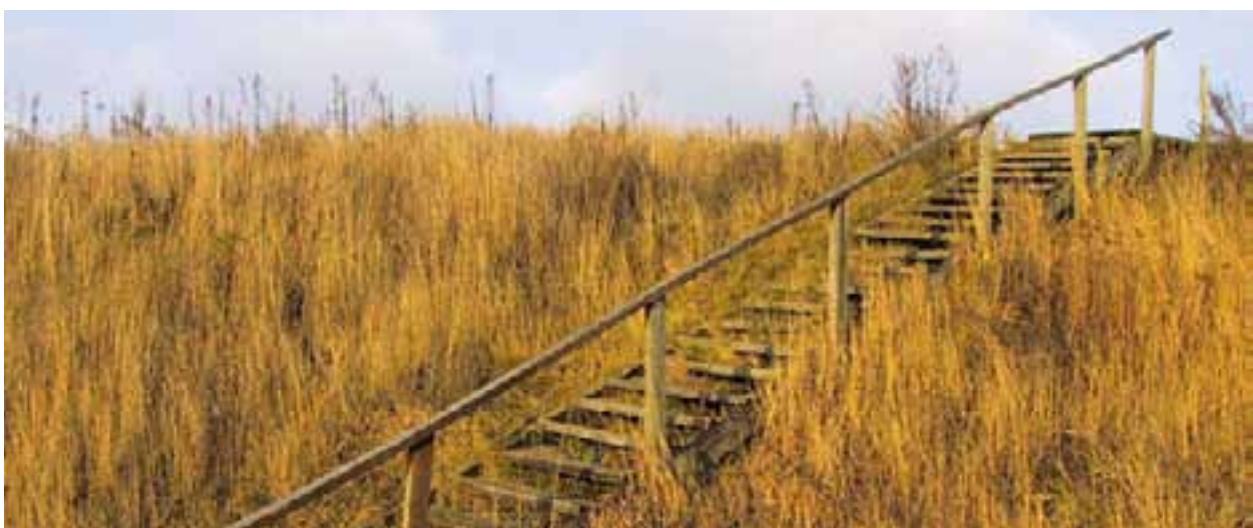
Repairing the earthworks on Suomenlinna and making them more resistant to wear and tear take up an increasing amount of the Governing Body's time. The photo shows a decayed staircase in Battery 4 on Kustaanmiekka; this was replaced in 2000. PN

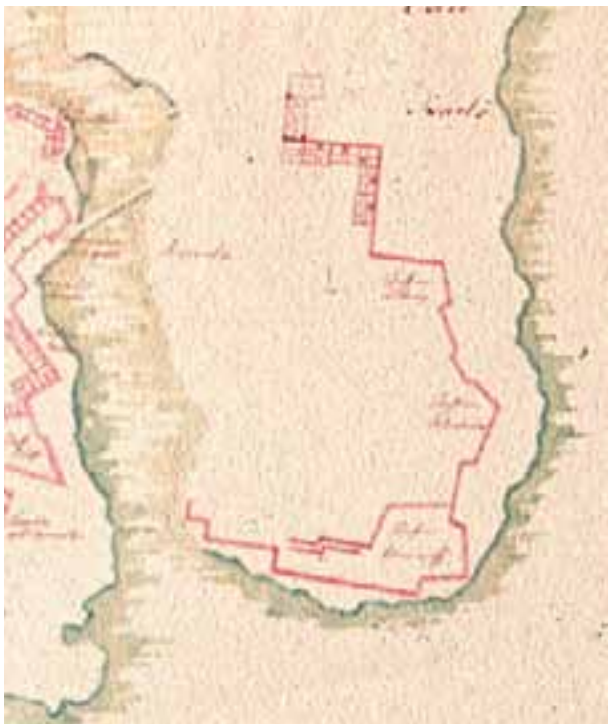
The shore fortifications and the Angled Building in a map dating from 1763. KrA

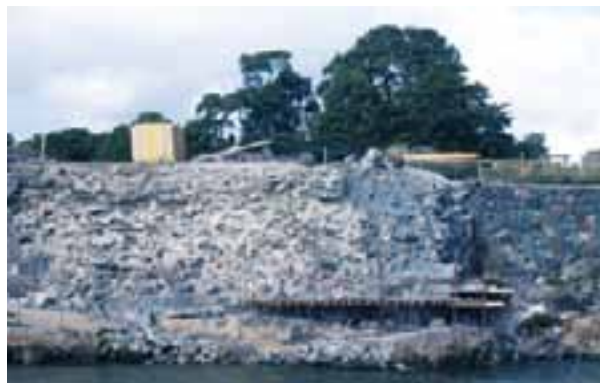
In 1986, the Governing Body of Suomenlinna continued the repairs begun by the National Board of Antiquities.

In 1977, responsibility for designing the repairs was turned over to the Governing Body of Suomenlinna. The work continued in May 1986, the work area comprising not only the greystone wall but also the open accessway between earthworks behind it, the rifle gallery, the 'Cherry Garden' and three cisterns built for collecting and treating fresh water. The walls were repaired initially with hard Parmu mortar, then a mixture of lime and cement and hydraulic lime mortar.

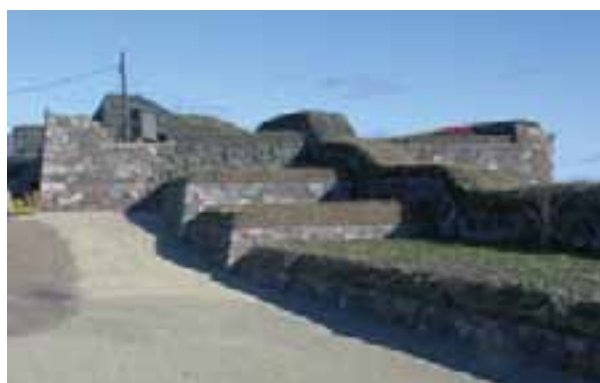
Repaired firing platforms, with a parapet on the right. LH

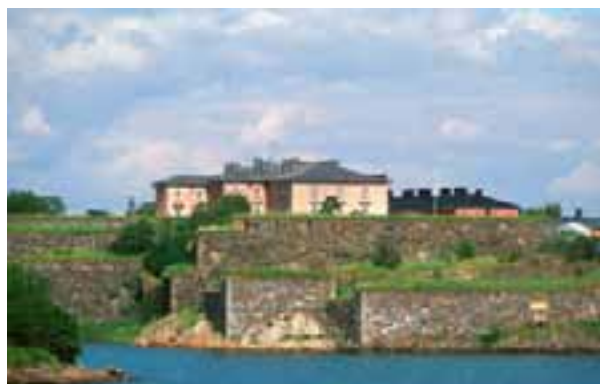
The repaired shore defences as seen from Susisaari island, with hornwork Hessenstein and the Vaasa Barracks in the background. PH

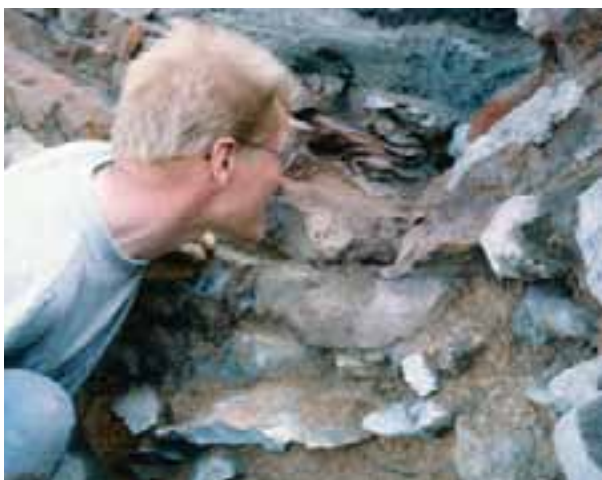
Test pits were dug to investigate the drainage system in the shore fortifications and ventilation shafts in the structures. The photo shows foreman Pentti Koponen examining a structure between casemates in 1992.

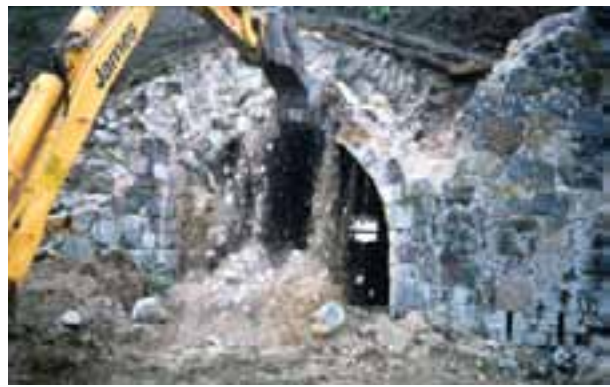
A masonry wall in imminent danger of collapsing was dismantled around an arch which was propped up in hopes that the leaning structure could be preserved and pushed back to its original location using a digger's scoop. This unfortunately proved futile, and the arch was eventually brought down in a controlled collapse.

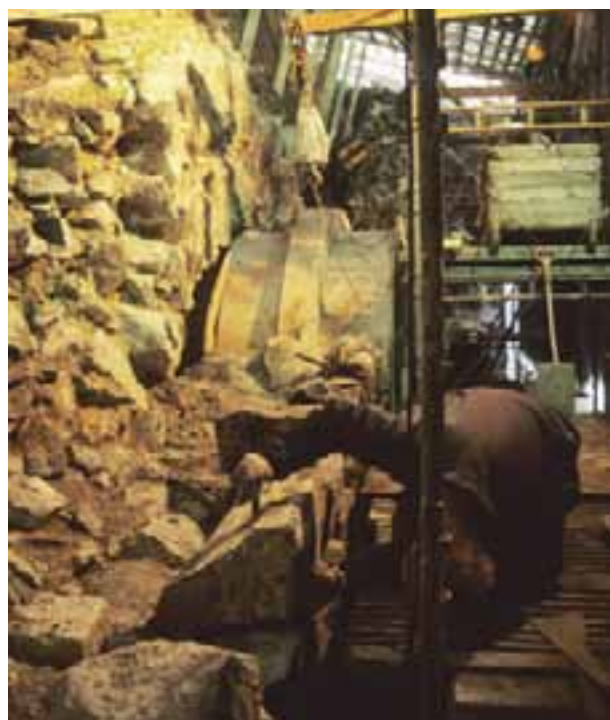
Reconstructing the dismantled arch and surrounding wall in winter conditions. MV

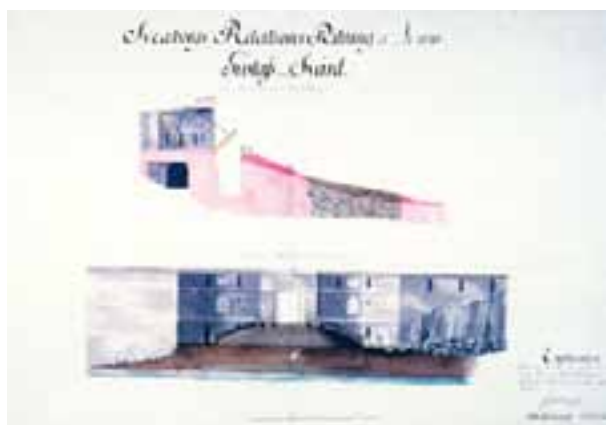
Plan for the King's Gate quay drawn up by fortress engineer Nils Mannerskantz in 1776. KrA

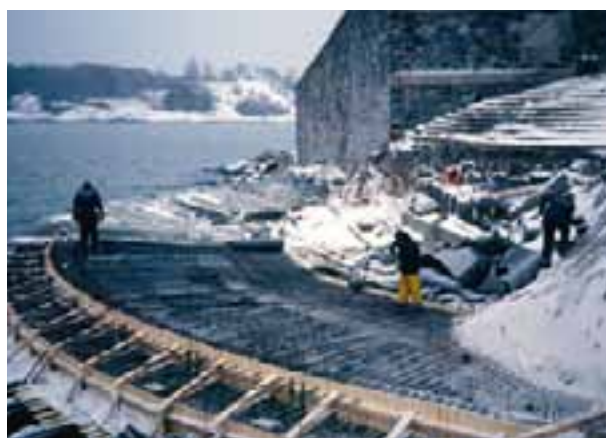
Laying the reinforcing irons for the new quay slab in December 1997. TL

Although many of the reconstruction initiatives concerning Suomenlinna proposed in the 1970s were gradually abandoned, reconstruction of the King's Gate quay was considered even in the 1990s to be an acceptable solution to harmonize the architecture of the location. The front face of the steps up to the King's Gate also required attention by then, as the currents caused by large passing ships eroded the shore more and more each year.

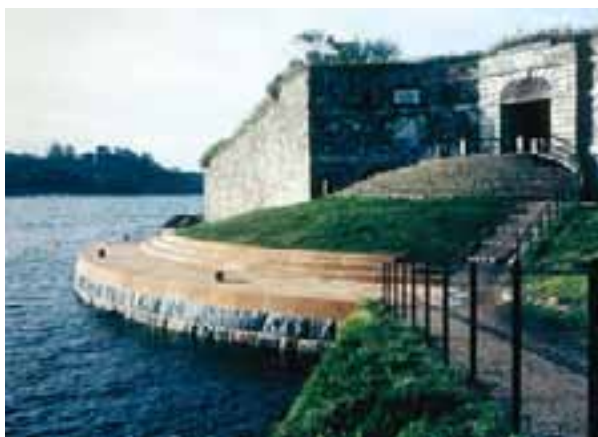
The King's Gate in 1998, after the quay was built. HS

In 1996, the principal architect on the project was asked to provide alternative designs, based on the history of the gateway and repair plans dating from the Russian era; the design selected was that which most resembled the original appearance of the quay. It was noted at the outset that modern technology would have to be used for the foundation of the quay. Land uplift over the past two centuries faced the construction project with an extra challenge.

The architect's design was based as closely as possible on the explanatory drawing signed by fortress engineer Nils Mannerskantz and dated 1774, where the central portion of the curved quay and the three steps above it are in Roslagen sandstone and the slope between the gateway steps and the quay is earth infill. But the 18th-century drawings did not indicate how the stones in the original quay were laid or how the foundations were built. Not even the diver's report could shed light on the latter. The parts of the quay for which the original design was not known were built in grey, black and red quarried stone.

The foundation for the King's Gate quay posed a considerable problem: the rock plunges to a depth of 10 m from the shore, and the currents caused by passing ships are extremely powerful. The structural designer proposed that the elements making up the edge of the quay should be suspended from a slab built on ten pillars anchored into the bedrock. In the initial plan, the deck slab rising from the quay joined the existing structure at the lower end of the steps. This, however, would have meant allowing the sea to erode the foundations of the 18th-century gateway steps; the design was therefore changed in mid-

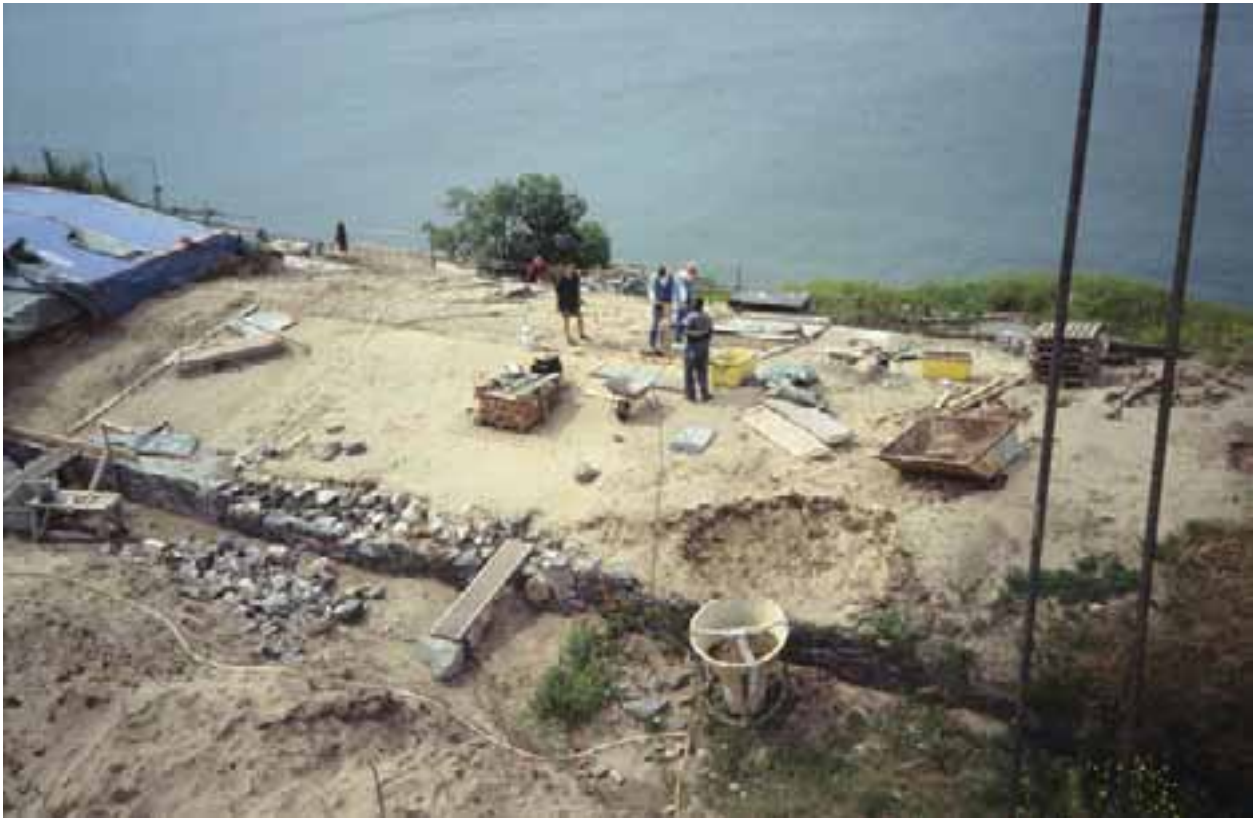
A view from the tower crane to the sand covering of the right flank of bastion Polhem, which is in the process of being waterproofed.

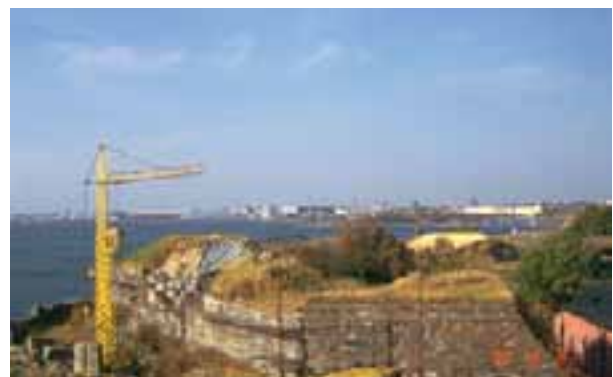
Bastion Polhem during the work process, seen from the top of bastion Hårleman. KH

A survey of the bastion’s condition showed that the wall of the left flank not only required repairs but also had to be anchored to the backing bedrock with iron bars. In the course of the repair work, too much earth infill was perhaps removed from the top of the left flank; the idealistic restoration principles declared in the project plan were thus somewhat compromised in the early stages of the work.

In addition to normal masonry wall repairs and waterproofing of wall tops, there was a further challenge in repairing the seven casemates in the right flank of the bastion. The cellars had not had a waterproof roof for

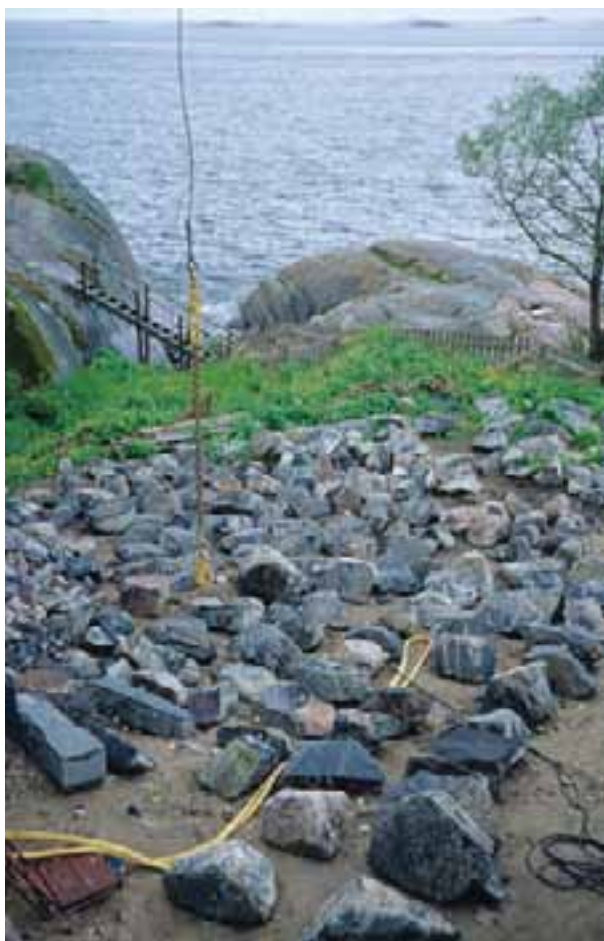
It is important for a wide range of stones to be available, so that as little work as possible has to be done in dressing them. When the stones are fitted with lifting hooks and there is a crane at the work site, progress is fast. KH

Repairing the casemates required extensive know-how in working with both brick and greystone. The stones for the vaulting in Polhem were mainly shaped using manual tools that the foremen had been inspired to acquire following a course in sandstone dressing in Tyrvää. Indeed, the Polhem work site was the first in Suomenlinna for a long time to ring with the sound of stone being worked manually.

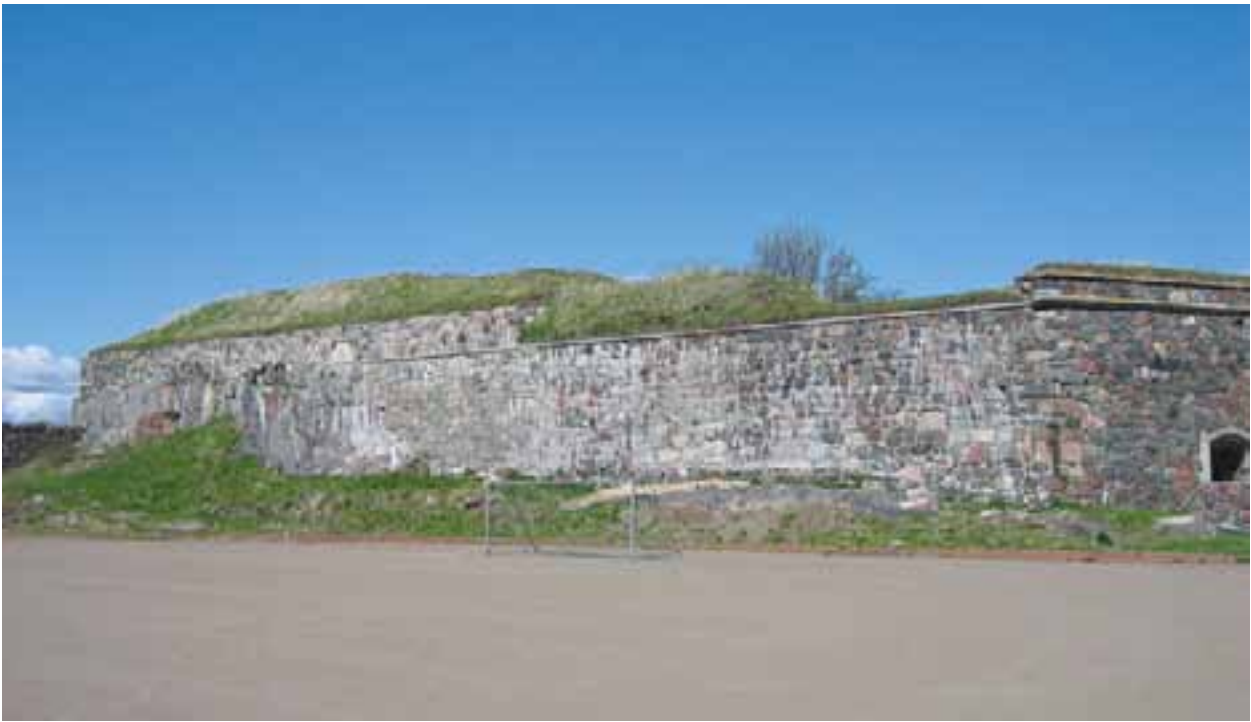
The repaired left flank and side of the bastion in 2005.

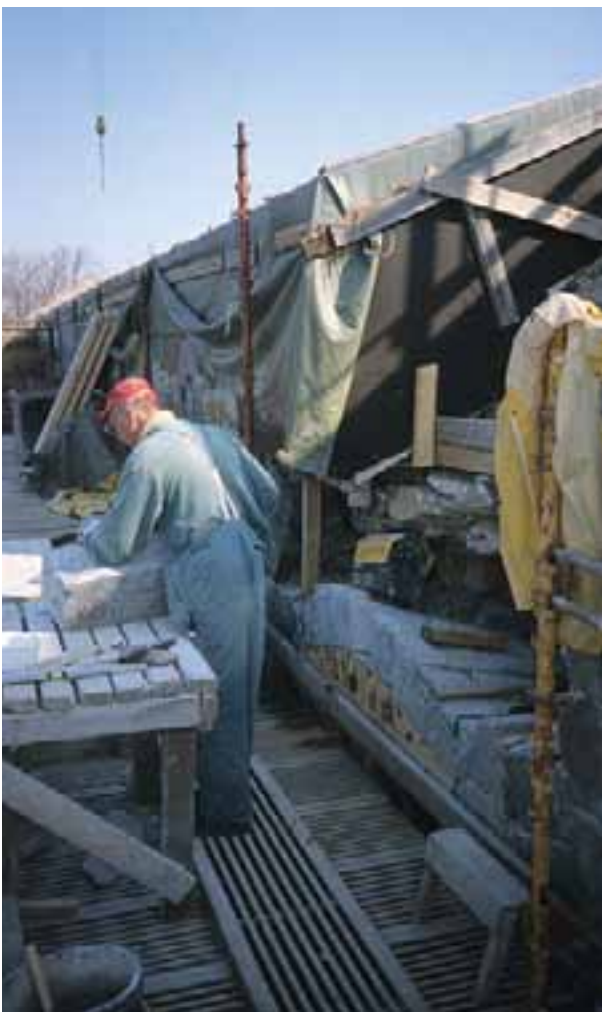
Replacements for vaulting stones missing from a collapsed embrasure being manually dressed in Kuru gray granite. TL

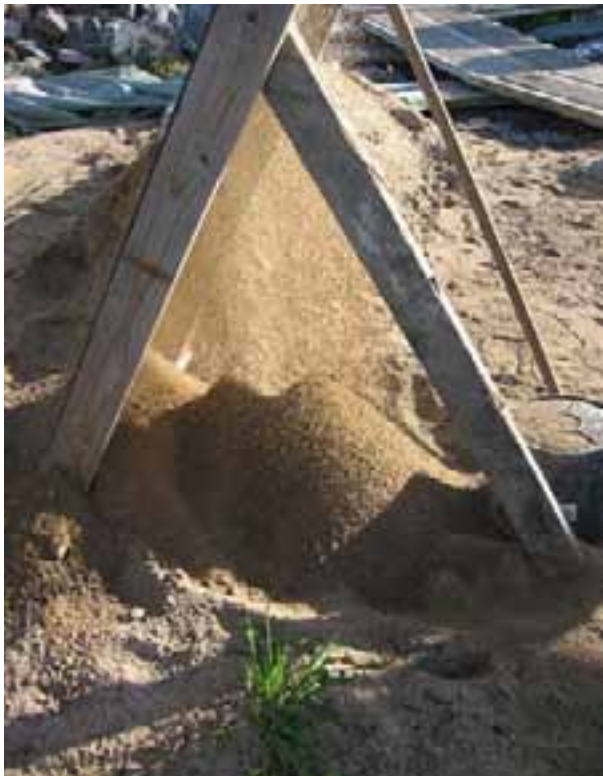
The maximum grain size of the sand used for mortar is 8 mm. For grouting, the sand is sieved manually at the work site using a 6 mm sieve. KH

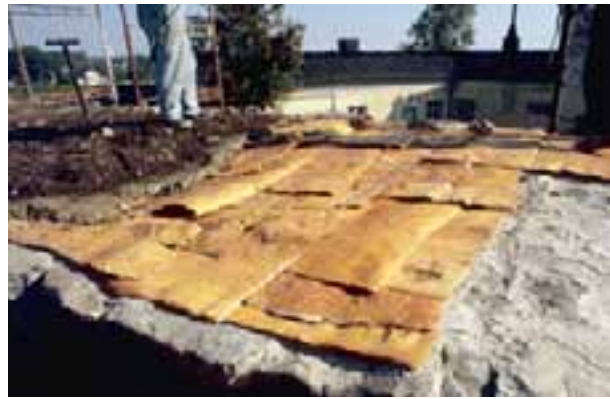
The birch bark and clay waterproofing for the top of the parapet on bastion Gyllenberg was laid in summer 2006. OH

Remnants of an old birch bark and clay waterproofing, probably dating from the 19th century, were found on the top of the left face of bastion Gyllenberg. Depressions in the plaster layer on top of the wall showed that the sheets of birch bark had been pressed into wet mortar. Initially an effort was made to preserve the old water-

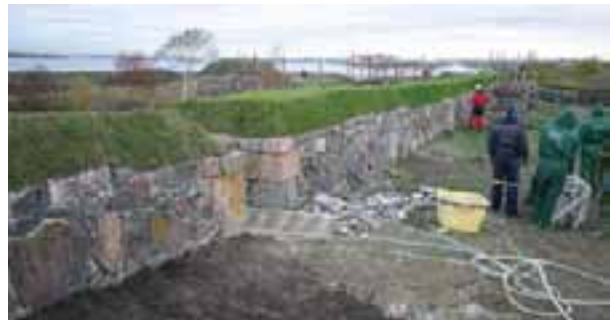
The repaired parapet on the left face of bastion Gyllenberg, seen from the firing platform. KH

Because of the severe weather conditions at the site, it was estimated that masonry laid with hydraulic lime mortar would not be strong enough on the top surface of the parapet. Thus, test areas were laid in autumn 2005 with Prompt quick cement manufactured by the French company Vicat. It was found that this mortar could survive the winter without frost damage only if it was laid very thick, whereas thinner layers were eroded, so the experiment was abandoned. Eventually the tops of the right and left faces of the bastion were repaired on the same principle as the elevations: as little space was left between the stones as possible, and the cavities were filled with injected hydraulic lime mortar.

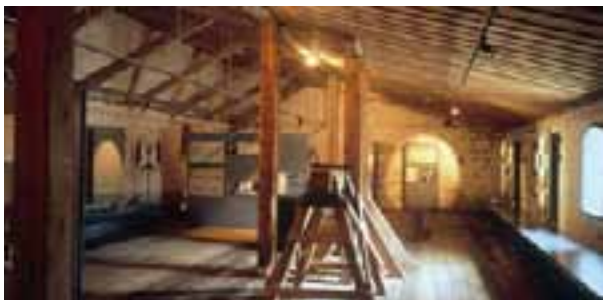
The thick pillars and beams supporting the floor in the old part – partly replaced and partly repaired (lower photo) – and the floor boards (upper photo) were left exposed. VN

The auditorium on the ground floor was given sufficient height by lowering part of the floor to the level of the 18th century floor. The offices, museum shop, toilets and technical facilities were housed in the extension, which was designed to match the size of the Russian-era mast store. The roof is carried on pillars in places and indicates the original, Swedish-era size of the mast store. Where the old and new parts meet, the buildings seem to fit one inside the other, underlining their historical cohesion.

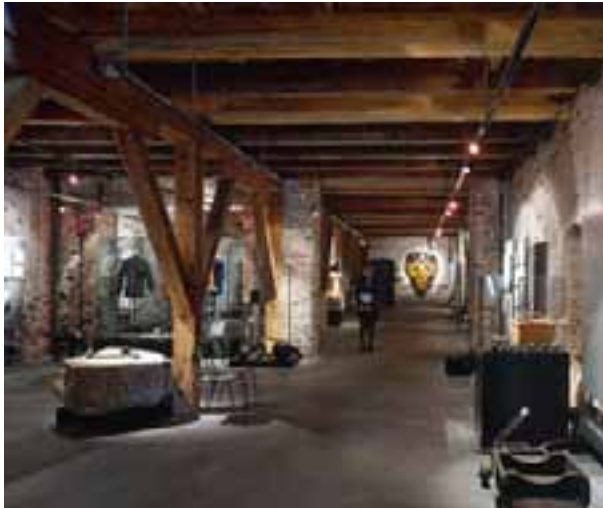
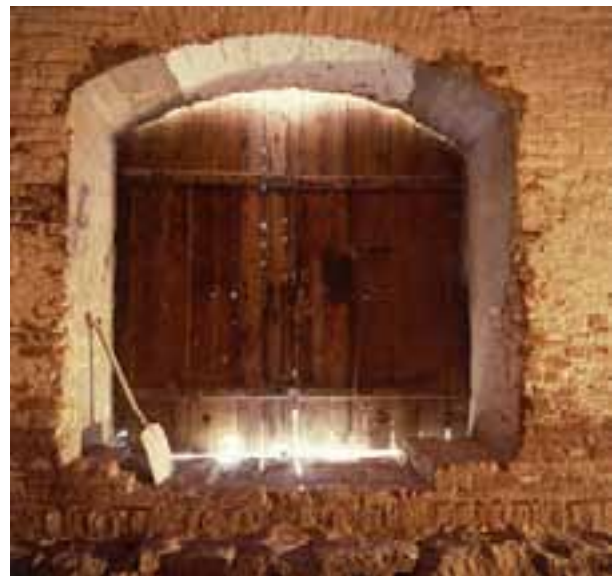
The vaulting in the doorway clearly shows where the doorway has been widened. MK

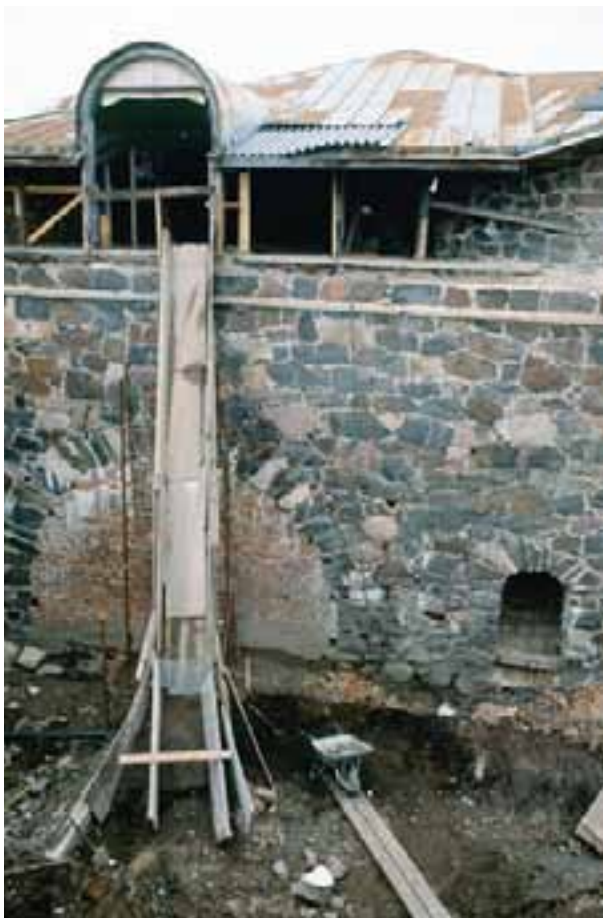
The old sheet-metal roofing being dismantled in 1991. TS

Hyvä Omatunto found a new use as a summer theatre in the late 1960s. It was initially used as such by Helsingin kesäteatteri, then by KOM-teatteri, and from the 1970s by Ryhmäteatteri. Until 1992, the salient and main body of the ravelin were covered by the Russian-built sheet metal roof, but the auditorium and stage remained uncovered in summer.

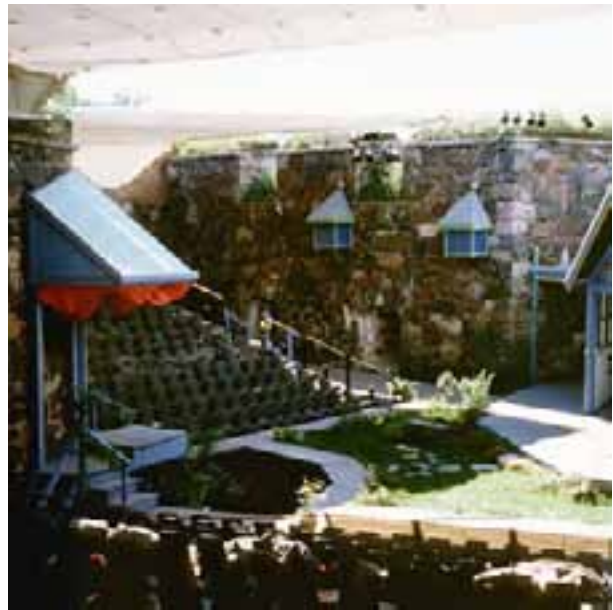
In 1998, *The Seagull* by Chekhov was performed at the summer theatre. The auditorium is sheltered by a canopy. HL

The National Board of Antiquities imposed certain conditions on any structures to be built for the theatre. The roof was not to be visible from outside the ravelin, and all auditorium and stage structures had to be designed so that they could be dismantled for the winter, when the ravelin was open to tourists. The roof thus had to be concealed below the level of the parapet. The roof as built is a white, rectangular sheet suspended from steel wires fixed to concrete beams and anchors installed on the firing platforms.

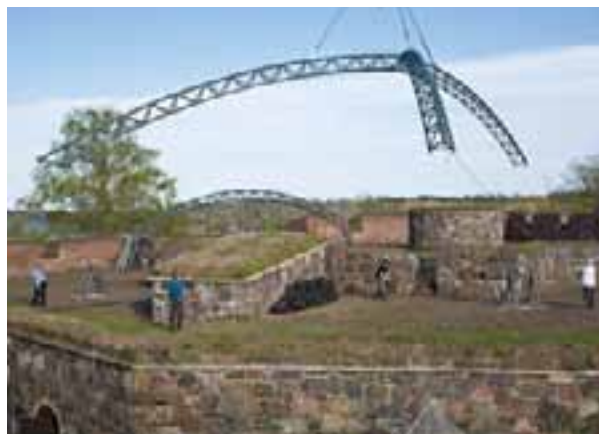
Installation of the load-bearing structures for the new roof in May 2007. JL

experiences of outdoor canopies acquired from roofing design experts. The end result was a roof consisting of a single sheet of PVC, assembled from several hand-cut pieces and pressed into shape. It is supported by one 30-metre Y-shaped steel arch and two smaller steel arches, fastened to steel trestles anchored to the firing platform. The final dimensioning of the steel arches and their anchorages was determined according to the forces acting on the sheet.

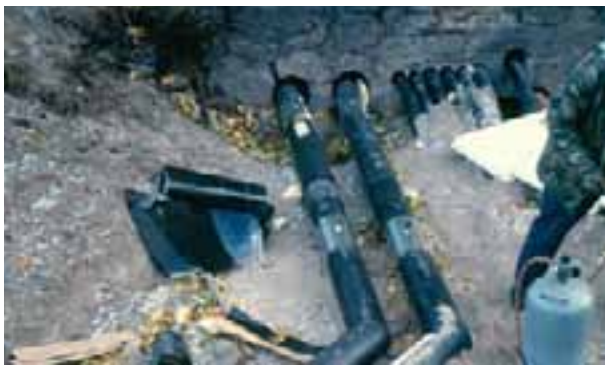
Installation holes in the stone footing. KH

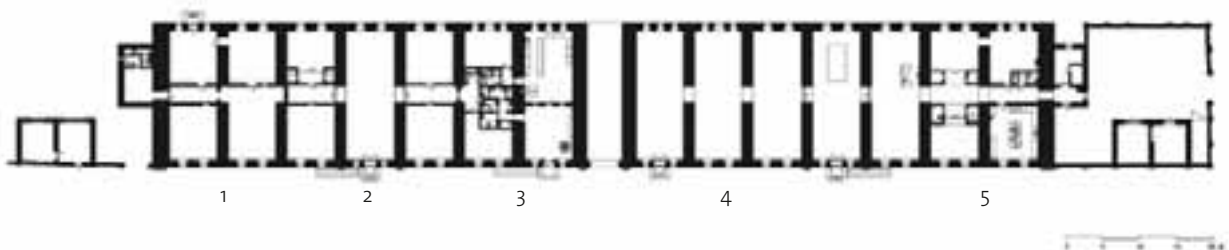
Floor plan: 1 recording studio, 2 workrooms, 3 kiosk and public toilets, 4 gallery, 5 brewery restaurant.

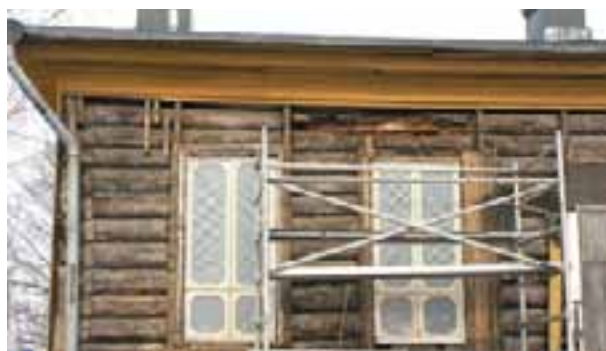
In the Russian-era log buildings, the outer faces of the logs were often left unhewn and simply boarded over, while the inside surface was hewn and plastered. A leaking ceiling had caused the upper part of a wall to rot at Yläkerho. RR

The kitchens and toilets were rebuilt and all heating, plumbing and electrical installations were replaced. Floors subject to subsidence and damp were rebuilt, the lowest courses of logs in the walls repaired, the old doors and windows reconditioned, and the inside walls and ceilings painted. The sauna suite is separate from the old structure.

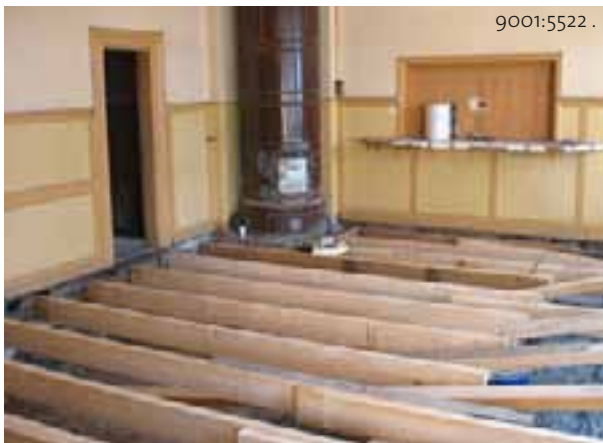
New solid wood beams being installed in the floor of the billiard room. The load-bearing structures of the floors were replaced nearly throughout the building. TK

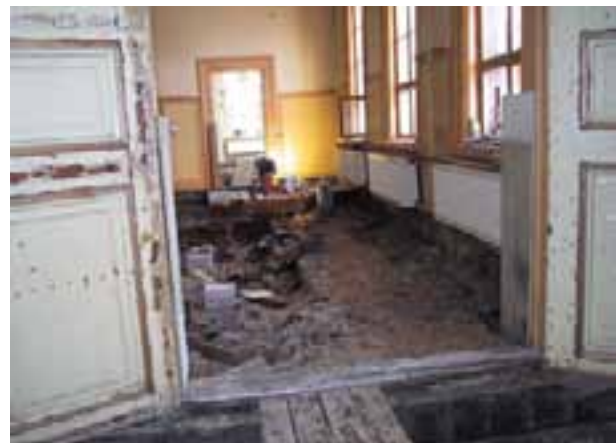
The floor structures being dismantled. TK

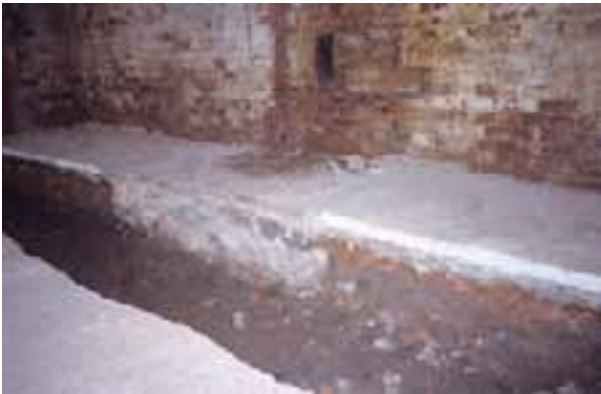
An installation duct for water mains, sewers and heating pipes was cut in the old flooring which was preserved. The base of an old fireplace can be seen in the middle. TL

The aim of the conversion work was to prepare the old building for what was expected to be quite heavy use by marina visitors, while preserving the five vaults and marks left by time. The foundry's earlier use for storing paints and solvents meant that some of the flooring had to be completely removed because it was contaminated.

The floor constructions in the washrooms, toilets and kitchen were completely replaced. In dry areas, the old floor was left visible or covered with new wooden flooring. The lime-washed brick surfaces of the old walls and ceilings were cleaned, but not re-coated. The new walls were built as separate structures. The remaining outside doors and windows were renovated and any missing ones replaced. Openings for doors and windows were made in the bricked-up archways only where necessary. Because of its original function, the building had several large flues, and these were used as ventilation ducts. New chimneys were built to replace those that had collapsed. The waterproofing of the turf roof was improved by replacing the structural layers around chimneys and at the eaves. Traditional materials such as clay and lead sheeting were used as waterproofing.

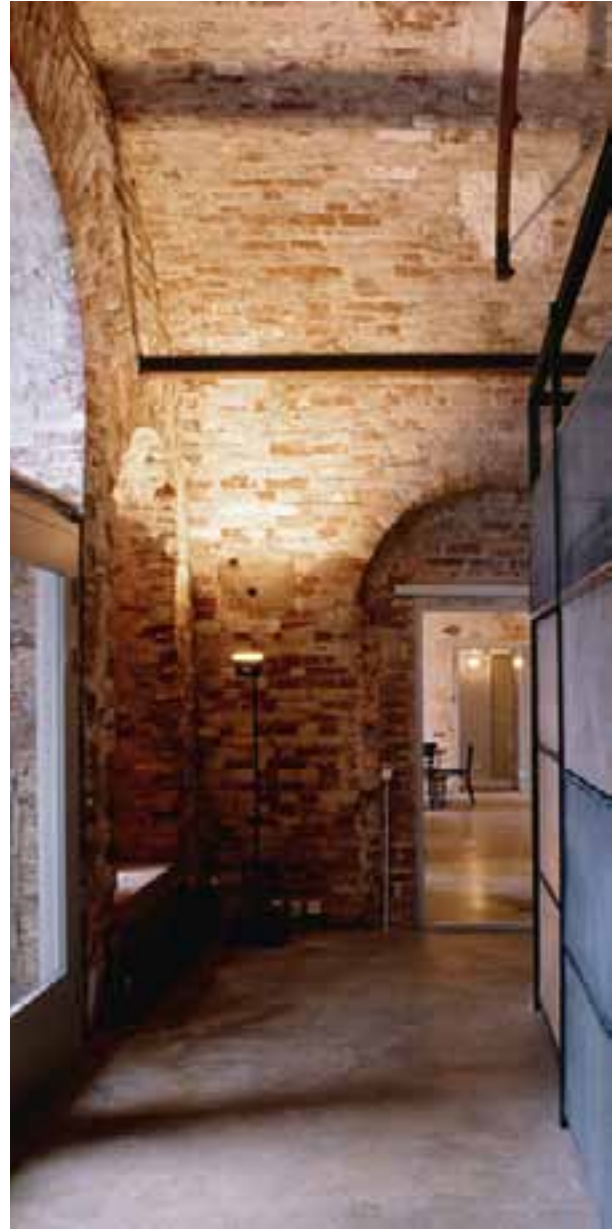
The old vaults in the foundry building were cleaned. JT

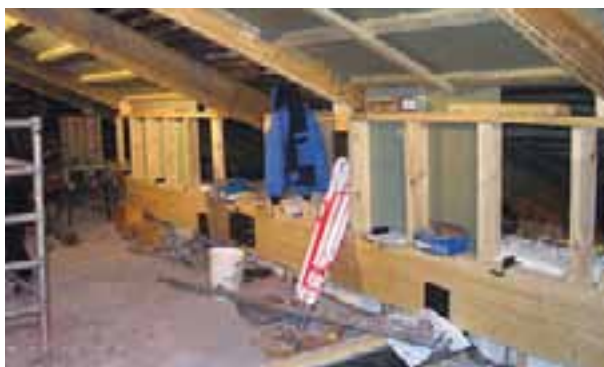
For new accommodation to be built in the attic, the floor had to be reinforced. The old floor beams were suspended from new laminated wood beams. KH

The purpose of the repairs was to preserve the original characteristics of the building, which was designed as a school. Old interior surfaces such as ceiling panels were uncovered by removing more recent panelling, installed mainly in the 1960s and 1970s, and old panelled doors were repaired. The attic floor was converted into a heated space for accommodation purposes to increase the number of beds in the building. This rebuilding was distinct from the old structures, and the unfinished brick surfaces typical of the attic space were left largely exposed. Natural lighting is through skylights opened in the roof. The former downstairs classroom was turned into a room for meals and teaching. The new upstairs accommodation was fitted with mechanical air conditioning, while the ground floor has mechanical air extraction. Also, all water and sewer piping and electrical installations were replaced. TK

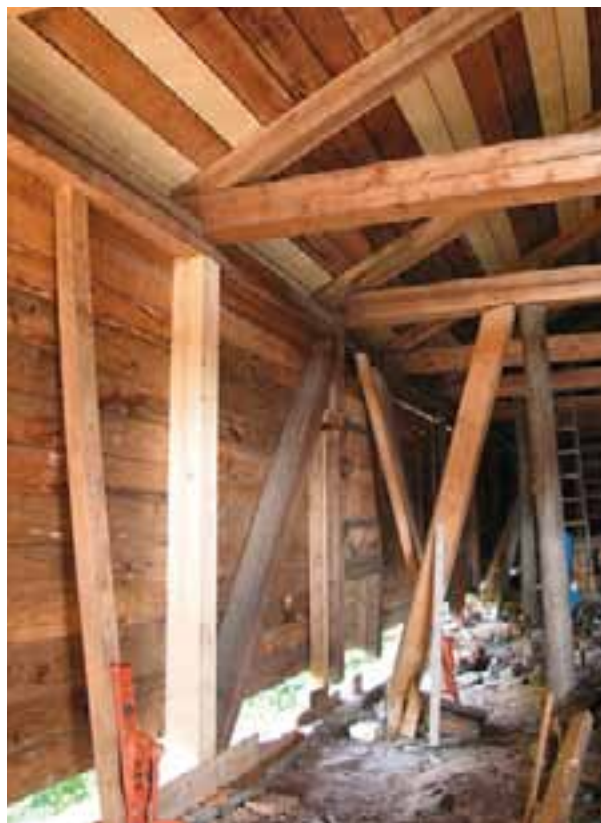
The wall was jacked up so that logs could be replaced. KH

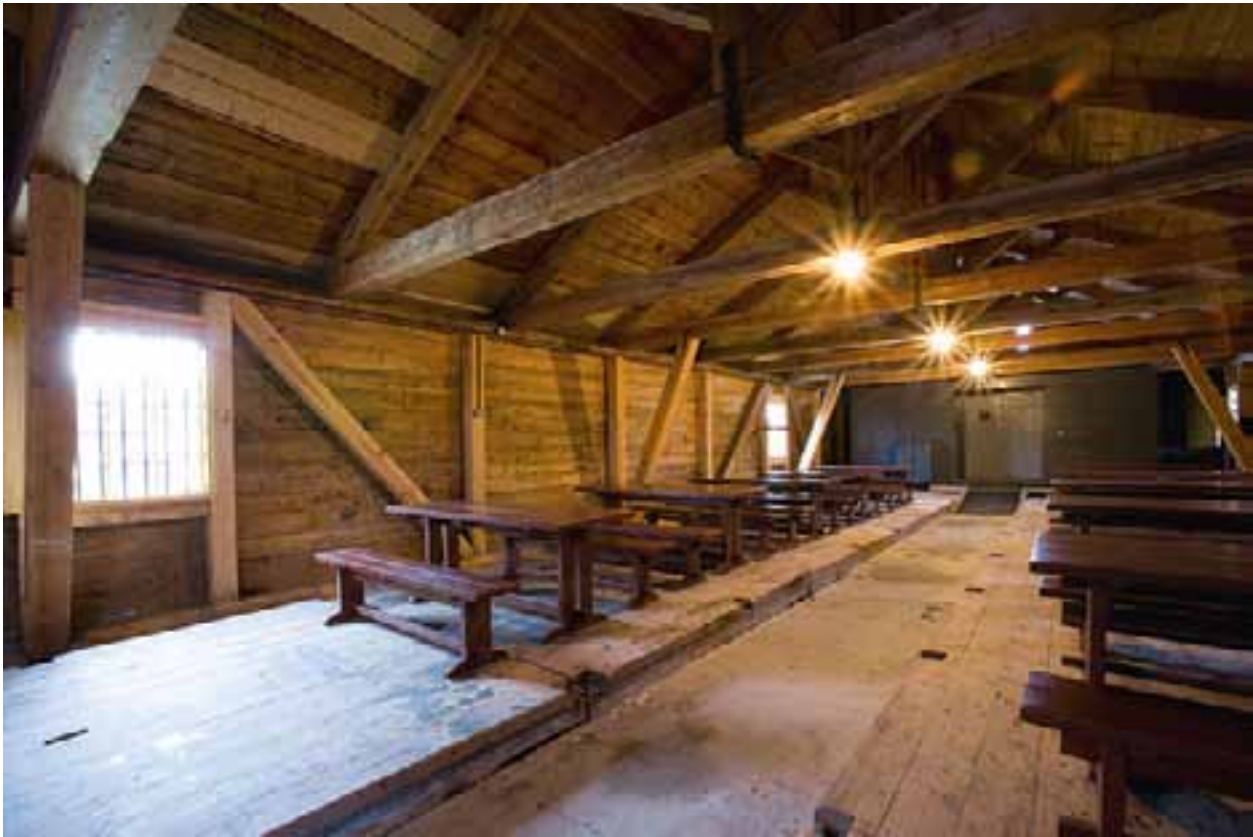
The picnic shelter. The panel-built WC unit is a distinct new structure at the end of the building. EJ

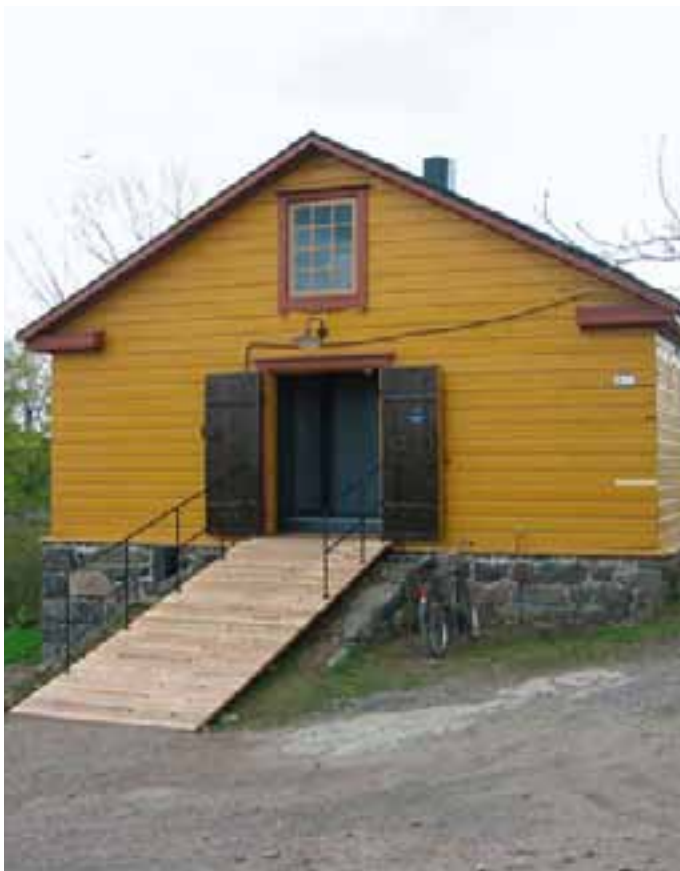
The toilets in the storehouse are open around the clock in summer. TK

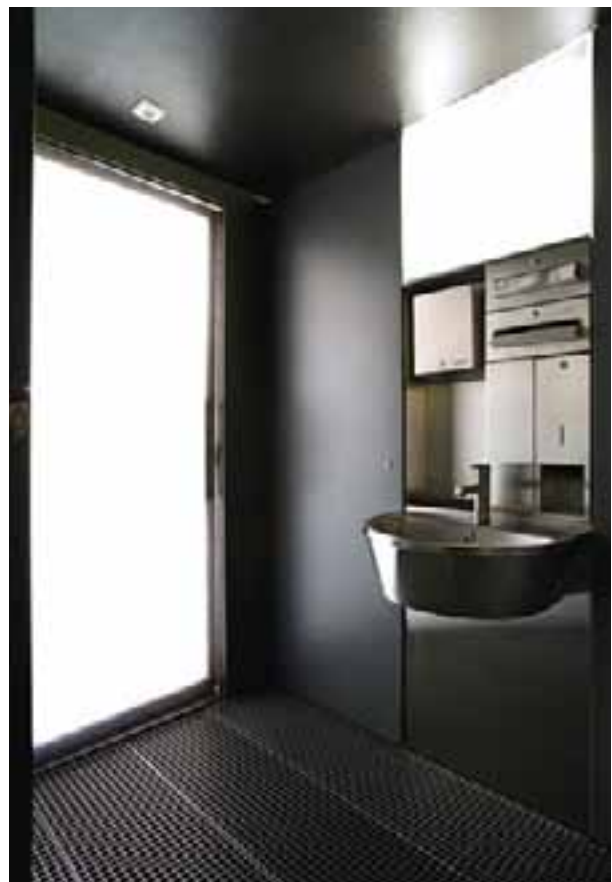
The polycarbonate sheet in the door has a random pattern of scratches to prevent visibility yet allows natural light to penetrate the interior. JKe

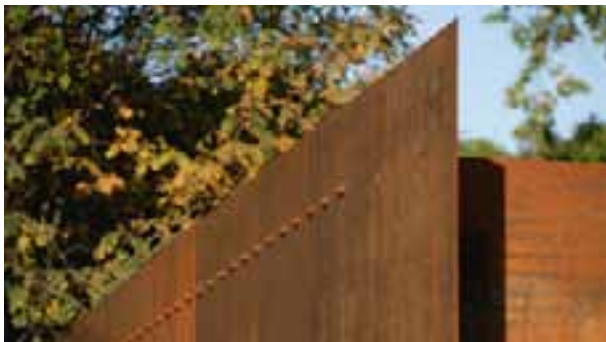
The ventilators in the elevation punctuate the smooth Corten steel surface. JKe
