Suomenlinna

Conservation and Reuse

GOVERNING BODY OF SUOMENLINNA

Publisher: Governing Body of Suomenlinna

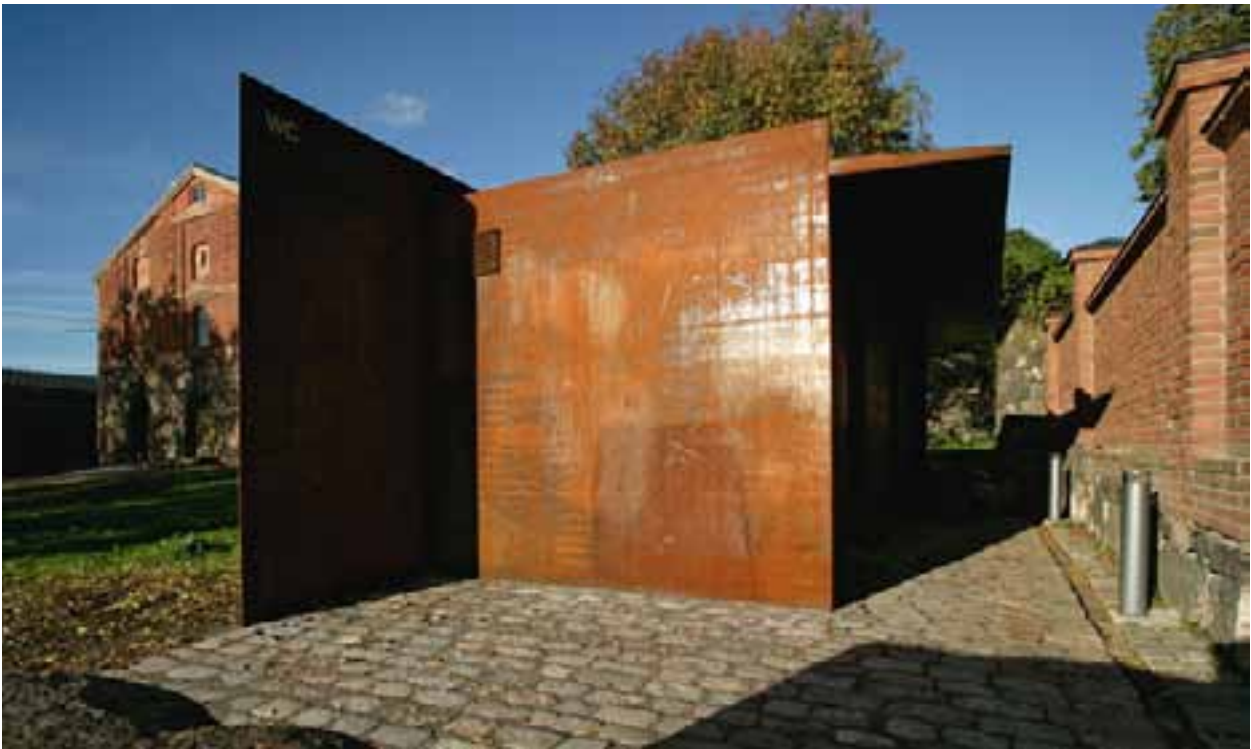
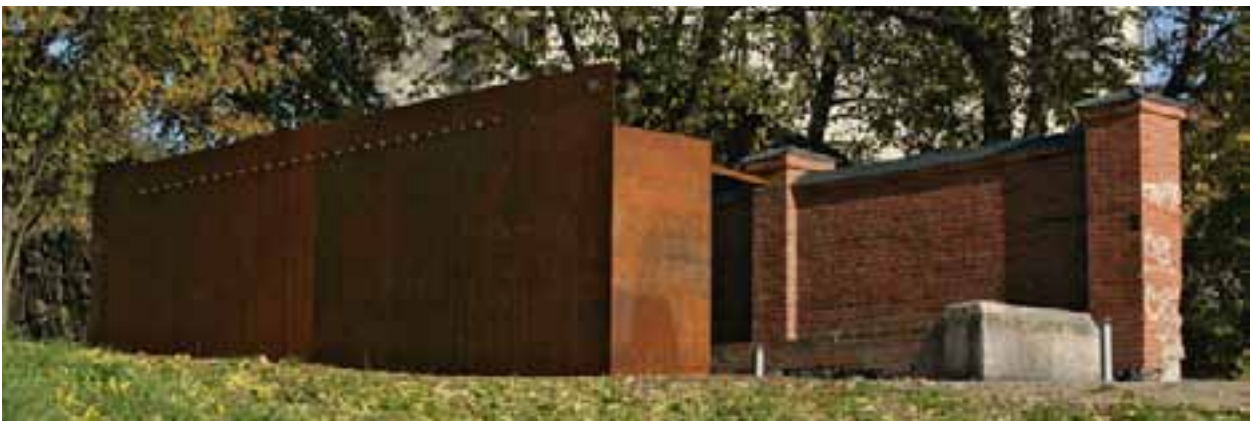
The vertical Corten surface will weather and become patinated like the quarried stone and brick that are Suomenlinna's main building materials. JKe

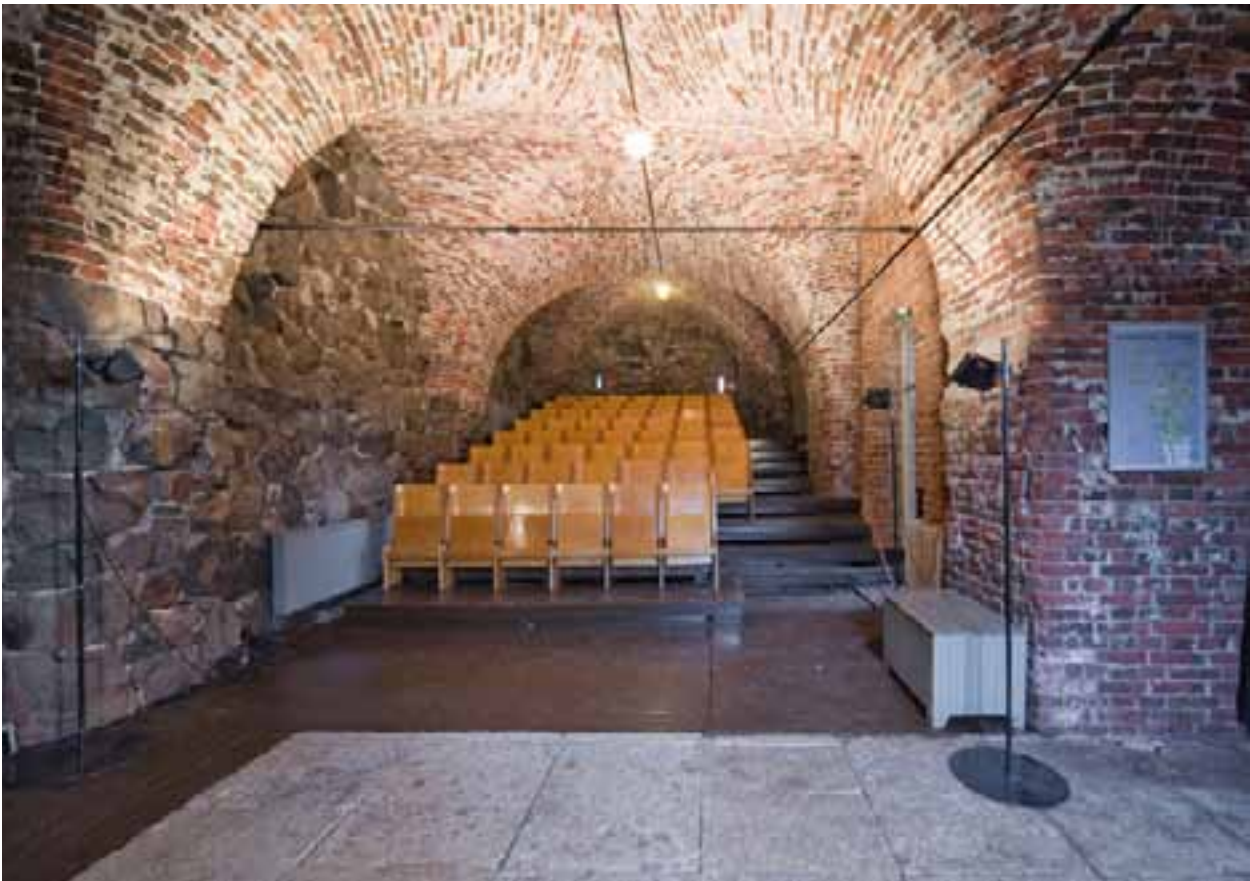
The floor in Paarlastihuone (Ballast Room) is part limestone, part wood; the entrance hall has a cobblestone floor. JL

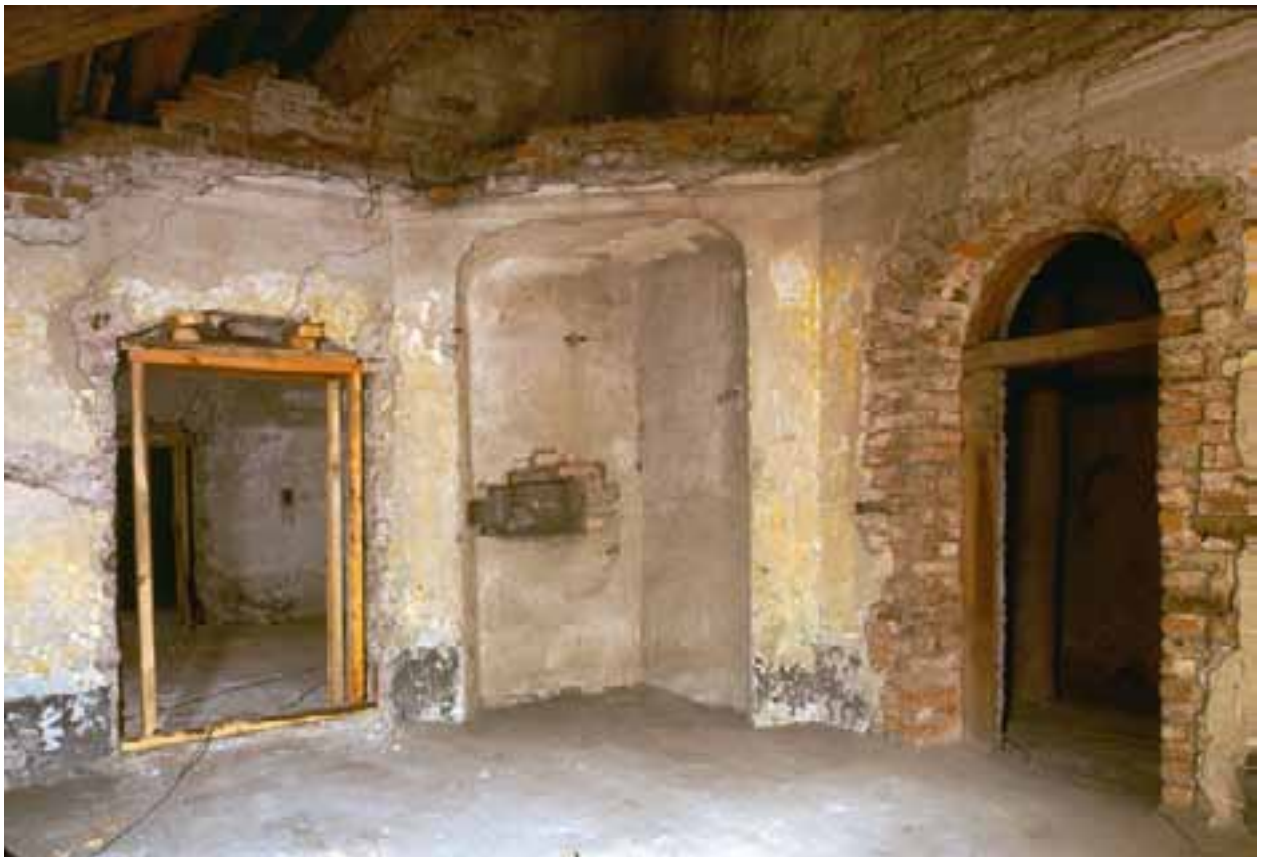
Ruins in the attic.

The attic has been kept in the ruined state in which it has been since the Crimean War. Some of the brick and stone surfaces in the cellar and on the elevation still remain to be repaired. Accessibility is a challenge, because the building stands on a slope and the rooms are located on different levels. The entrances on both floors allow for wheelchair access, but so far only the first floor has a disabled toilet.

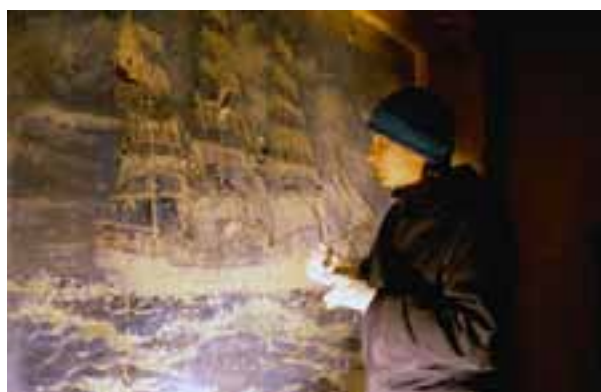
Art conservator Anne Karjalainen at work on the stairwell mural.

As the repairs progressed, it was considered important to preserve the various historical surface layers. The murals on the walls of the private rooms and stairwell on the main hall level dating back to the Finnish Army period have been conserved. Mechanical exhaust ventilation was installed in the kitchens and toilets.

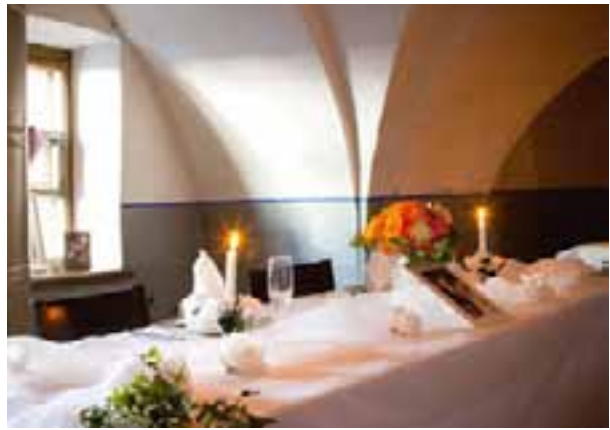
The rugged vaults and unpainted wood floor provide an elegant setting for formal occasions. EJ

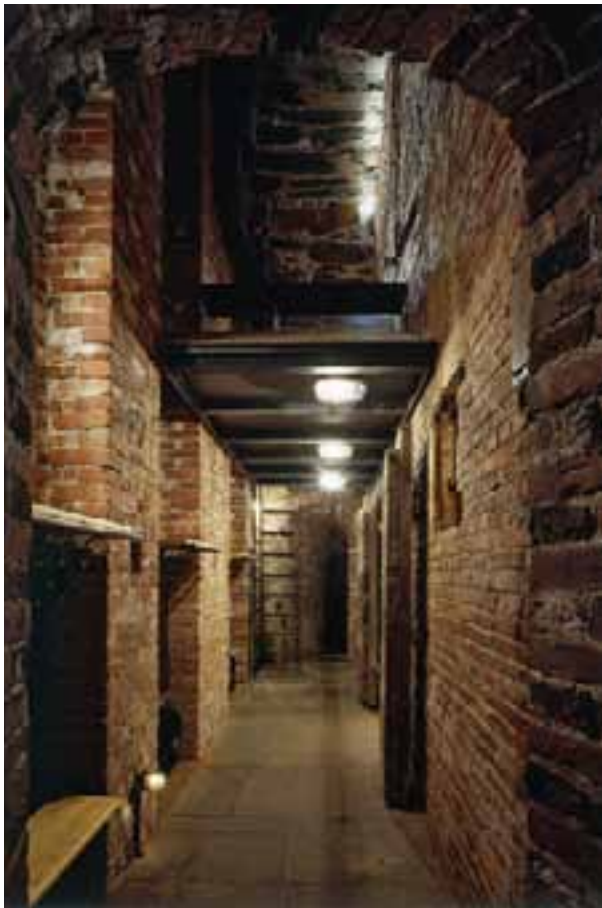
Coat racks and a steel-built balcony for AV equipment were built in the narrow circling corridor at the south end. JT

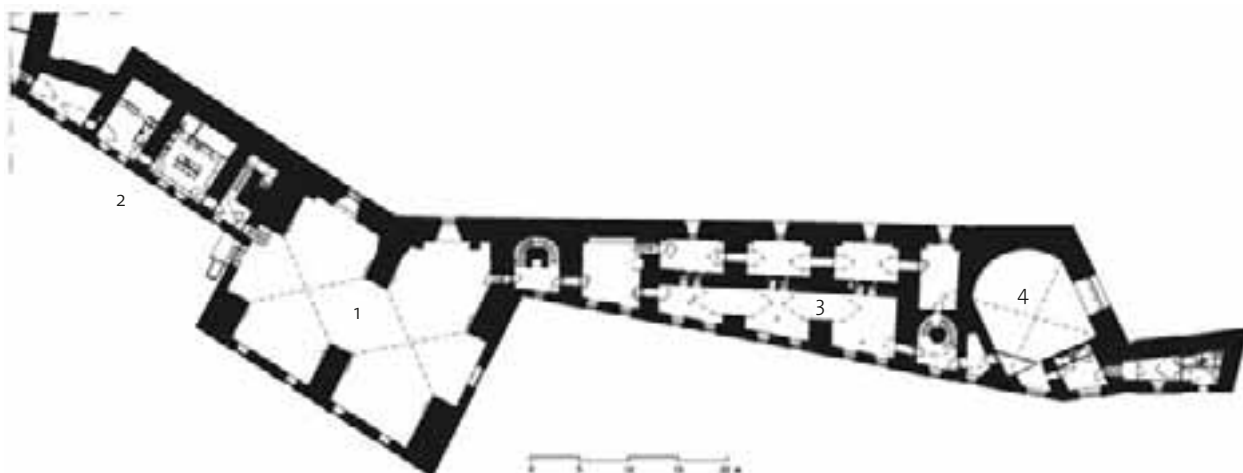
Floor plan of the main hall level: 1 main hall, 2 kitchen, 3 biscuit drying chamber, 4 mill hall.

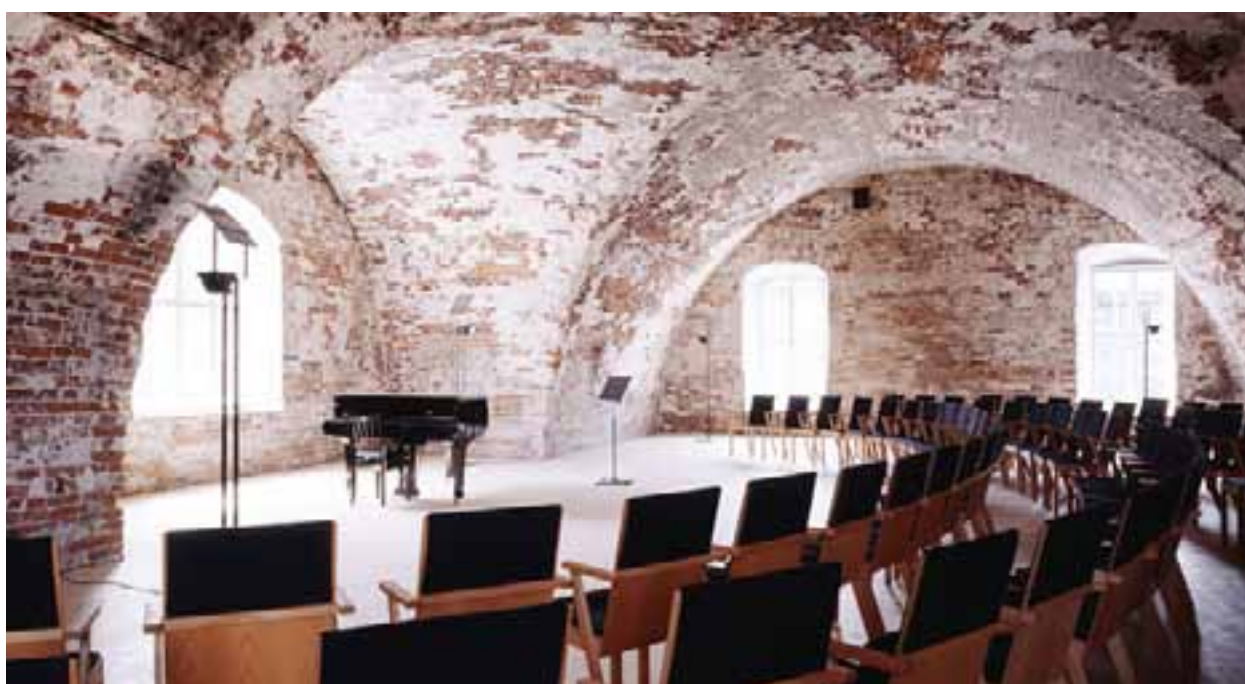
The main hall can be arranged for concerts, conferences or functions to seat a maximum of 240. The hall has a flexible lighting system thanks to movable free-standing lamps equipped with dimmers. AdIC

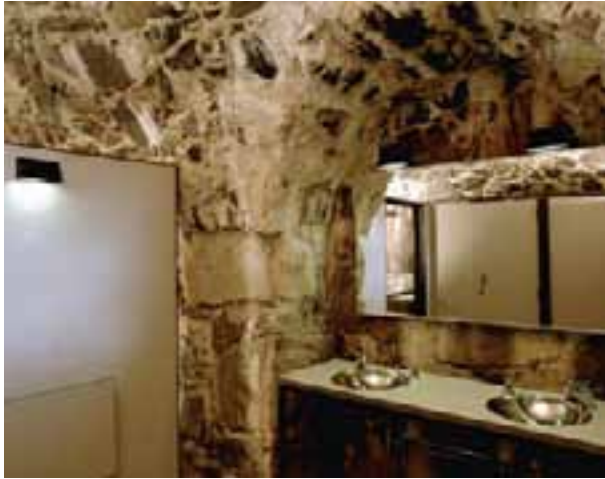
Public conveniences were built in the greystone casemates in bastion Seth so that the new structures stand free of the stone vaults. KJ

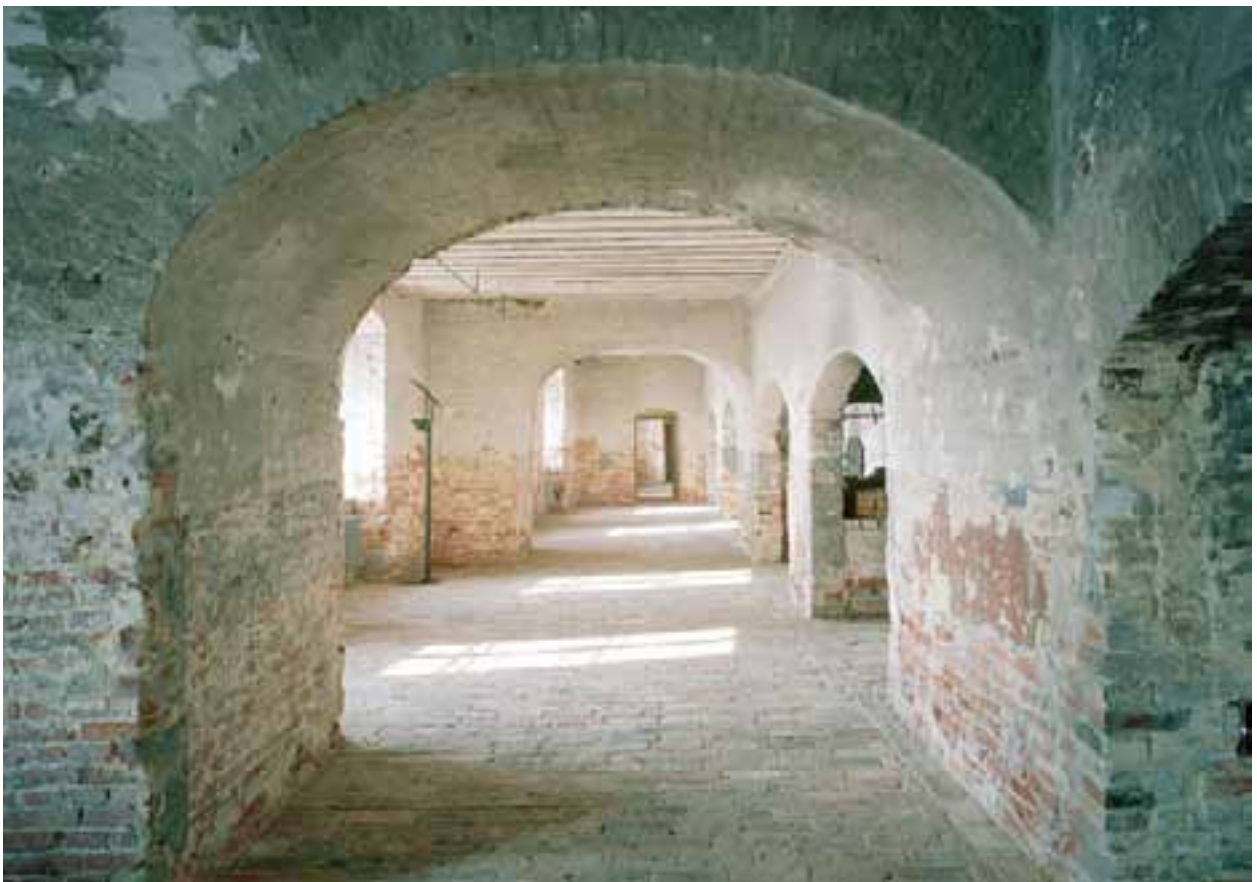
The bakery contains six large baking ovens built for provisioning the Archipelago Fleet. The new floor was made of bricks from a dismantled structure elsewhere and built to the level of the original brick flooring, which had been dismantled in the 1960s. The paintwork on the walls was conserved. JT

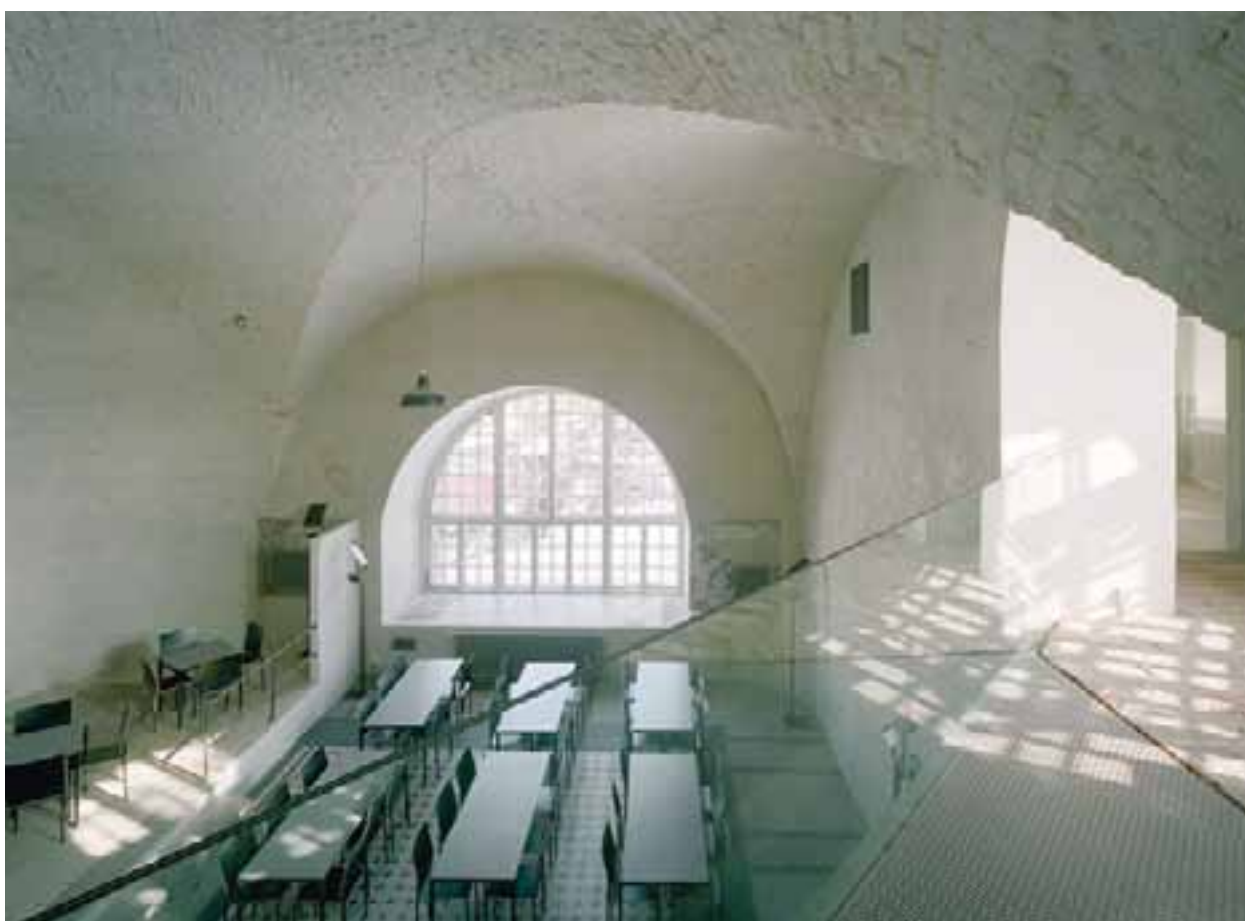
The mill hall was renovated for use as the main hall foyer, a meeting room and a small-scale theatre. JT

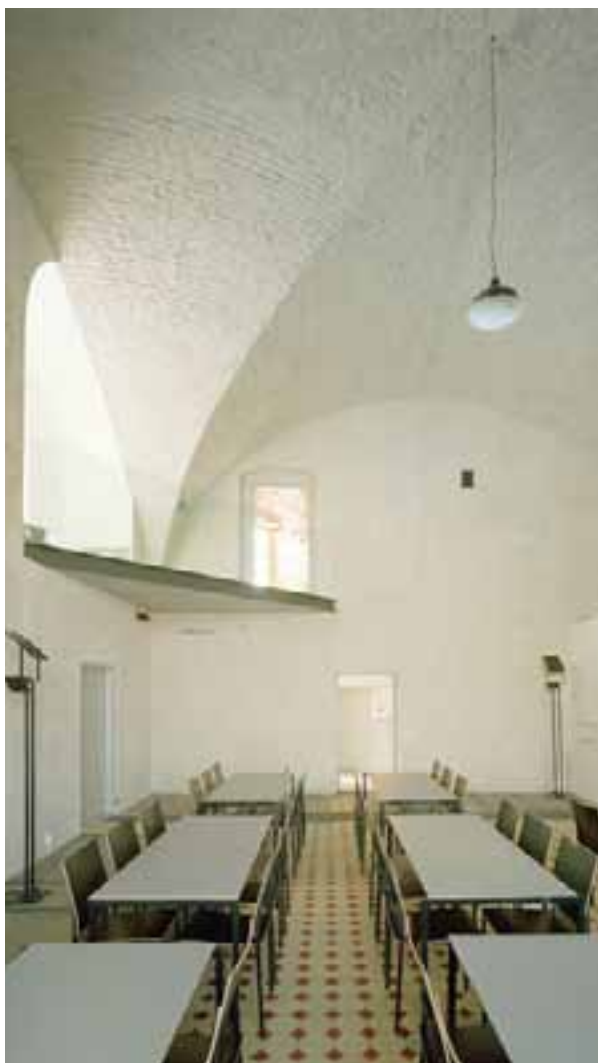
The mill hall, a large cross-vaulted space, was originally divided into two storeys by a wooden intermediate floor. The modern steel-and-glass platform that leads to the rear rooms on the second floor marks the location of the dismantled floor. JT

Originally, a wooden intermediate floor divided the mill space formed by the great cross-vault into two storeys. Now, a new accessway was built to the rear of the second floor in the mill hall, and a small, triangular platform added to mark the location of the original intermediate floor. At the same time, the doorway between the bakery and the mill hall, which had been bricked up for a long time, was reopened.

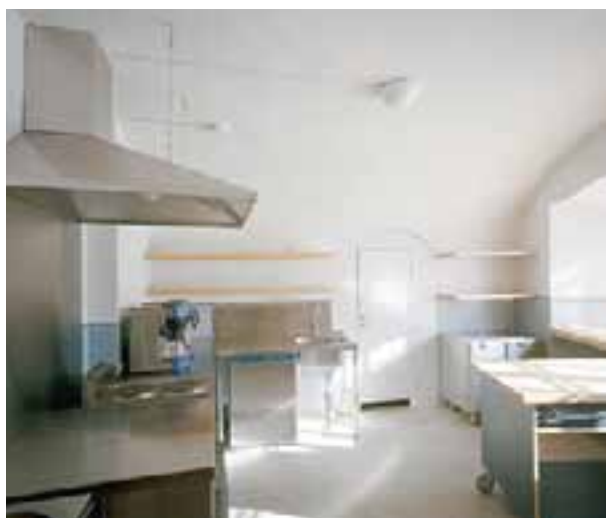
The small kitchen adjacent to the mill hall was built in an intermediate space that had undergone numerous alterations. The mill hall, kitchen and toilets have mechanical extractor fans, though elsewhere the ventilation is natural. JT

All the kitchen and WC facilities needing air conditioning and access to water, and those to be used mainly as staff or theatre changing rooms, were built in the areas to the rear of the mill hall. Public toilets are located in the case-mates of bastion Seth around the same courtyard.

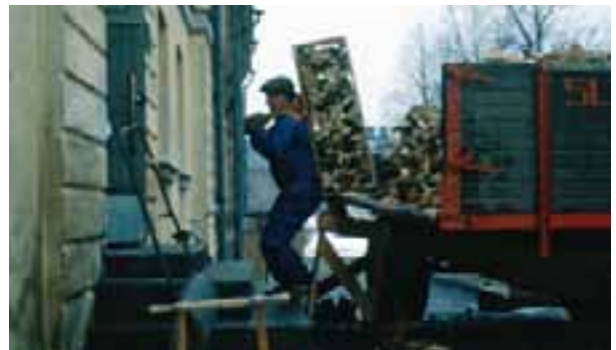
Up to 1993, the apartments in bastion Bielke were heated with wood.

Construction of the district heating network in the early 1980s meant that burning wood for heating could gradually be abandoned. However, the aim is to ensure that every home has at least one functioning chimney flue and fireplace as a backup heating source, though this has not always been possible.

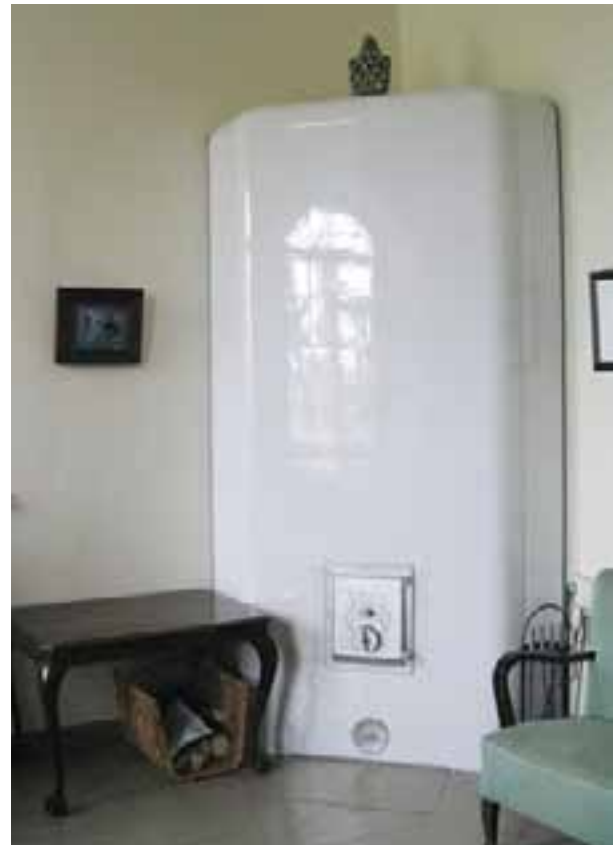
There are many kinds of stoves in the apartments, from simple sheet-metal ones to highly ornate tiled stoves. The photo is from apartment B4. RAm

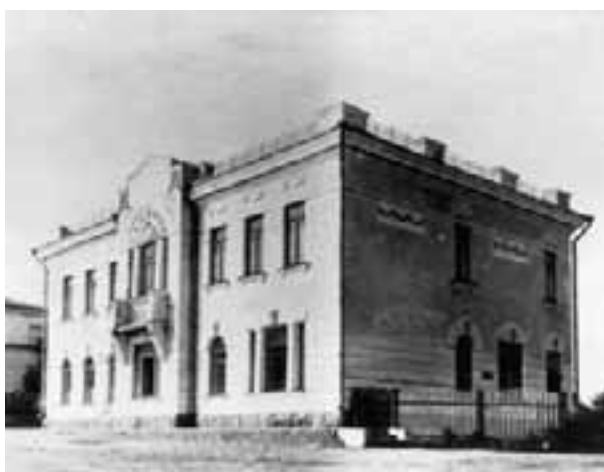
The elevation in its original guise in the early 20th century. MV

Building C 71 was constructed in 1906–1910 to house Russian officers and the military telegraph office. The upstairs was used as the office manager's apartment. The surroundings were heavily terraced to allow for construction of the adjacent the ice cellar, building C 72.

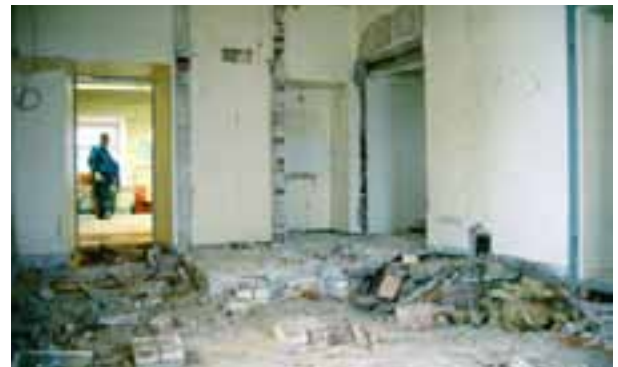
The wooden floor of apartment C had been destroyed by furniture beetle and was demolished. RAM

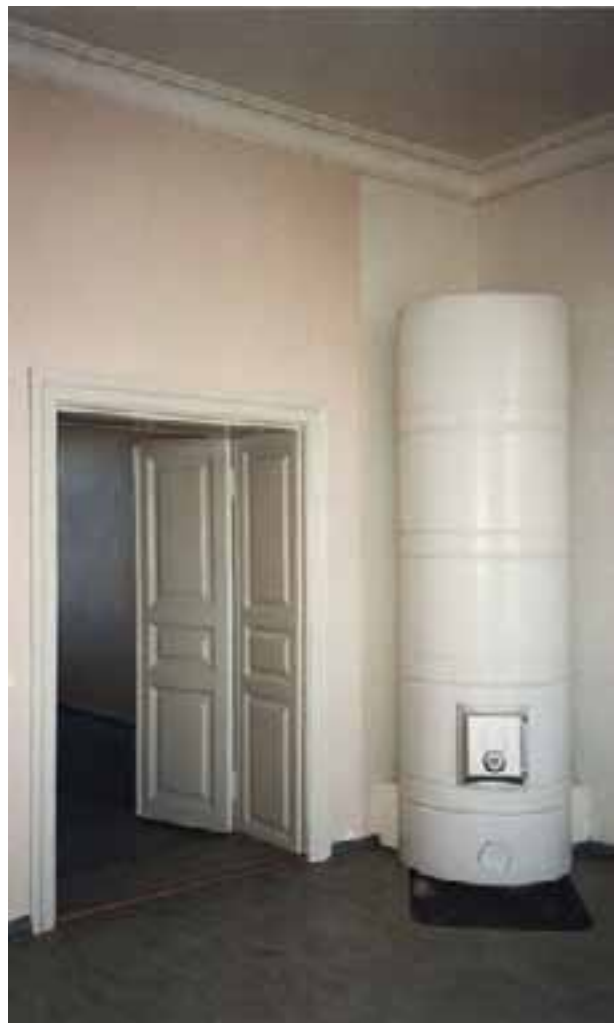
Some of the floors in the apartments are made of varnished or painted planking; some, as here, are covered with linoleum. LH

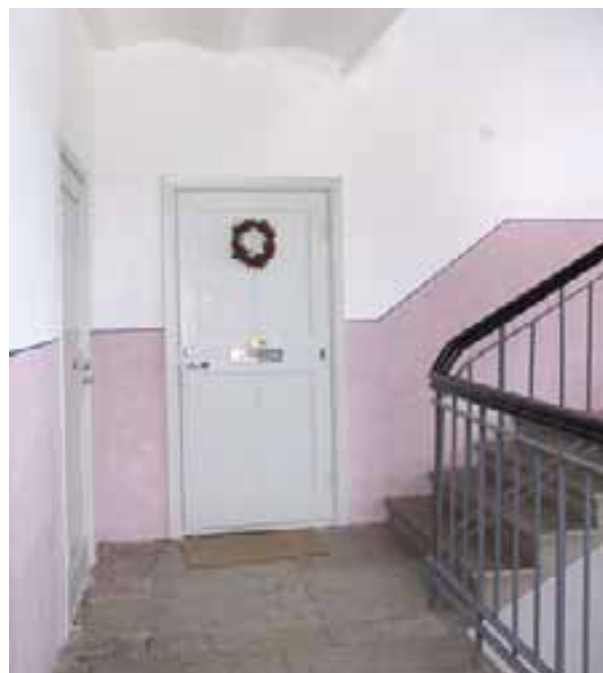
The colour chosen for the lower part of the walls matched the oldest colour scheme of the staircase: pink, with red and white splashes. MN

Built in the late 19th century, staircase A has cap vaults built on railway rails supporting the half-landings and rails supporting the concrete flights. The walls, painted with organic-based paint, were flaking badly and were thus cleaned and primed for a new surface treatment. The colour chosen for the lower part of the walls matched the oldest colour scheme of the staircase: pink, with red and white splashes. The doors had been replaced with flush doors at some point, and these were in turn replaced with doors panelled to reflect the shape of the original high and narrow double doors.

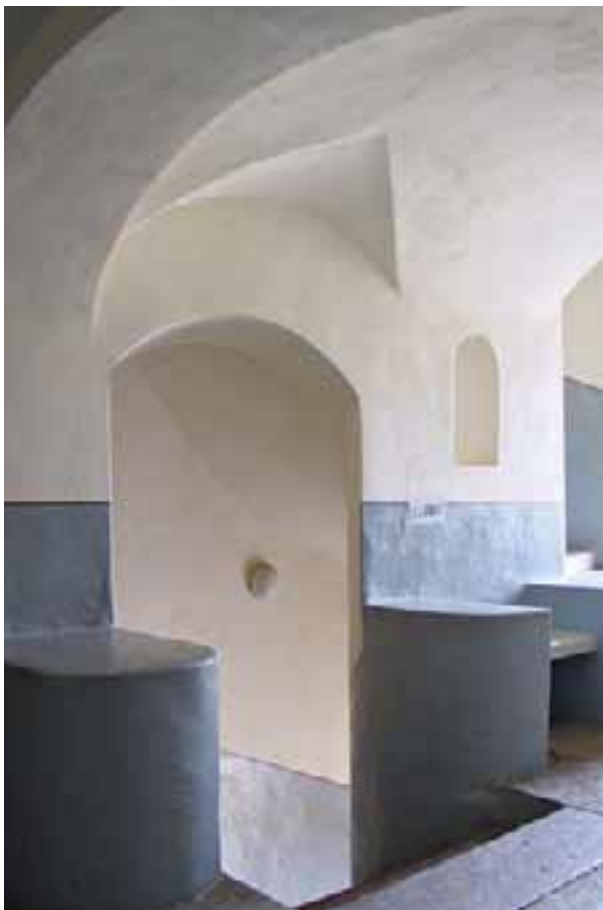
In staircase C, the vaults are whitewashed, and the dado is painted with a grey oil-based paint with a red painted outline. MN

No fewer than 24 layers of paint were found on the walls of staircase C, a handsome vaulted structure dating from the Swedish era. The three latest layers were latex, oil-based and alkyd paints. The harder modern paints were removed from the vaults and the upper parts of the walls, where they came off in large sheets. The vaults were whitewashed, while the lower parts of the walls were treated with oil-based paint laid over the reconditioned earlier layers. The colour scheme adopted was that which appeared in a number of variations in the earlier paint layers: grey dado, red line and yellowish-white upper part. The flush doors of the apartments were replaced with late 19th-century panelled doors found in storage.

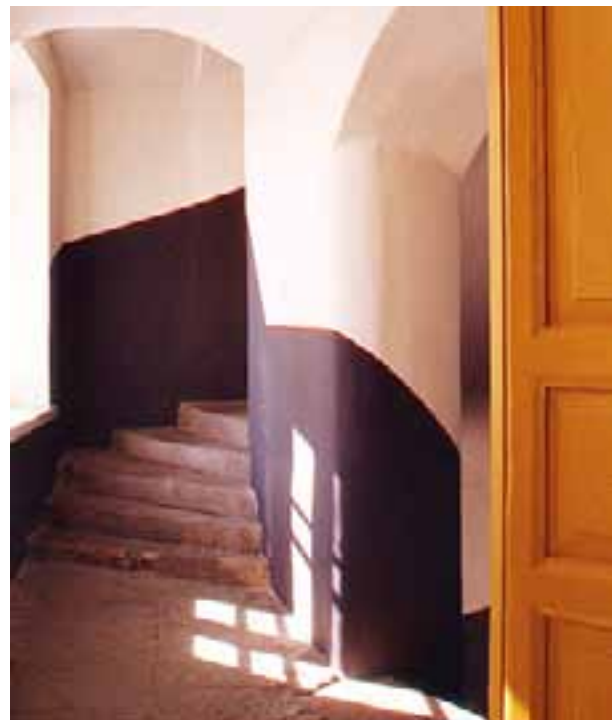
The strong colour scheme in staircase D is based on Russian-era colours discovered in the surface layer examination. MN

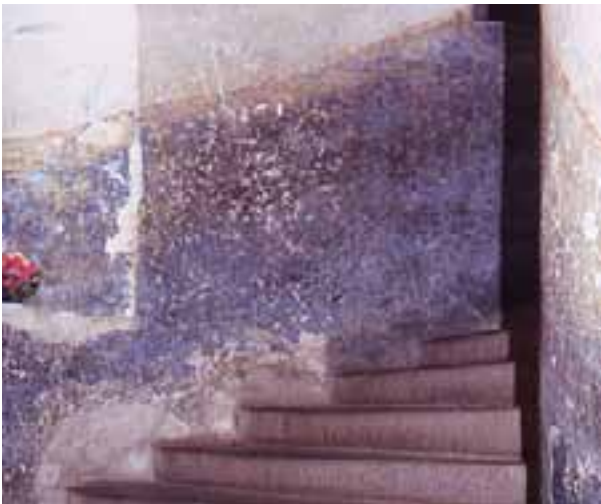
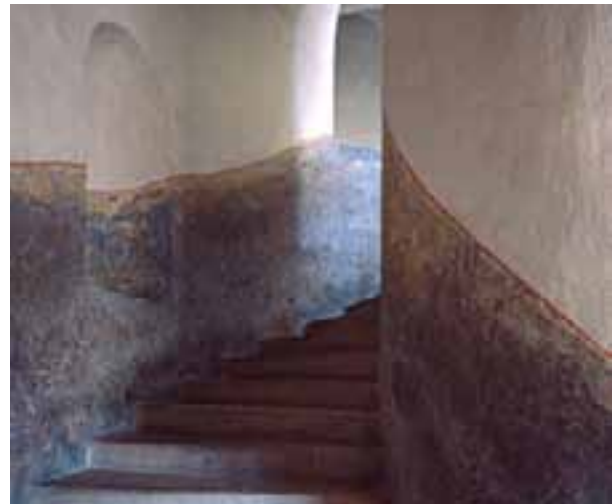
A flight of steps in staircase B before and after conservation; the aim was to preserve the staircase as it was while 'refreshing' it. MN, AdIC

Built during the Swedish era, staircase B is today almost wholly in its Russian-era guise, complete with late 19th-century railings and privy. The historical layering – partly visible worn paint layers, doors of different ages and appearances, the worn lathed railing, the old privies and the graffiti and scratchings – bring a strong sense of time to the space. The worn surfaces emphasize the plasticity of the architecture and the massive material feel of the walls.

The present colour scheme of the staircase dates from the 20th century: dates in the graffiti on the walls indicate that the most recent layer of lime paint was painted in the 1940s at the latest. In a colour examination, 29 layers of lime paint were found on the walls. The oldest of these date back to the Swedish era, though the majority are from the Russian era. Some of these layers are covered by a mid-19th-century layer of plaster.

The aim in the conservation was to preserve the impression of wear and tear and of historical layering yet make the space more coherent. Only places which were fragmented or flaking on the walls and ceiling were patched up, and the surfaces of the stairwell were conserved. A test spot was first treated to test for suitable methods and materials. Conservator Anne Räsänen dry-cleaned the surfaces, patched and reconditioned the damaged plaster, conserved the paint layers and filled in the fragmented sections using lime water tinted to match the surrounding wall surface.

The flush and panelled doors of various ages in the staircase were reconditioned, with all their various fillets and fittings. The window sills almost worn down to the wood, the wood door to the cellar and the steel door to the attic with its graffiti were left unpainted. An original limestone floor was found underneath newish floorboards in the downstairs apartment corridor, complementing the other limestone floors in the staircase.

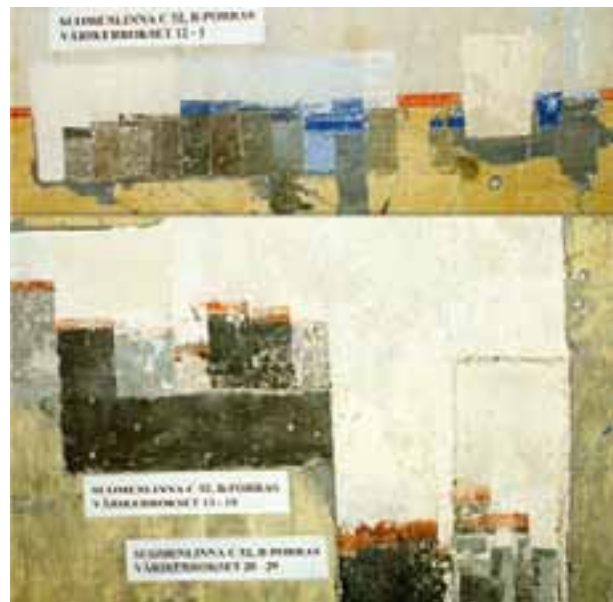
There are 29 layers of paint on the walls of staircase B, going back over 200 years. MN

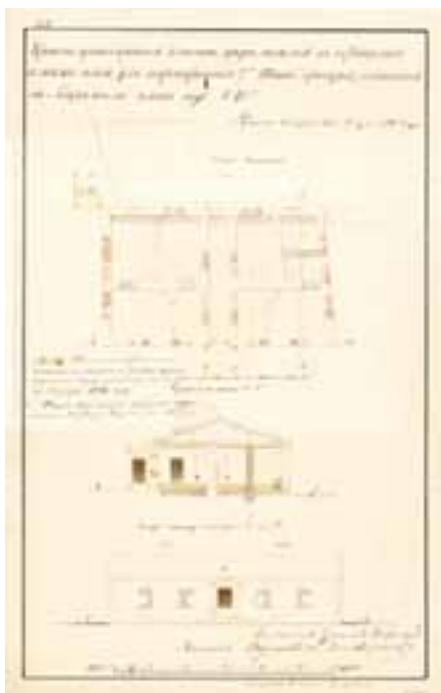
Conversion of the stable for residential use in the 1840s. MV

In 1770, a stable was built in the courtyard of bastion Palmstierna, part of the inner ring of Susisaari island defences. In 1843, this was converted into accommodation for senior officers from the Russian engineering detachment. At that point, the little window openings were enlarged, but the room division remained unchanged. The wooden parts of the building burned down in the Crimean War bombardment in 1855, and during repairs a protective roof three timbers thick and reinforced with earth was added.

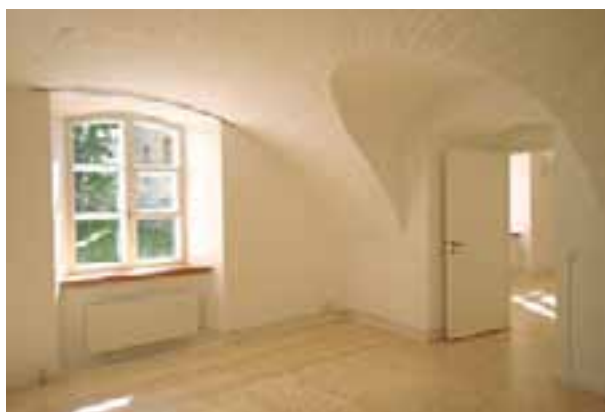
Although there are not many windows, the vaulted rooms are well lit due to their light-coloured surfaces. PM

The new plans aimed to minimize any structural additions and preserve the fine vaulting as far as possible, using loose fittings instead. New fresh-air ventilators were installed in the front wall, the old stove flues being enlarged to act as exit air ducts. The heating was improved by installing additional radiators and under-floor heating in the bathrooms. The vaults were painted in tempera, and the existing varnished floors were repainted with linseed varnish.

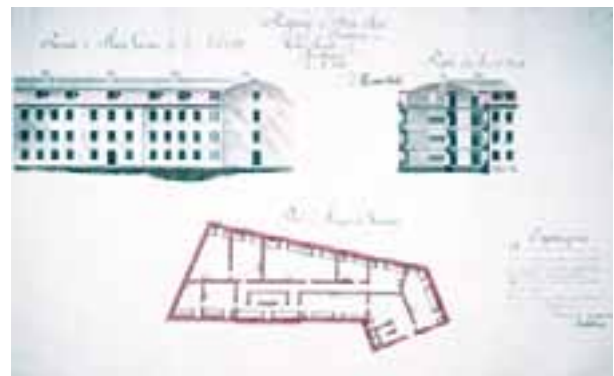
Drawing of the officers' pavilion (E 4) from 1776. KrA

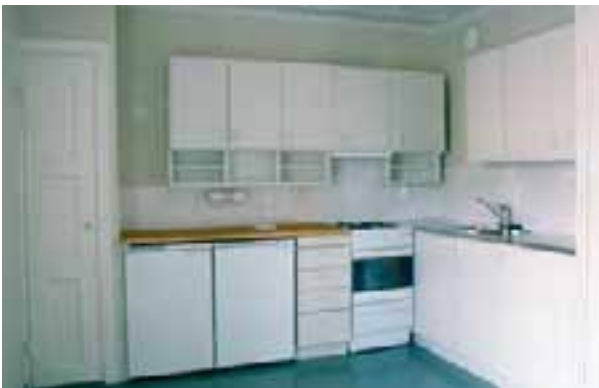
New lower cupboards were installed to complement the old, reconditioned kitchen fittings. Building E 3. SW

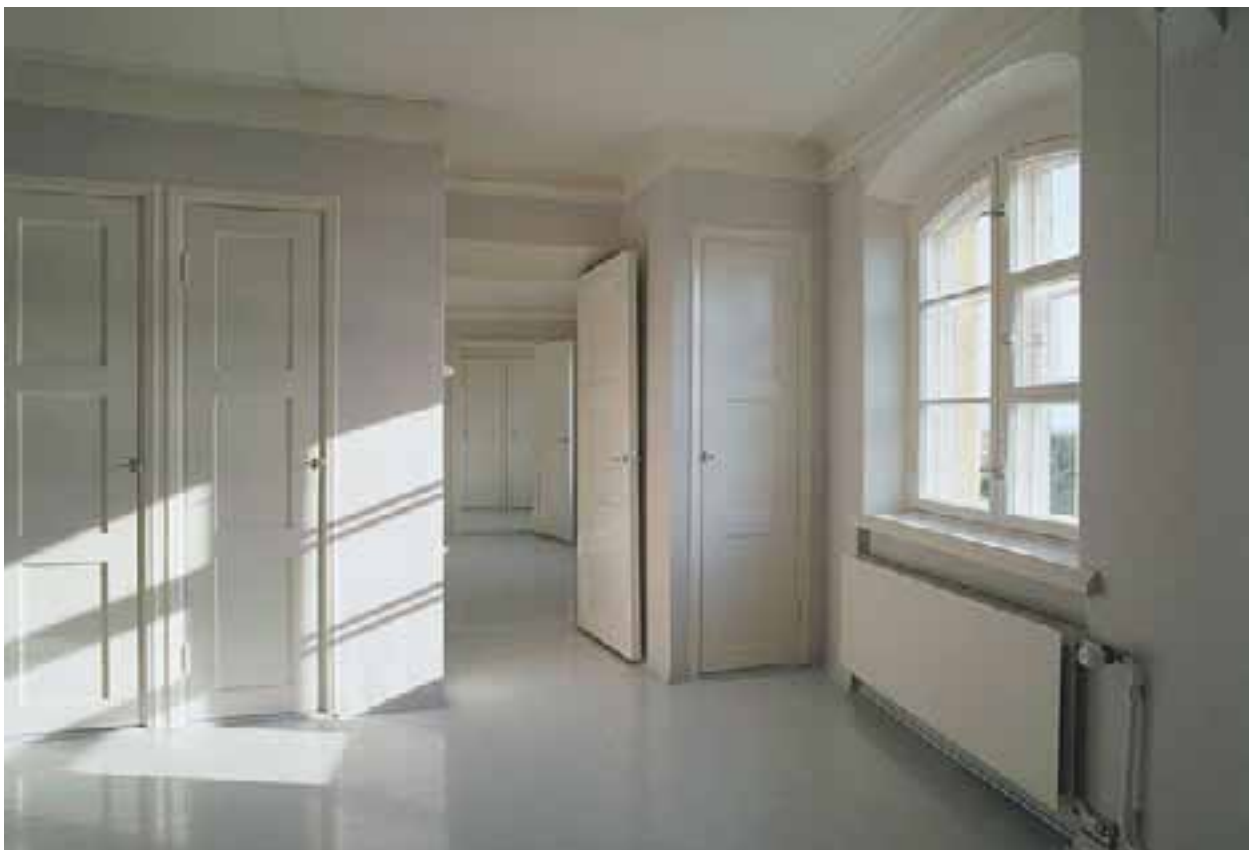
The built-in closets in building E 4 were retained. AdIC

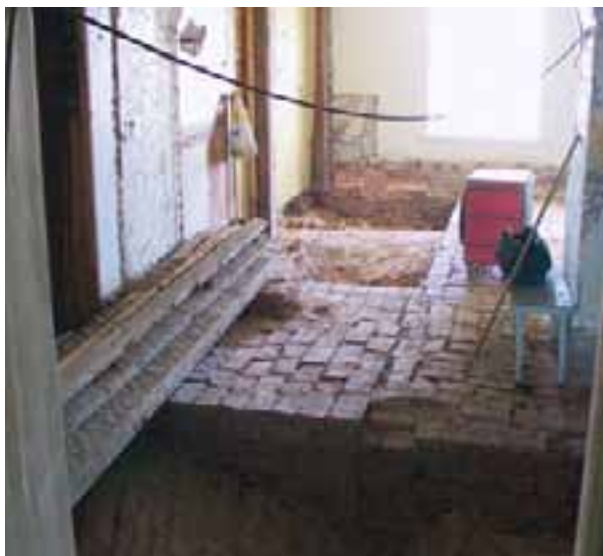
The ceilings of the lower floors are brick-vaulted, those of the upper floors wooden. RAM

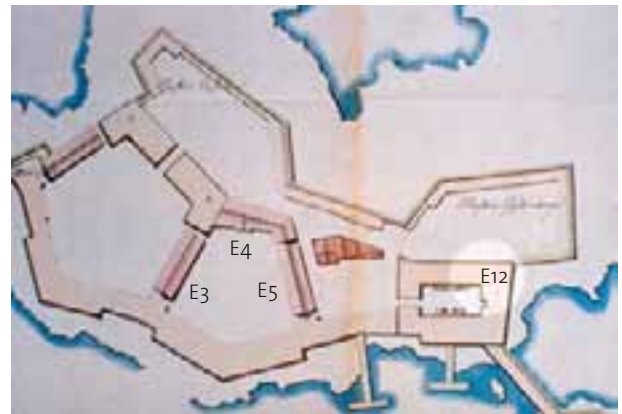
The Russian conversion plan. UUb

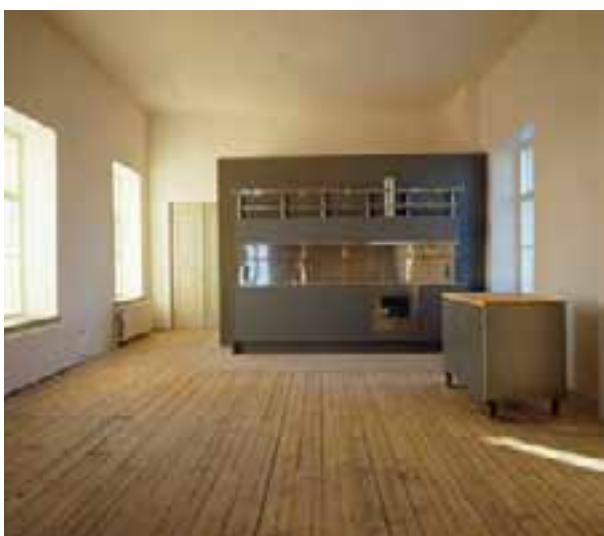
The laminate-surfaced kitchen fittings were commissioned to the architect's design. The cold storage appliances and dishwasher are hidden behind integrated doors. A movable cupboard was added to the fixed steel-frame unit. AdIC

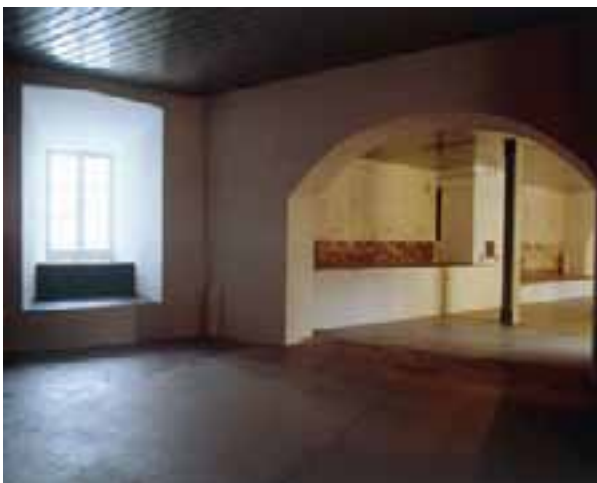
A thick defensive wall surrounds the ground floor of the bastion. The old surface layers on the wall behind the reconditioned stove have been conserved. AdIC

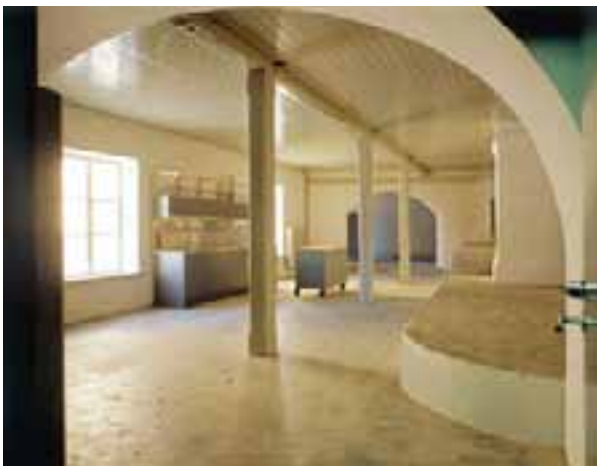
The floors in the downstairs apartments are of worn concrete that has been smoothed and waxed. AdIC

The ground floor has old concrete floors, patched in places. On the upper floor, two apartments have parquet from the Armfelt Museum period, and in two other apartments the old well-worn wood flooring has been preserved, with all its cracks and unevenness. **LH**

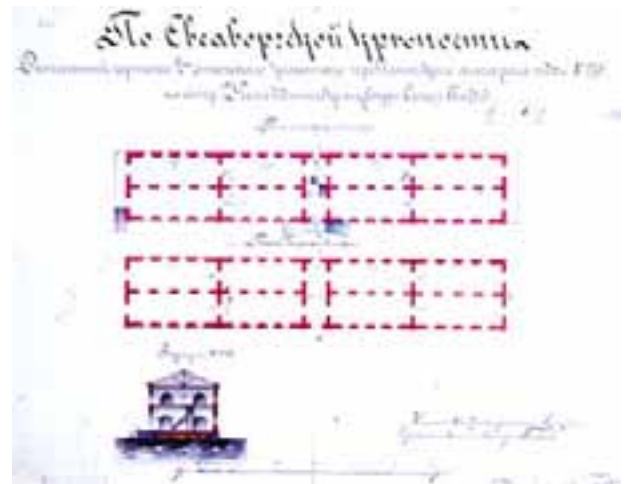
Plan from the 1890s. MV

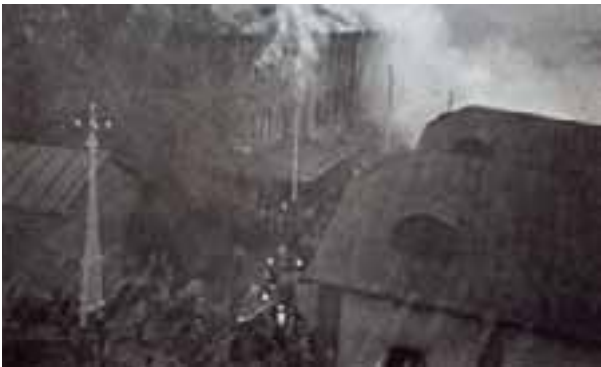
A fire broke out in the non-commissioned officers' building in 1920. The boatsheds on the right were not damaged in the fire. MV

The building was used for storage up to 1920, when its interiors were destroyed in a fire that also burned down two adjacent boatsheds and building C 57. In 1931–1932, it was converted into accommodation for non-commissioned officers, with three staircases and 26 apartments. The intermediate floors were laid on concrete beams, and central heating, WCs and mains water and drains were also installed. In the late 1980s, communal showers and a sauna were built in the basement.

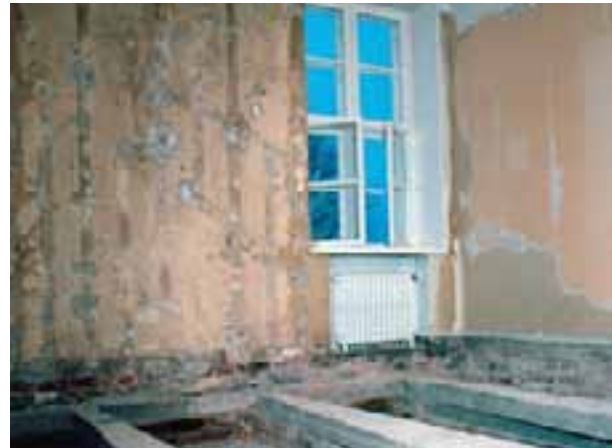
The concrete floor slab structure built in the 1930s exposed during the repairs.

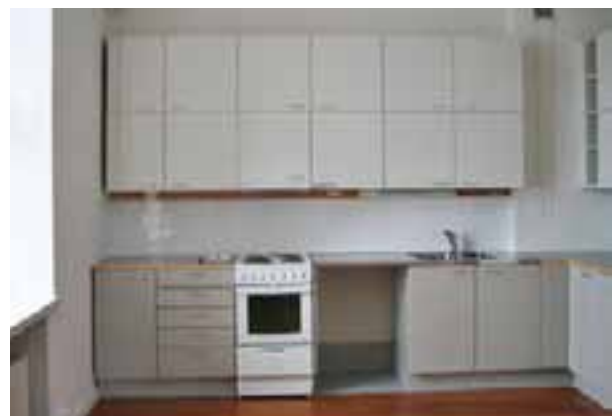
The new kitchen fittings were made of blockboard. LH

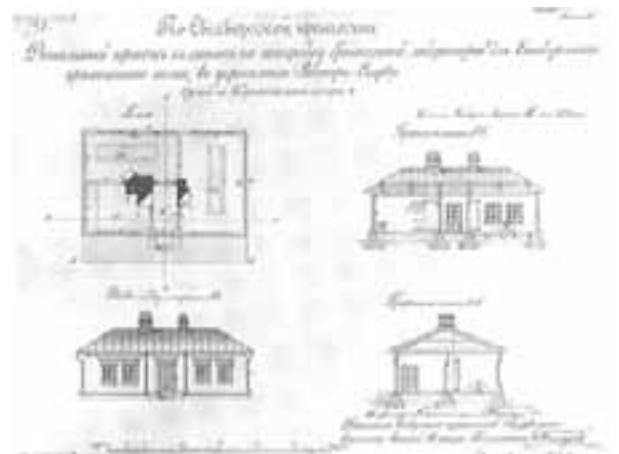
Original plan from the 1870s. MV

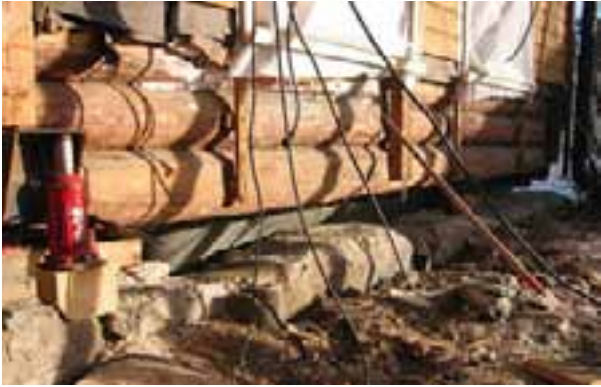
The lowest timbers in the outside walls were replaced. KH

had rotted and were replaced, and the floor structures, which rest directly on the ground, were repaired to improve their heat insulation.

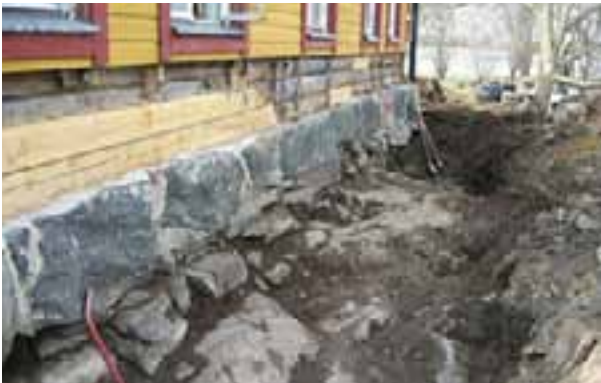
The old foundation wall was repaired by putting displaced stones back in place. The photo also shows some of the repaired log wall on the eastern side. KH

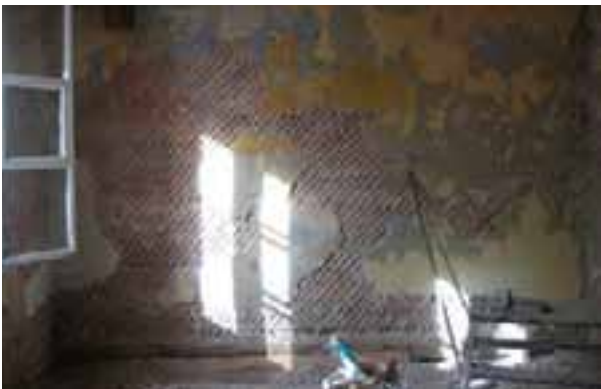
The plasterwork in the kitchen before repairs. TK

The plasterwork on the inside walls, typical of log buildings built on Suomenlinna during the Russian era, had been preserved under the wall panelling but had badly deteriorated. The plasterwork was reconditioned in the renovation but then covered with porous chipboard which was papered over. Surface structures and interior doors from various periods were preserved, though some of the partition walls installed at a later date were removed. The 1950s kitchen fittings were repaired and modernized. **TK**
