Suomenlinna

Conservation and Reuse

GOVERNING BODY OF SUOMENLINNA

Publisher: Governing Body of Suomenlinna

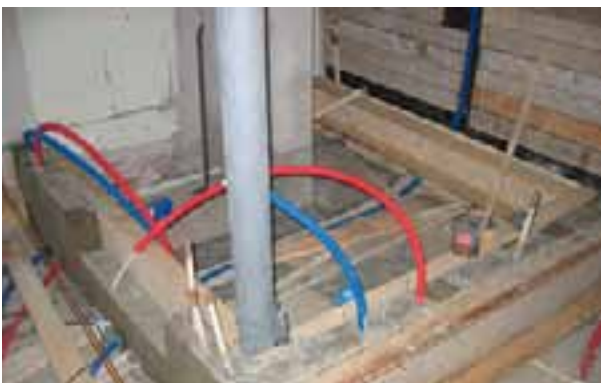
Bathroom installations in the floor structures. KH

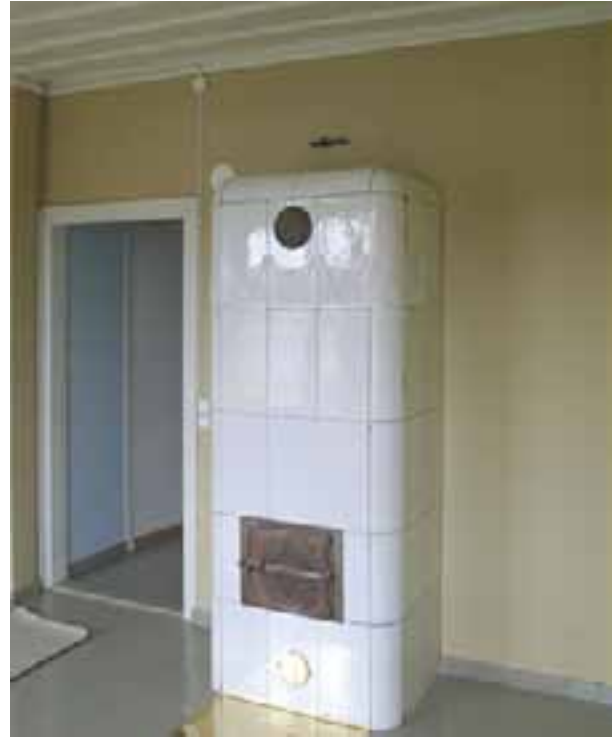
A re-erected tiled stove in the sitting room. TK

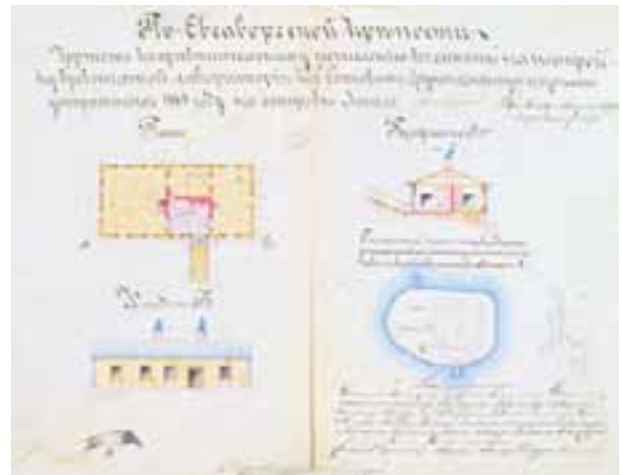
1889 plan. MV

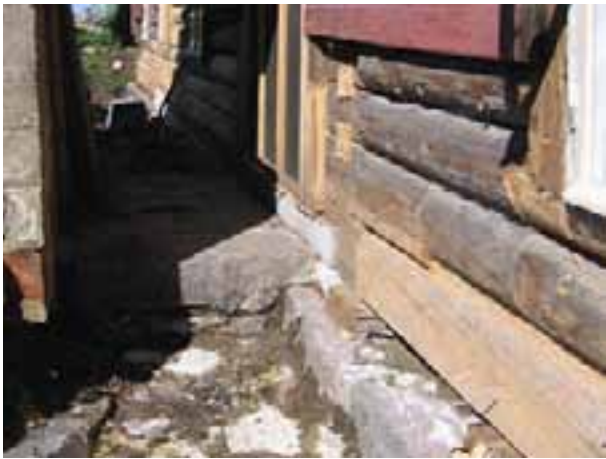
The soil that had accumulated between the building and the adjacent rock face had rotted the lowest logs. The concrete foundation of the cistern is on the left and the original entrance with its stone step on the right. RAM

Once Lonna island was transferred from the Defence Forces to the Governing Body of Suomenlinna in 1998, repairs began there with the building in the worst shape, i.e. the mine laboratory. The lowest logs had partly rotted because of the rainwater that gathered between the building and the adjacent rock face. While the frame was being repaired, it became clear that the leaky sheet-metal roof had also caused damage to the upper parts of the wall facing the sea. Tests for dangerous substances found that heavy metals including mercury had accumulated in the underflooring packing from the building's time as a laboratory. The floor structures therefore had to be completely demolished and treated as hazardous waste.

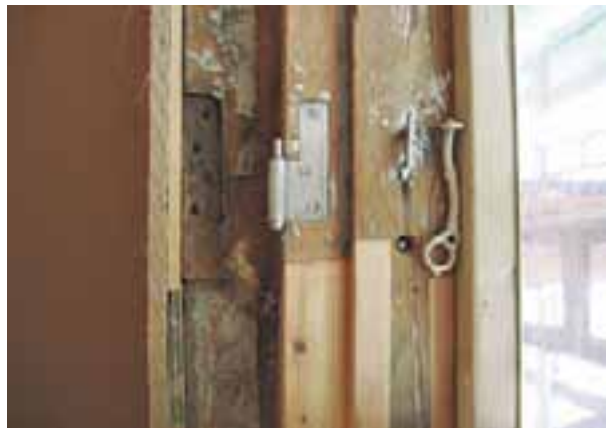
The window frame spline shows a trace of the original window or the hinge of a window shutter. The current windows were probably made in the 1930s. RAM

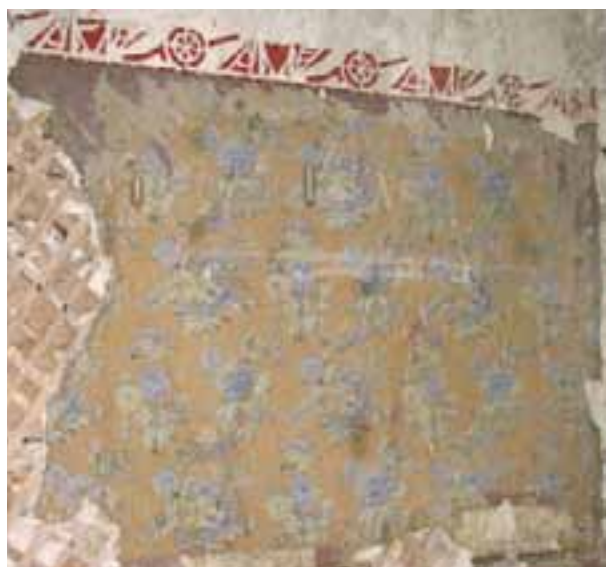
The Governing Body of Suomenlinna conservators carefully examined and documented the numerous layers of paint and wallpaper on the walls. RAM

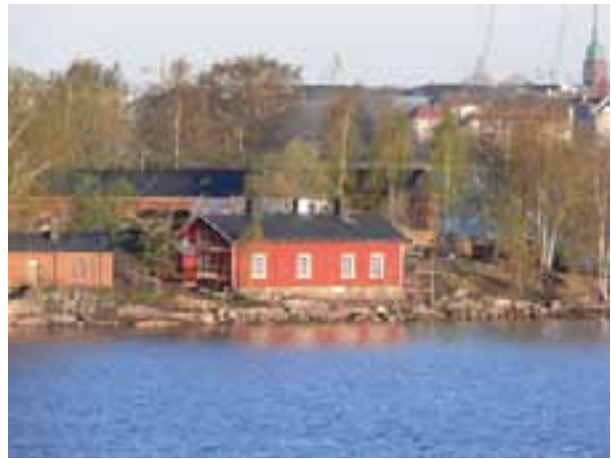
In the renovation, the elevation cladding and weatherboarding were restored to match the old style. HL

The mouldings of the windows and the weatherboarding in two of the elevations had been replaced at some point, and these were replaced to match the surviving originals. One window boarded up after the 1930s was also re-opened. The wooden protective structures of the cistern were replaced apart from the log frames. **RA**

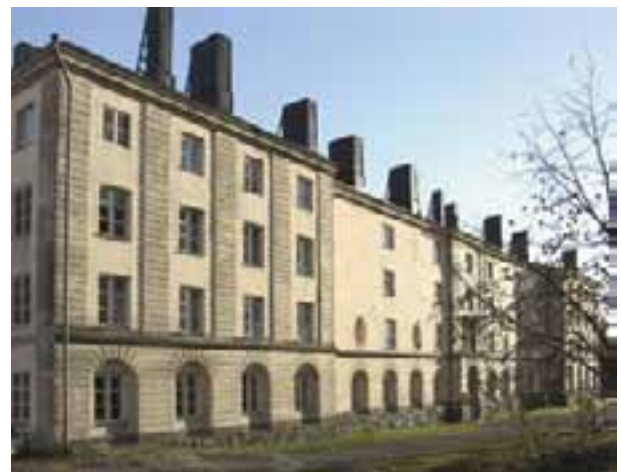
Elevation towards the church park. MN

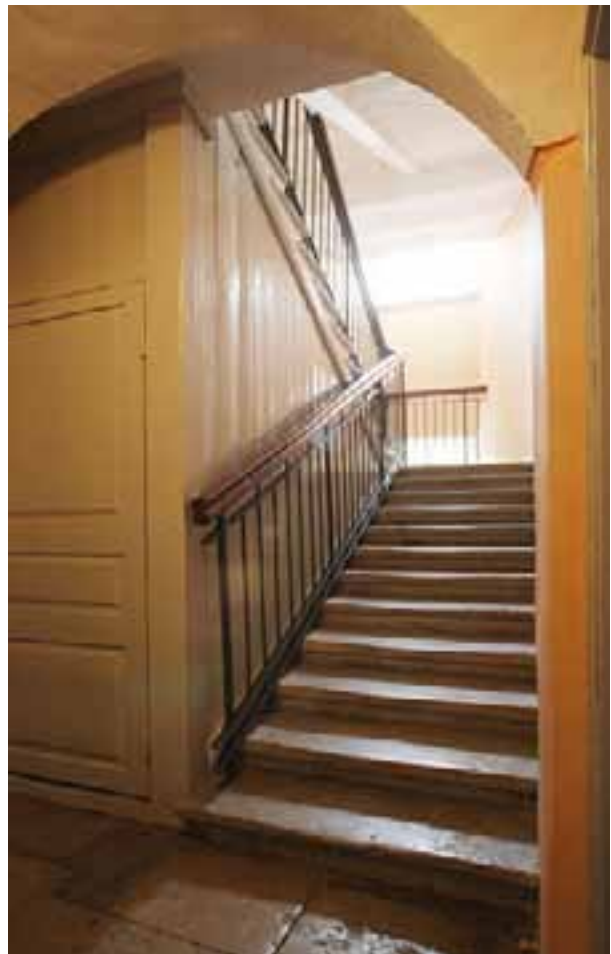
Limestone steps from the late 19th century, staircase C. AdIC

The old wood flooring was patched up and new flooring installed to replace removed floor boards. The wood floors were painted either yellow ochre to match the oldest paint layer discovered in the colour examinations, or grey. Floors that had been smoothed and varnished in earlier repairs were now glazed a translucent grey using modern materials. The glaze was applied over the old varnish so that the old boards did not need to be sanded any more. The old concrete floor in staircase D on the parade ground side was dismantled, as it had been pierced several times for piping installations, and a reconstructed limestone floor was laid in the entry hall, using old stones from stone stockpiles on Suomenlinna itself.

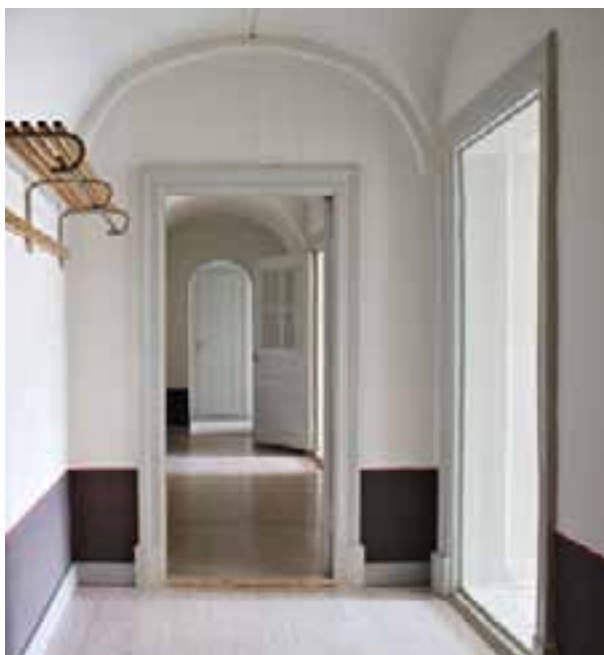
The wall in the front hall is decorated with a dark, splash-pattern 'lamp-black dado' in tempera, outlined in red. The old floor was given a translucent grey glaze. AdIC

egg matt. In late 18th-century and early 19th-century style, suites of consecutive rooms were painted in different colours – pink, light yellow, light blue and light grey – based on period colour schemes. Existing wall-papering was redone using modern products resembling the old paper in colour and design (typical late 18th-century wallpapers employed small leaf, flower or other plant motifs, or marbling or splash patterns). The stairwells were coated in pink whitewash based on the Finnish-era colour scheme discovered in the 1980s restoration project.

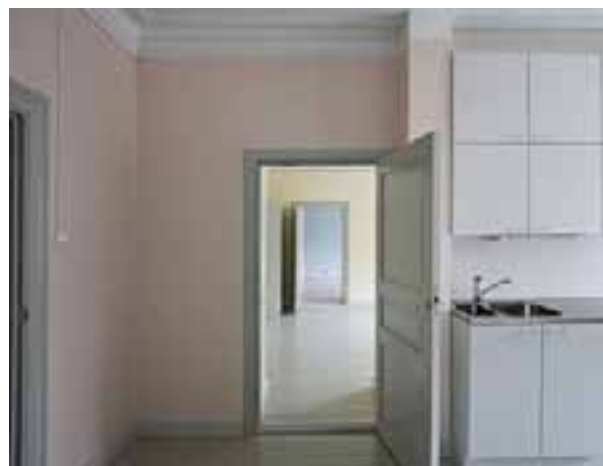
Grey-painted wood floors link consecutive rooms decorated according to a late 18th-century colour scheme. AdIC

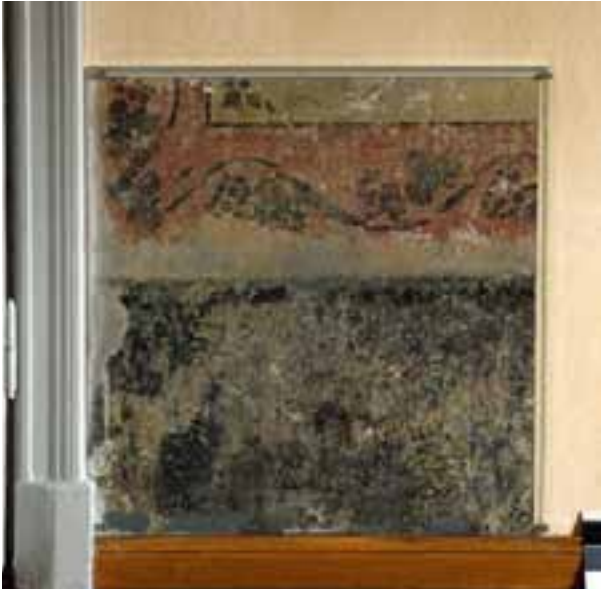
A fragment of 18th-century painted vine ornamentation framing a dado was uncovered in an apartment in staircase C and protected with a pane of glass. AdIC

The long history of 'Noah's Ark' can be seen in its structures and details. Although it has undergone numerous changes, there are many surviving details such as mouldings, doors and floorings dating from the 19th century and even the 18th century. Conservators Riitta Karjalainen and Sari Salo-Kiviluoma undertook comprehensive colour and surface layer examinations at all phases of construction. On the interior walls, they uncovered Gustavian painted wreath borders from the late 18th century, sphinx borders from the early 19th century and fragments of Empire-style wallpaper, reflecting a unique cross-section of changing fashions in interior decoration on Suomenlinna.

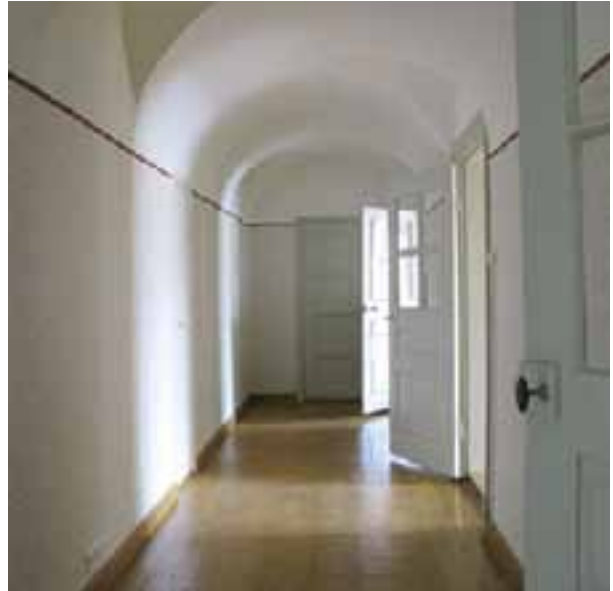
The walls of the vaulted corridor are covered in splash-pattern wallpaper with a red border. Old glass doors allow natural light into the centre of the building. MN

The aim was to retain their existing locations but to enlarge them by combining rooms or taking some space from the front hall. In the case of the apartments with the smallest kitchens, one room was integrated with another apartment on the other side of the long central corridor, which now receives light from two directions through glass doors.

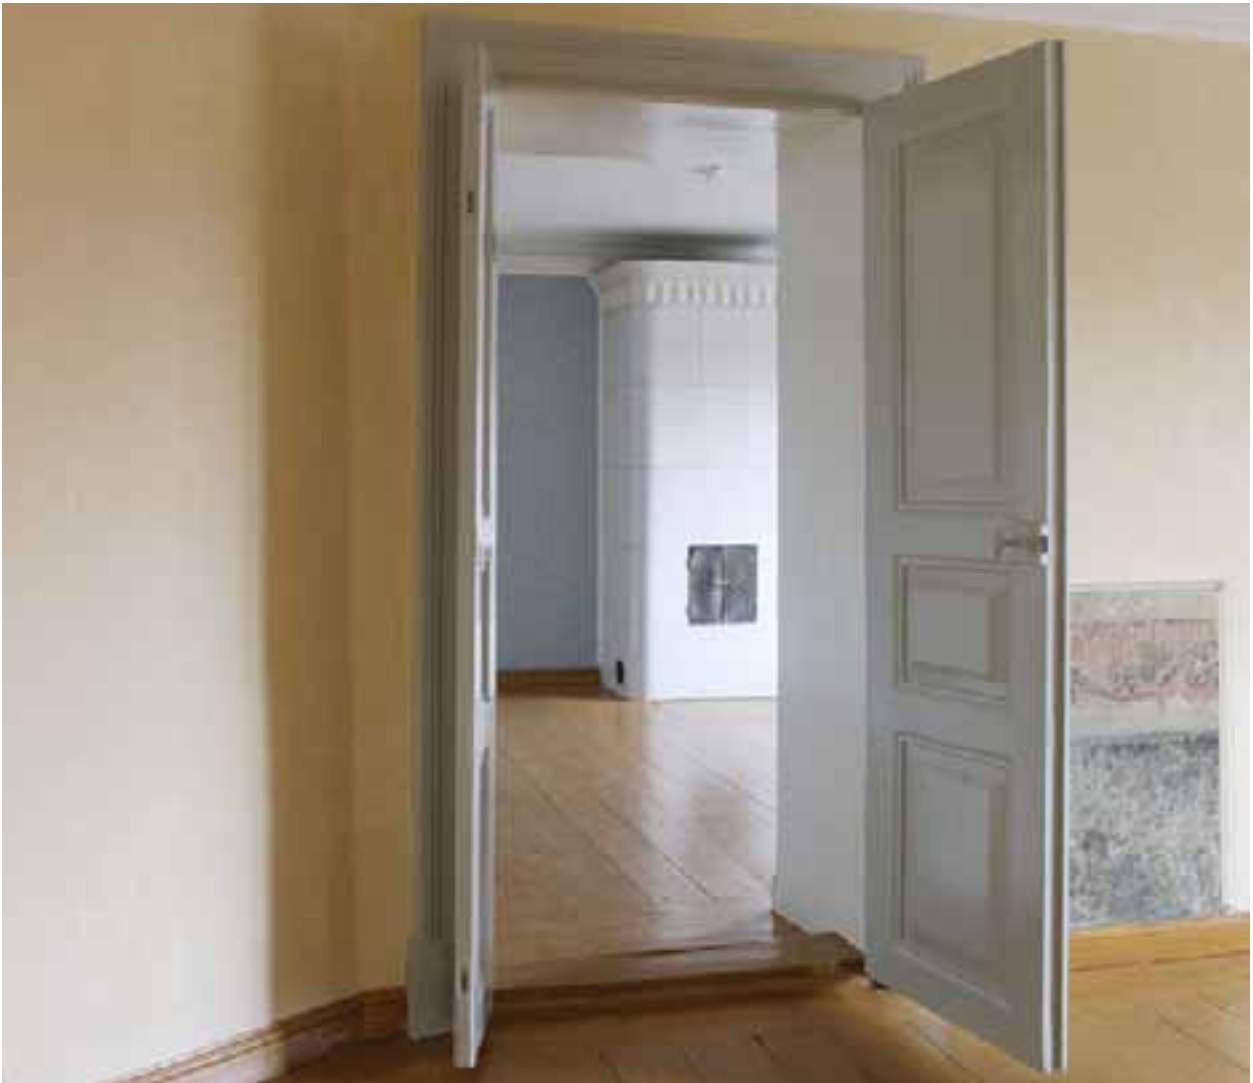
The old wood floors are painted yellow ochre to match the oldest paint layer uncovered in the colour examinations. The wallpaper was chosen to match the late 18th-century colour scheme. AdIC

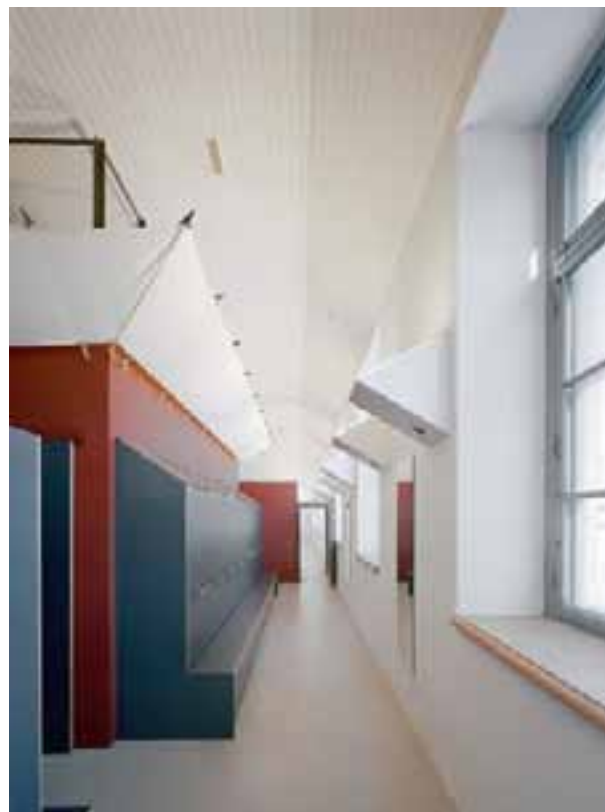
The changing rooms are arranged around the sauna and wash-rooms on the window side. JT

The sports hall was designed as a space that can accommodate a variety of sports, such as ball games. Since the space is only 4.7 m high, it does not conform to the official standards for all games, but is sufficient for amateur sports. A gym was also built. The facilities that by their nature must be enclosed – washrooms, WCs and storage – were built as a grouping structurally separate from the outside walls and ceiling. The changing rooms surround these in a free-form shape, flexibly accessible both for users of the sports hall and gym and for larger, public functions. A gallery was built over the washroom and sauna facilities to diversify the gym functions, and a bridge leads from this to the office above the entrance at the south end. Users of the sports facilities enter the changing rooms through the south entrance, while the north entrance, closed for more than 60 years, was re-opened for the use of people attending public functions held in the hall.

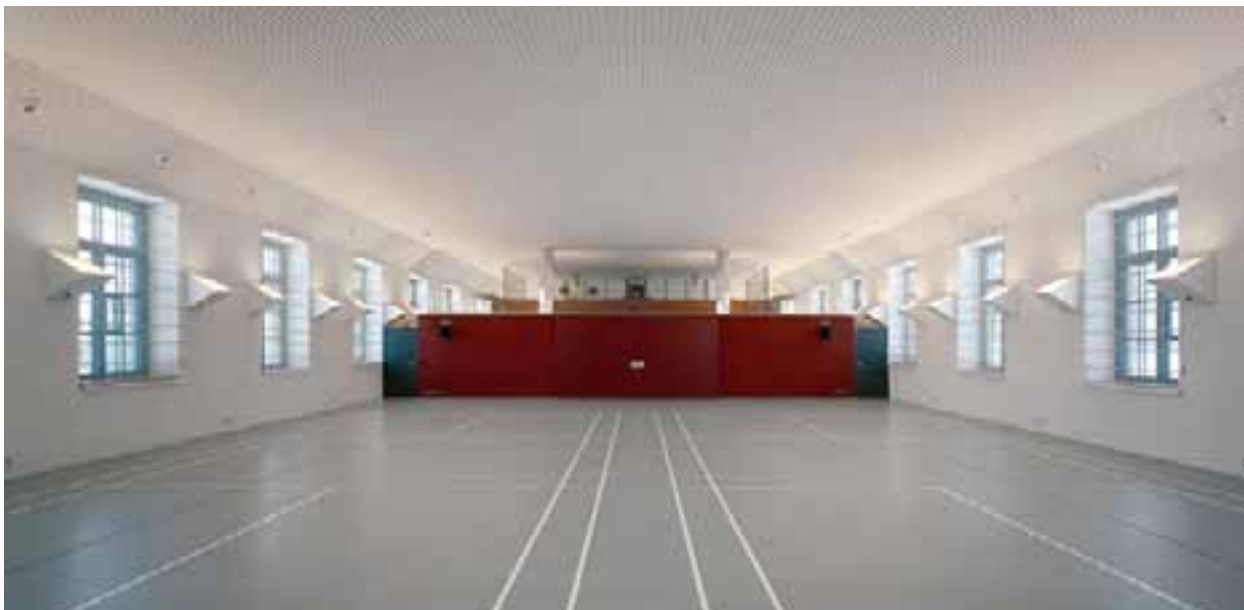
The sports hall is used by gymnastics groups and for playing badminton, volley ball and the Finnish game of floorball (sähly). JT

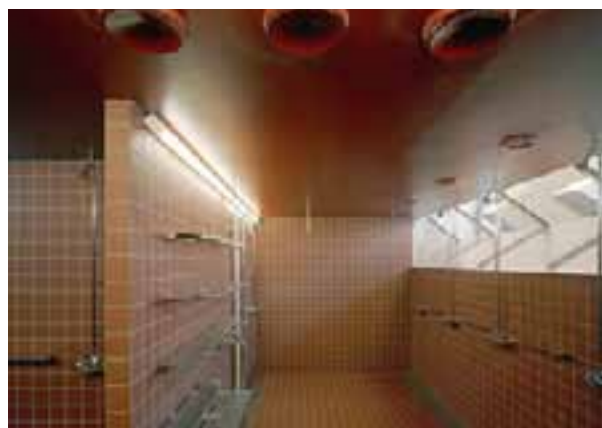
Natural light enters the washrooms through sloped clerestory windows. JT

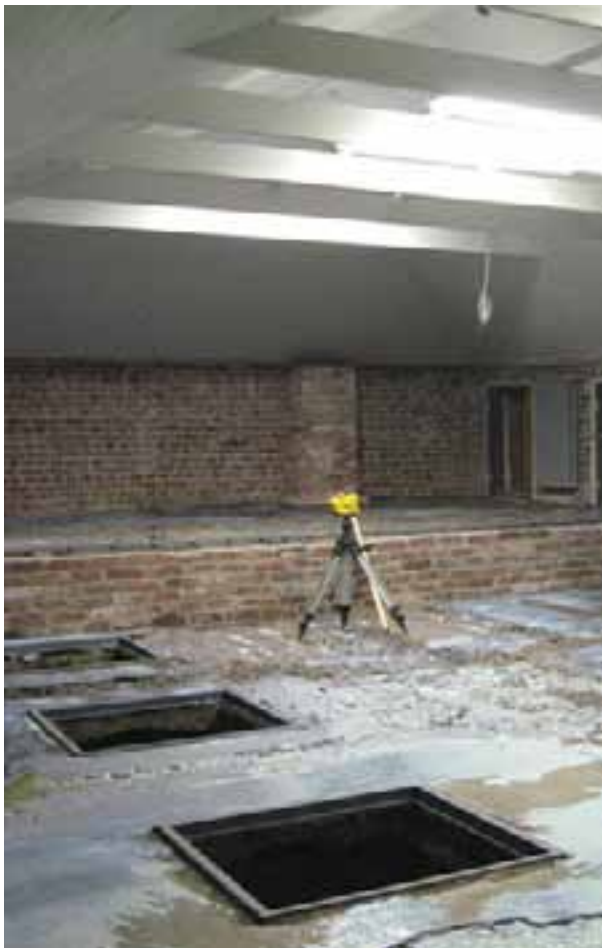
Cellar hatches. The raised platform in the background is the roof of the former civil defence shelter. PM

During the occupancy of the Finnish Army, the cellar was turned into a bomb shelter, with an entrance in the east end. Later, the building was used for a long time for storage by those living in nearby buildings. In 1990, the roofing felt was replaced with sheet metal.

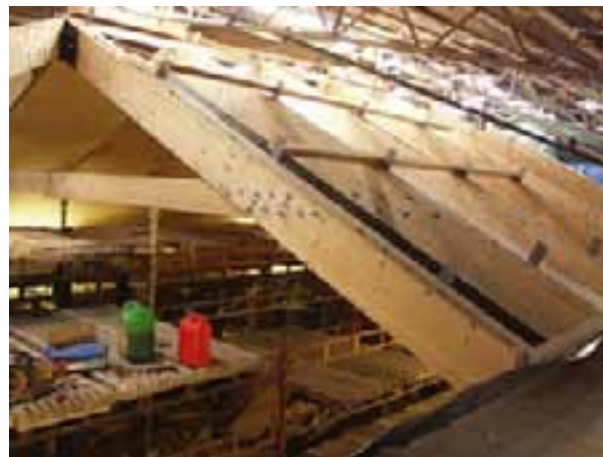
Roof rafters being installed in winter 2005. PM

Repairs to the ice cellar started at the end of 2004 and are being done by the Suomenlinna division of Helsinki Open Prison, mainly during the winter when the worksites on Lonna island cannot operate. The building was converted into a work and meeting room forming a single uniform space as per the room programme in the project plan. Because the roof trusses of the old roof had been supported by wood pillars in the middle of the building, the entire roof structure had to be rebuilt.

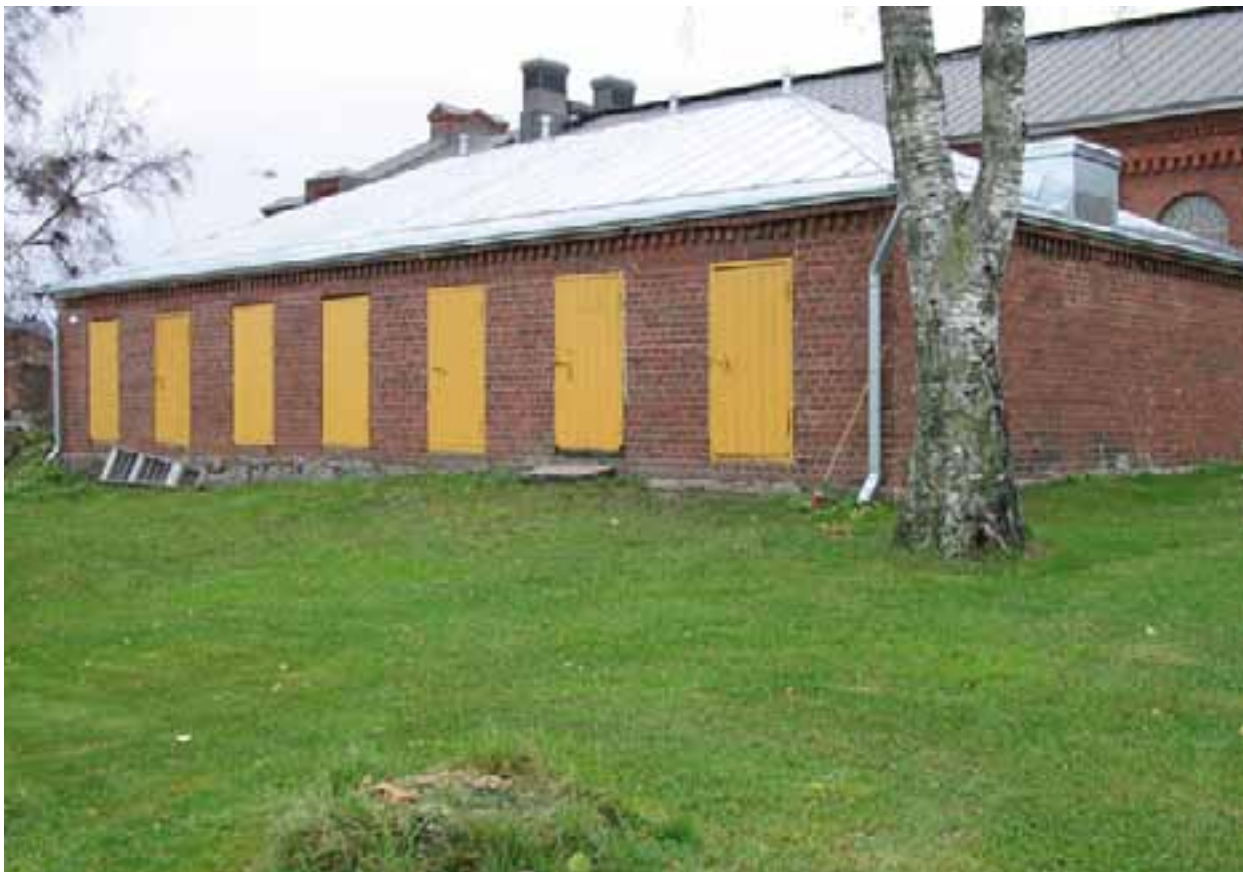
Each storeroom in the ice cellar had its own entrance. PM

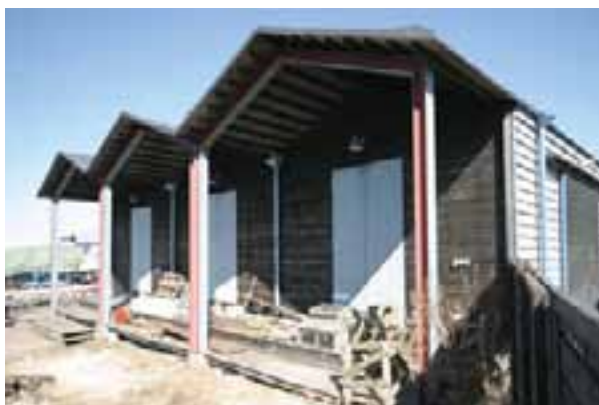
The south end of the lumber storeroom is treated with tar. The other elevations are blue-grey. PM

The building differs from the boatsheds and the Russian-era brick buildings in the depot area in its details too. The design is wholly modern, and its details are carefully considered. The eaves are very short, and broad horizontal clinker planking is used as cladding. At the draft stage, the cladding was to be Corten steel, which becomes rust-coloured through natural oxidation; however, a negative opinion from the National Board of Antiquities prompted this to be replaced with wood. The large sliding doors at the north end and the hatches at the south end are faced with sheet metal.

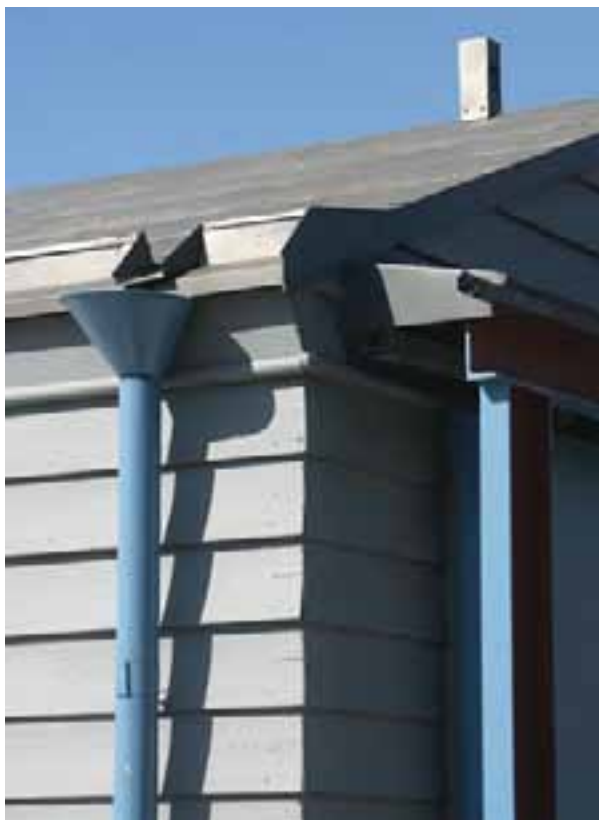
Detail of the storeroom eaves. PM

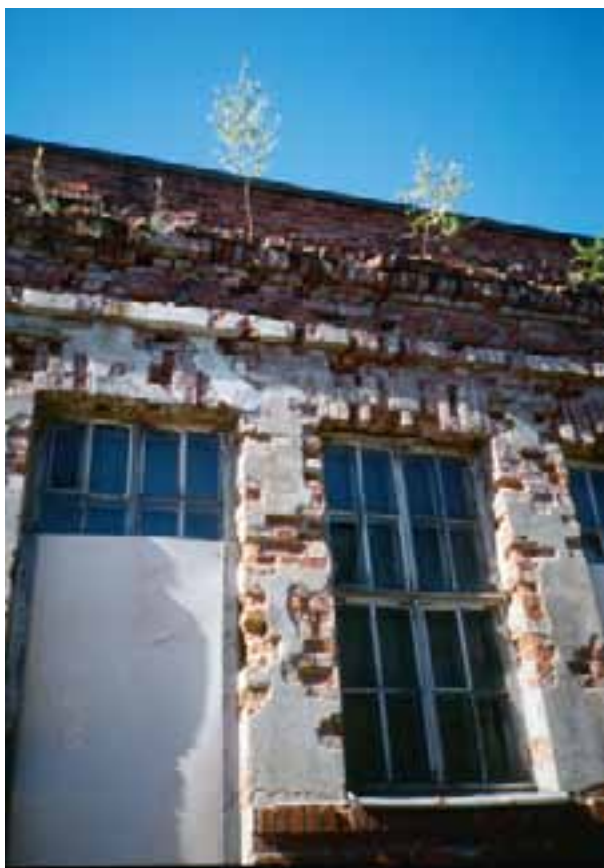
The brick elevations of the former mine workshop (C 34) were in extremely poor condition when repairs began.

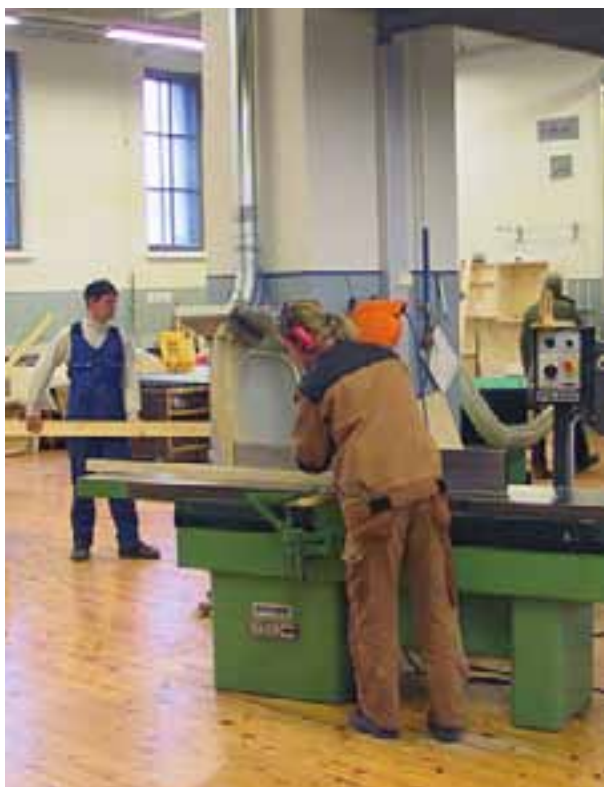
The woodworking workshop is used for reconditioning old doors, windows, furniture, etc., and for making new ones. HL

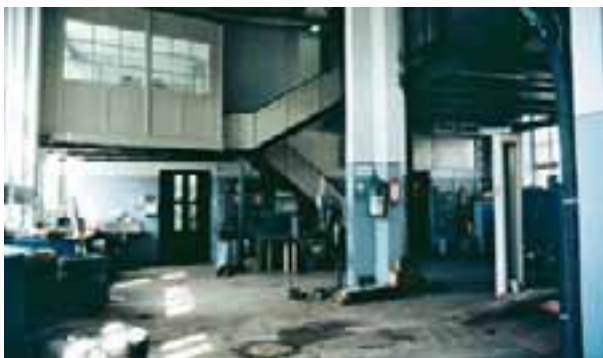
The metal workshop in use after the repairs. RAM

Only slight alterations were made to the elevations and load-bearing walls, but the HPAC and electrical installations were completely replaced. The machinery and equipment were also upgraded.

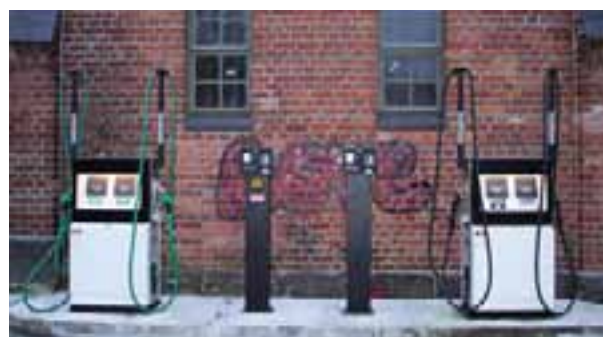
The fuel pumps outside building C 37.

Fuel storage required improved ventilation, and fuel pumps and the necessary drainage were installed in front of the building. The original plan was to include a boat fuelling station, too, but this was abandoned. The fuelling station serves the vehicles of the Governing Body and the labour colony. The other half of the building is a building supplies warehouse.

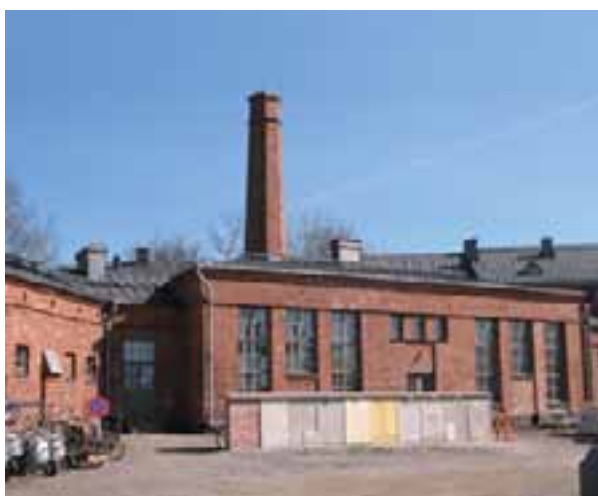
The yard side windows in the construction office were extended downwards, and the garage door, a later addition, was restored to two windows (on the right in the photo). In the foreground is a brick wall erected for weather-testing lime mortars. PM

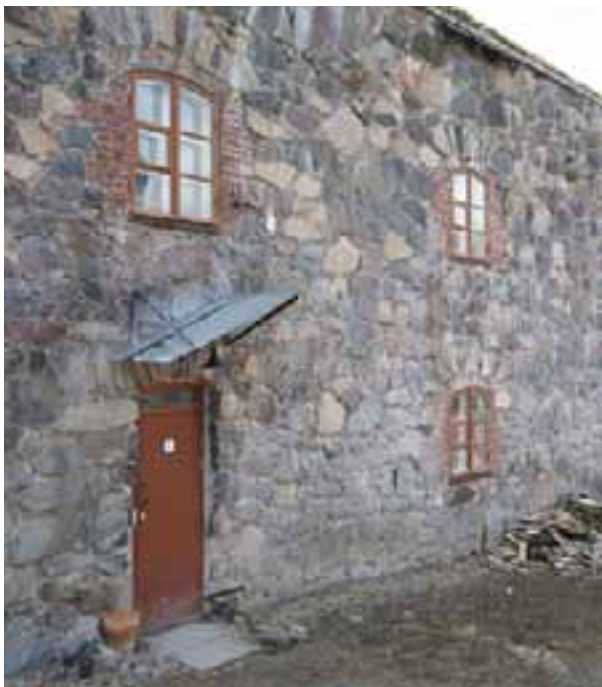
The two-storey portion of the right face of the bastion. PM

Eight workrooms were built into five of the casemates in the right face and flank, partly on two levels, and three old staircases were repaired. Five casemates were left in their original condition as monuments. The intermediate floors were made of wood. Logs suitable for use as supporting beams were fortuitously discovered in the attic of traverse Adlerfelt (building B 1), which was being repaired at the same time. The workrooms all have mains water. The heating, lighting and water/sewerage systems needed could be installed in the new intermediate floor, leaving the other space and structures largely as they were. New metal-clad brick stoves were built in the four workrooms where the outside walls required most attention at the old flues. The greystone walls and the brick vaults in the stairways were left untouched, but the brick walls of the

The leaking 1950s concrete slab covering the firing platform on the right face was waterproofed with rubber and bitumen. Another concrete slab was cast on top of this and covered with turfed landfill. This solution is not entirely unproblematic, and damp patches requiring repairs have appeared in some of the workrooms.

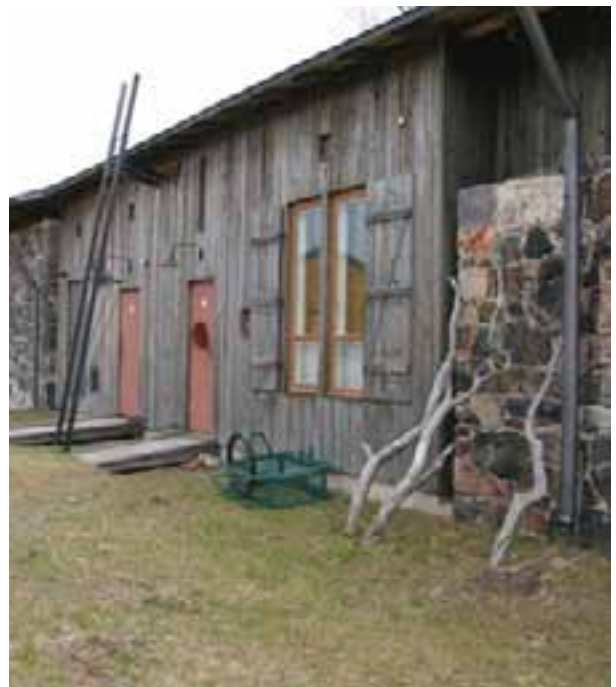
The new building erected on the site of the demolished left face. PM

In the renovation work, the whole left face was covered with a single roof which protects not only the new building and the ruins but also those casemates from the Swedish era still in good condition. A new building was erected on the site of the missing casemates, with five workrooms and a joint recreational area, a transformer station and an electrical substation. The preserved casemates were renovated as storerooms.

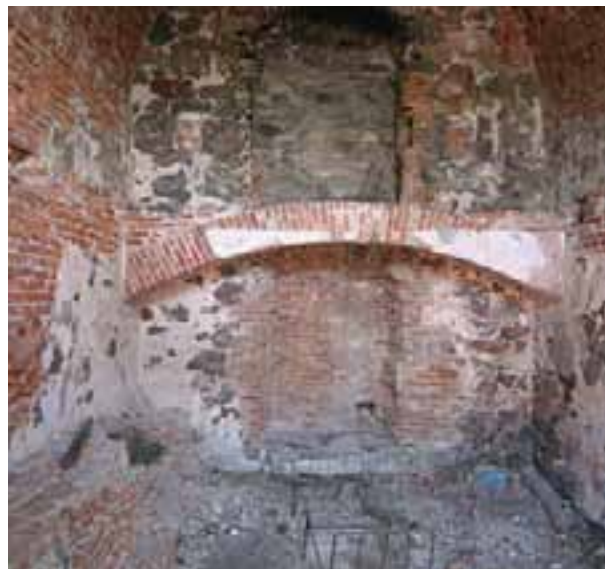
A casemate in the right face preserved in its ruined state. PM

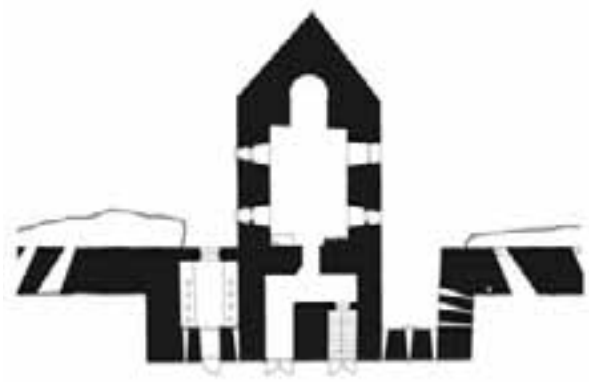
Floor plan of the second floor: the former privy on the left, the staircase leading to the downstairs workroom on the right.

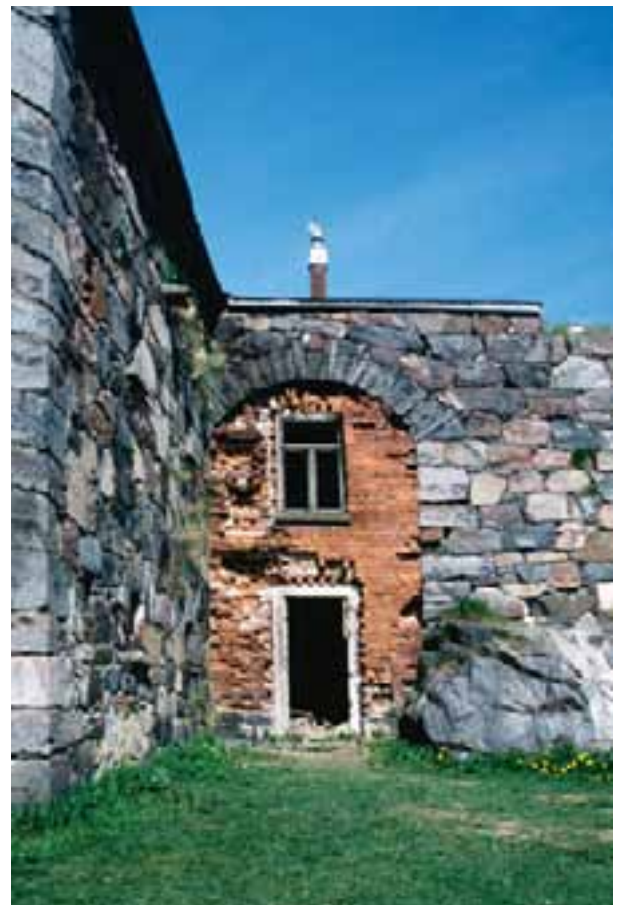
The caponniere before renovation began. The photo shows the privy built in the gateway closed in 1839, which has been preserved as an interesting feature. SG

Because caponniere de Carnal had stood empty for a long time, it was in poor condition, so the repairs launched in 1996 focused first on the elevations, roof and windows. The building was connected to the district heating network and fitted with mains power, water and sewerage. A workroom with kitchenette was built on both floors, and a WC for both workrooms downstairs. The building has natural ventilation. **RA**

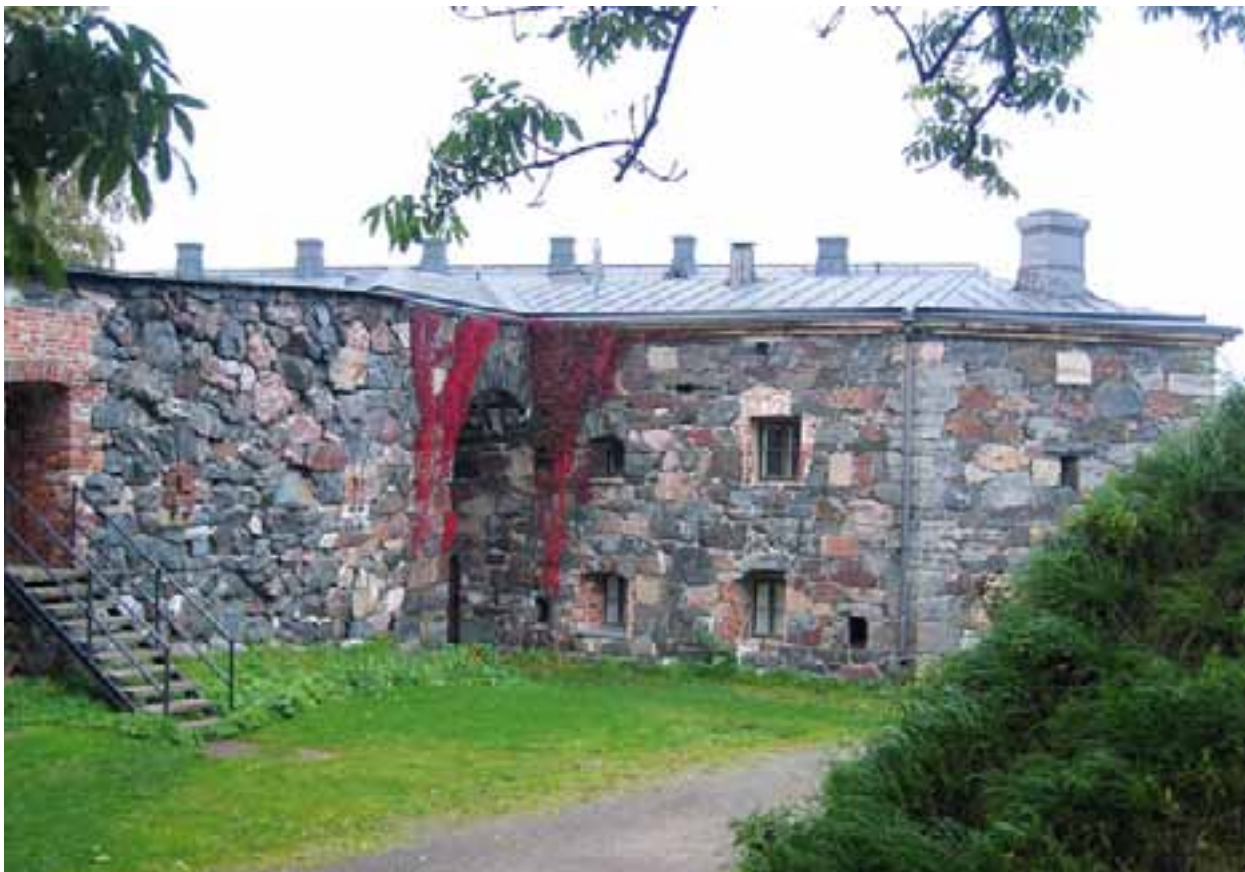
The caponniere after renovation. HL

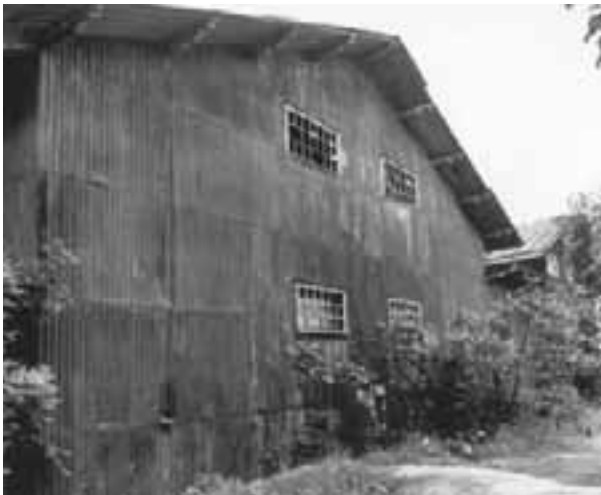
Prior to the repairs in the 1970s, the boat sheds had fallen into disrepair. JR

The interior walls in the wet rooms were built of concrete blocks, and the floor was covered with an acrylic compound. The external walls were covered on the inside with galvanized corrugated metal. The new facilities were equipped with mechanical air conditioning. All alterations were carried out within the building, without changing the elevations and the inside structures were also preserved. **RA**

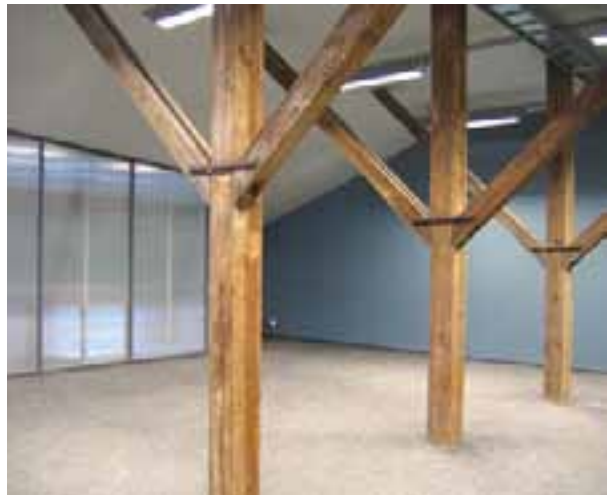
The old wood pillars still stand in the gym. The changing room light shaft can be seen in the background. RAM

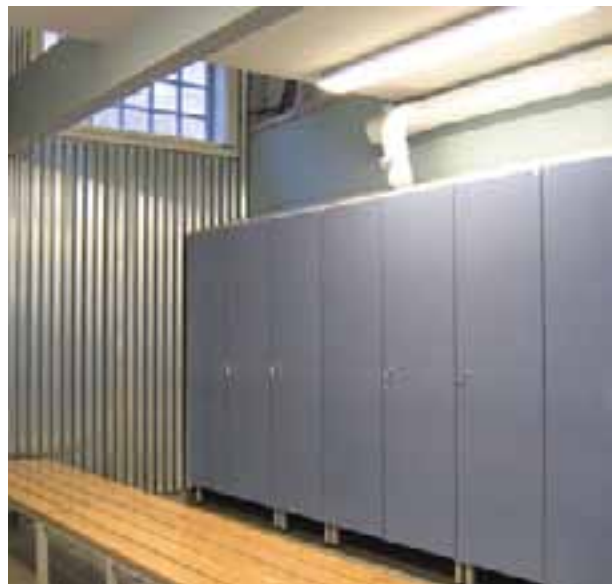
A light shaft was left in front of the windows at the height of the intermediate floor to allow natural light into the changing room. RAM

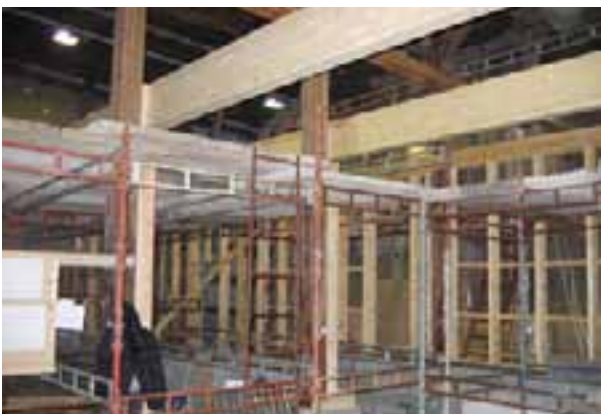
New load-bearing wood pillars were affixed to the existing wood pillars to support the new floor beams, and concrete blocks were used for the interior walls in the wet rooms. RAM

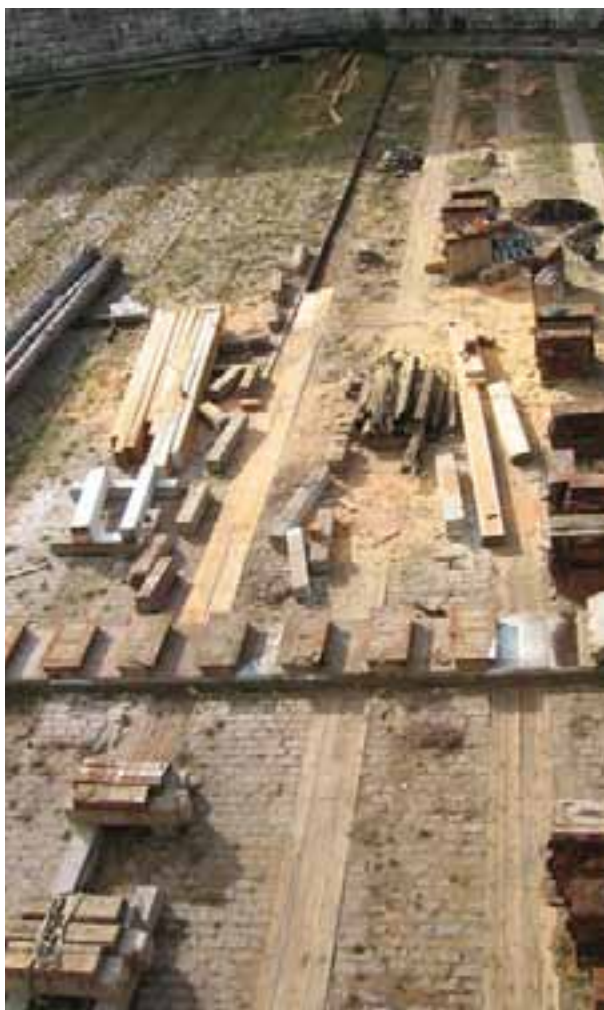
Replacing the bottom timbers in the dock basin. Besides major repairs the dock structures require continuous maintenance.

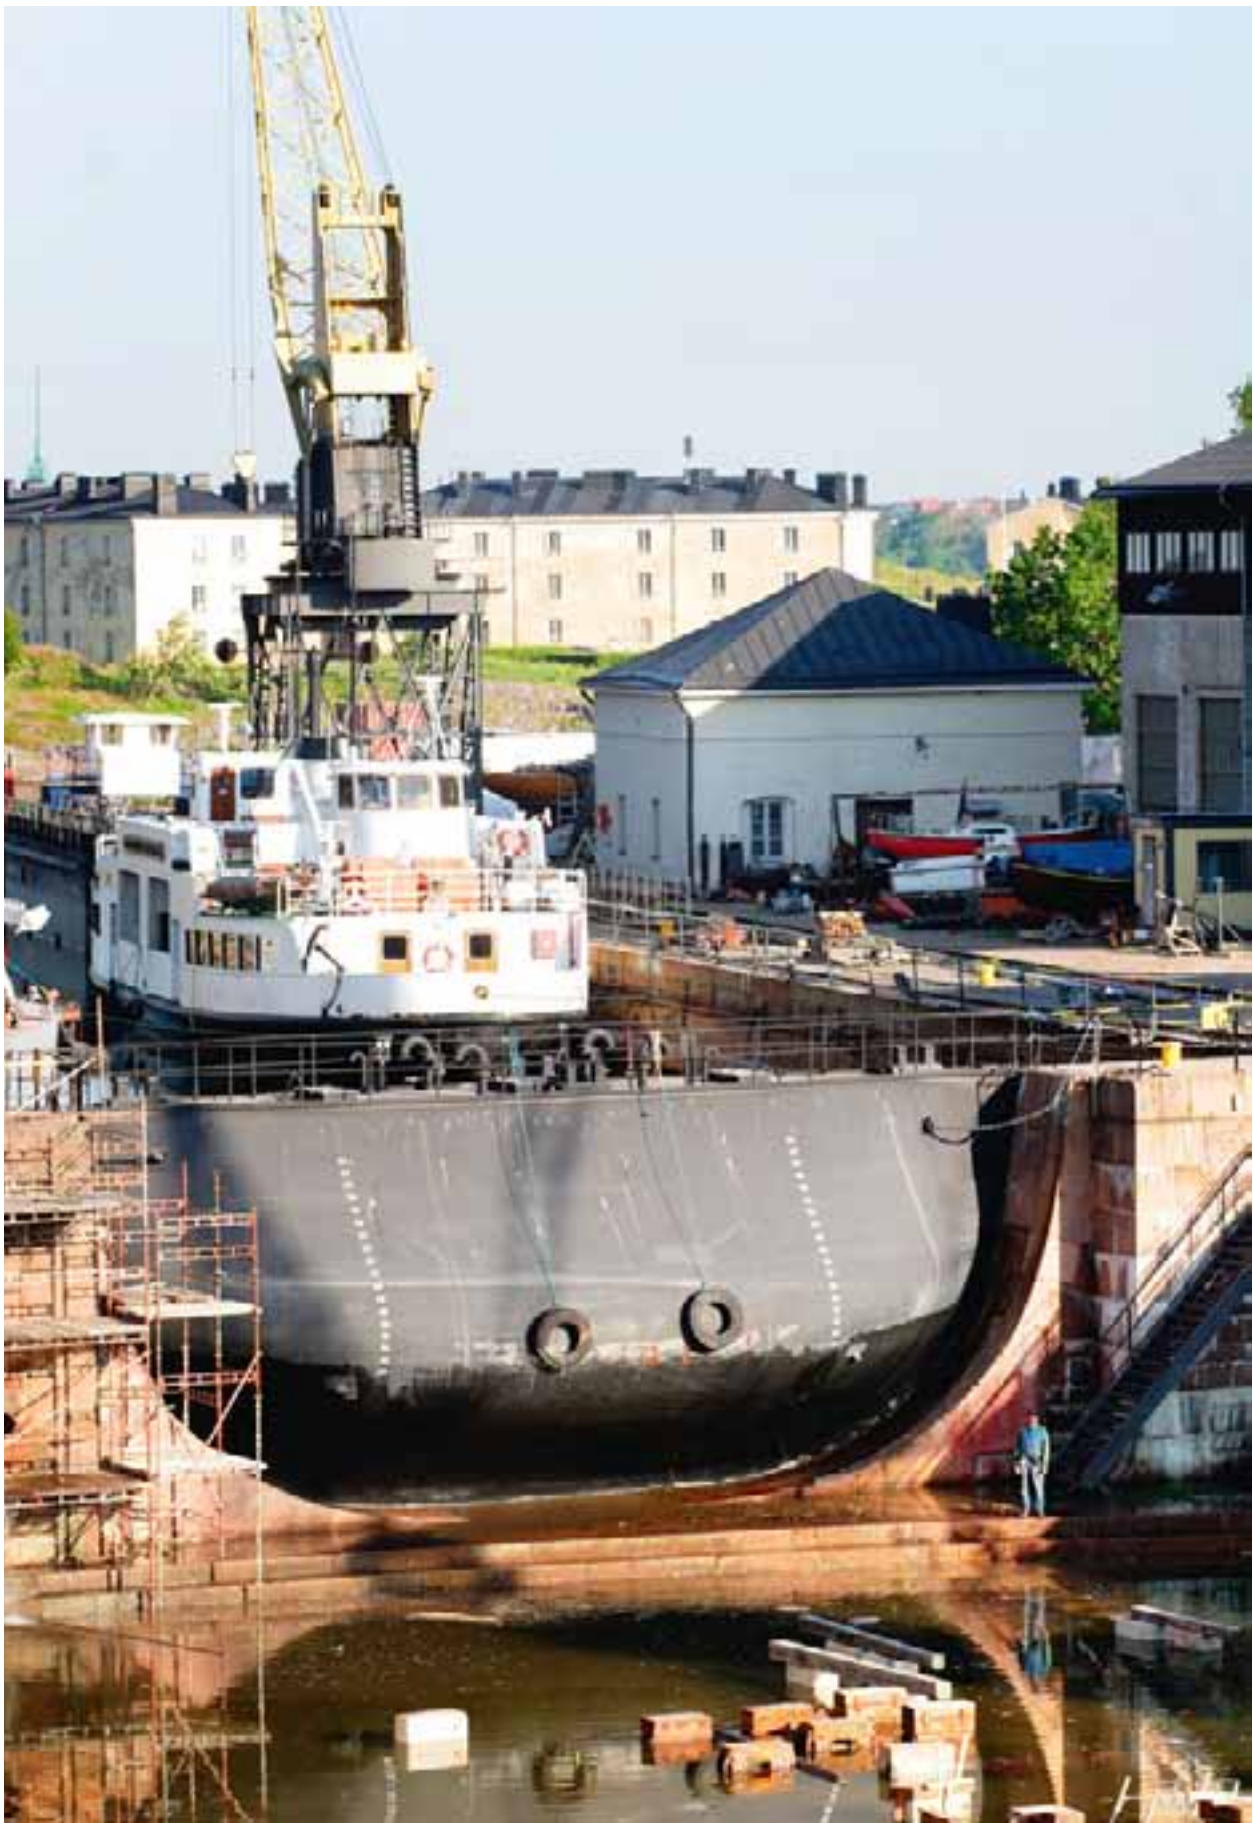
The two dock basins are separated by an intermediate lock gate, thanks to which vessels can be docked in the outer basin without filling the inner basin with water. The original intermediate lock gate dated from 1862; it was replaced in 2004. MRa

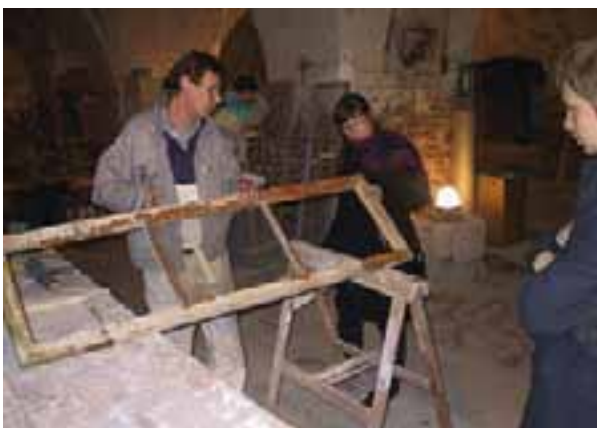
Renovating windows.

tion, were replaced. The old doors and windows were repaired and painted with linseed-oil-based paint. The colours used matched those used in the Russian era, as established in colour analyses. The old fluorescent-tube lighting fixtures in the offices were upgraded to give the large work spaces better lighting.
