Suomenlinna

Conservation and Reuse

GOVERNING BODY OF SUOMENLINNA

Publisher: Governing Body of Suomenlinna

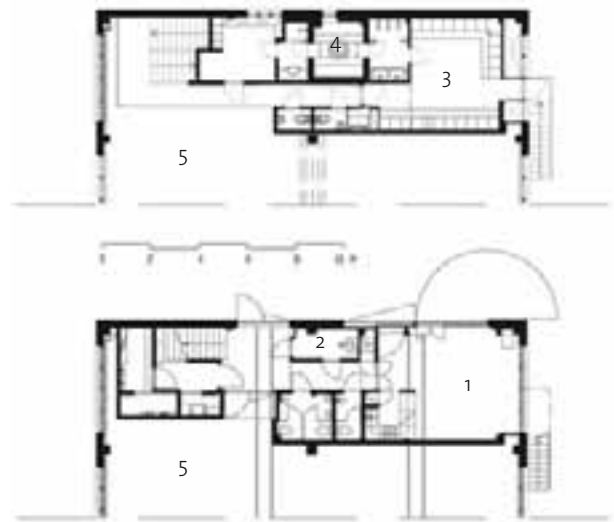
Floor plans of the ground floor (bottom) and loft floor (top) of the members' facilities: 1 break room, 2 drying room, 3 changing room, 4 sauna, 5 main hall

As the Viapori shipyard association (Viaporin telakka ry.), which renovates old ships, needed proper washrooms and other members' facilities, it was decided to build these on two floors at the end of the plate shop as a 'building within a building'. The lower floor holds a drying room, coffee room and kitchenette, the upper floor changing and washing facilities for about 25 people and a sauna. Steel was used as the construction material, in the spirit of the old plate shop. A new outside stairway was built

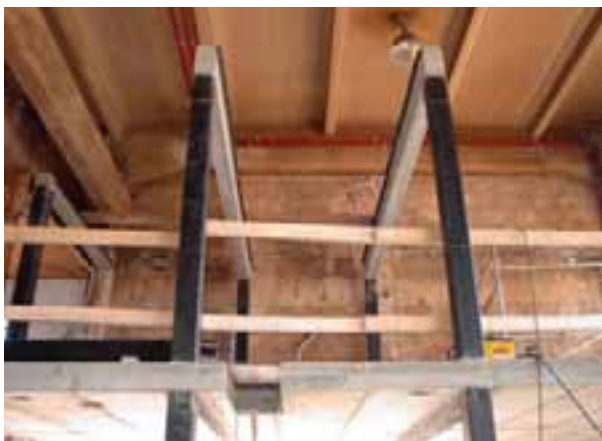
The new cast framework.

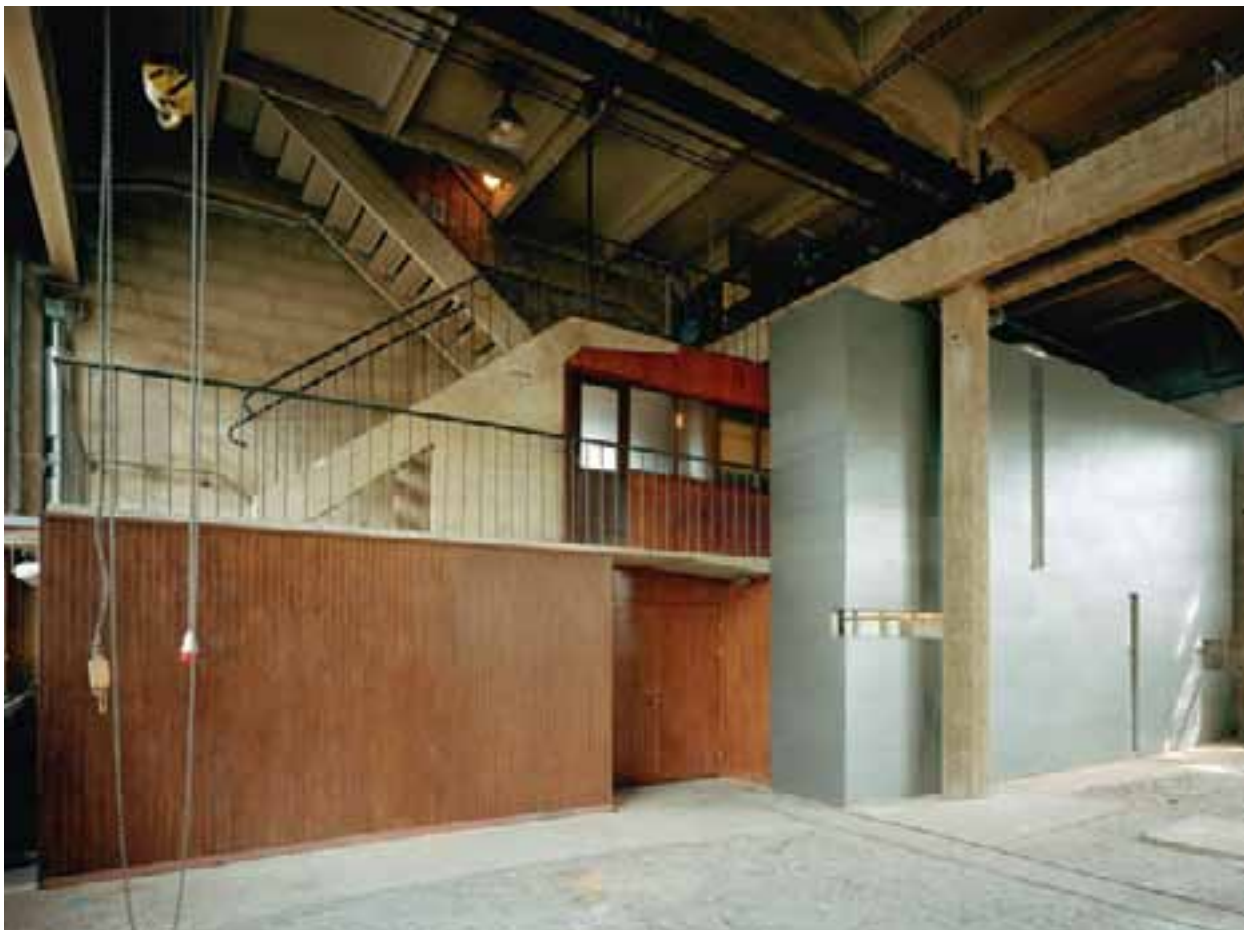
The new members' facilities at the end of the plate workshop. JT

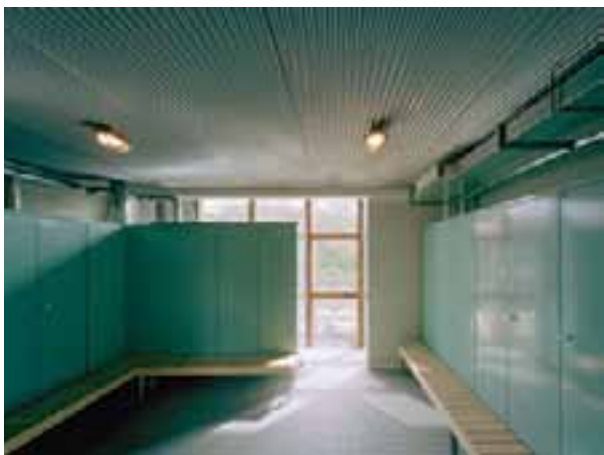
The new changing rooms. JT

as an emergency exit for the upper floor. The members' facilities were equipped with mechanical air conditioning, and the building was connected to the mains water and sewerage systems. **RA**

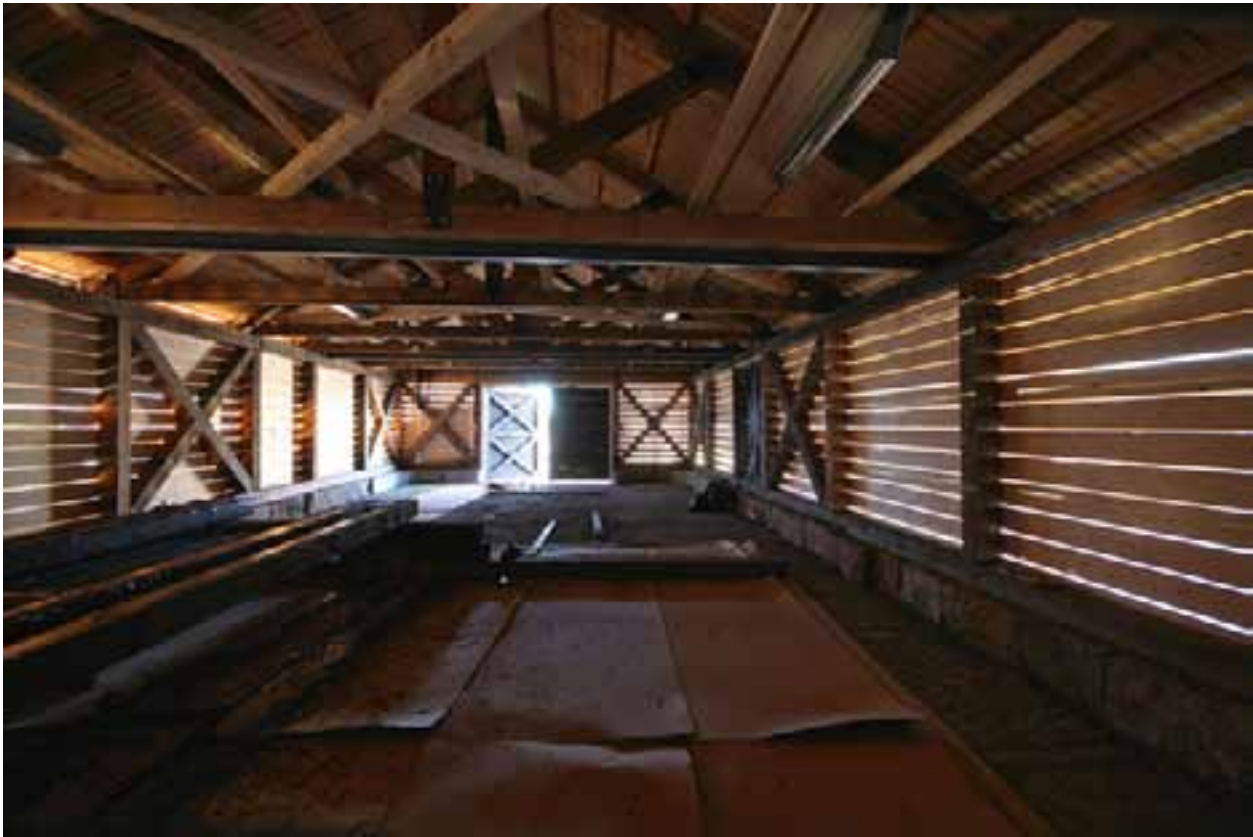
The weatherboarding was designed to allow air to pass through. PM

The design principle was for the new building to emulate the adjacent old artillery shed in its proportions and materials but to be obviously modern in its detail. The end result was a simple building made of traditional wood and stone materials. The frame was made of massive larch beams joined with steel bolts; the weatherboarding is of broad, bevelled spruce planks fitted with 10 mm gaps, ensuring the ventilation required for lumber storage. A traditional design was also used for the large, wood-frame doors. The stone foundation, cobblestone floor and paved ramps outside the doors were built as part of a masonry course at the Open Prison. TK

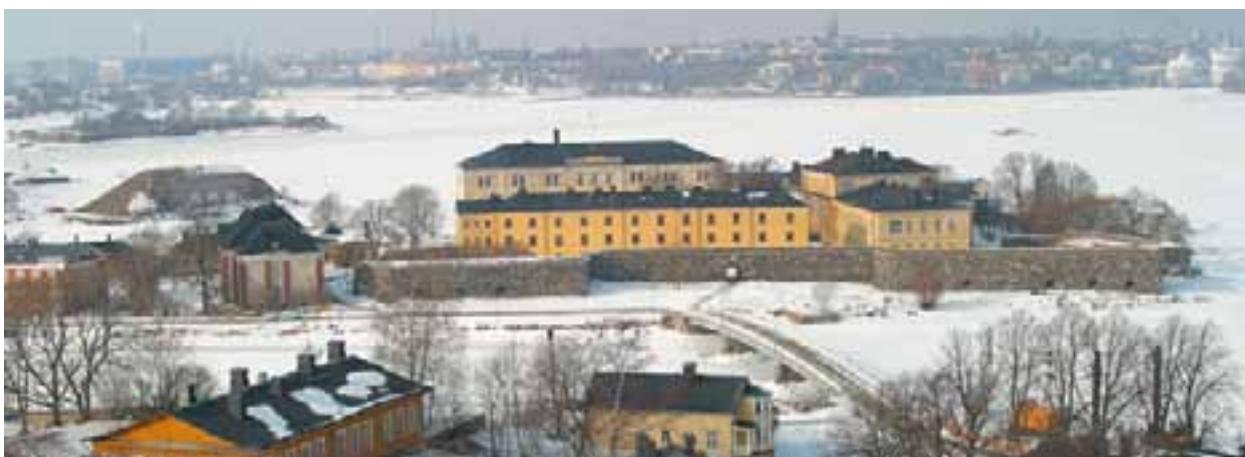
Beyond the bridge to Pikku Mustasaari island lie the rendered yellow buildings of the Naval Academy: D 12 (at the rear), D 13 (on the right) and D 14 (in front). To the left stands the Headquarters building (D 23) with its high hipped roof. The end of the red-brick sauna building (D 26) is also in the picture. The earth-covered Mine Classroom (E 14) is barely visible in the background. PM

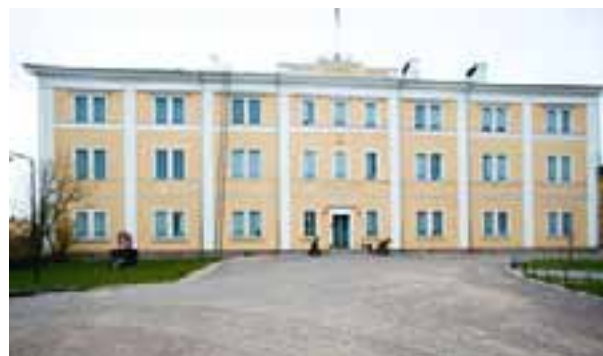
The main building, completed in 1852, was originally the Russian garrison hospital. The main designer of the renovation and conversion of this building and of the canteen building (D 12) was Keijo Koskinen of Koskinen & Schalin Oy, architects. EJ

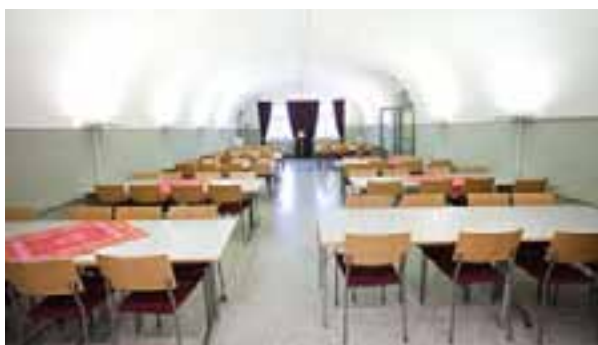
Building D 12 housed the dermatology ward of the Military Hospital until 1965, at which point it moved to the Tilkka Military Hospital. The renovated canteen on the ground floor of building D 12. EJ

Building D 12, which houses the canteen and classrooms, was renovated in 2007–2008. Because of damage from damp, all the intermediate floors were replaced except in the equipment store at the east end. The ventilation machinery room required by the new, larger kitchen was installed in the attic, and the compressors of the refrigeration equipment and the waste management room were housed in the vaulted casemates of the adjacent bastion Löwenhjelm. The soldiers' club that formerly occupied second-storey premises between buildings D 12 and D 13 was given a better location beside the main entrance to the canteen building.

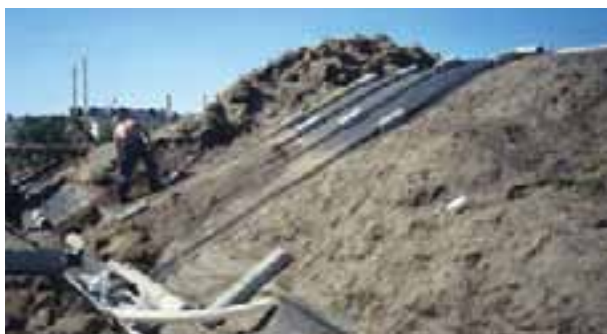
Rainwater had been seeping through the turf roof into the building for a long time. The entire top of the structure therefore had to be waterproofed by installing a rubberized bitumen mat on top of the sand layer and a ventilation network under it made of drainage pipes and concrete covers. TL

The restoration project that began in 2001 fell into two clear parts: functional alterations and structural renovation. The latter included both outside and inside work. The layer of sand on top of the building had worn away, revealing the roof of the old powder magazine. Exploratory digging showed that the top of the building had no proper waterproofing. In the repair work, about 40 cm of sand and grass were removed from all over the powder magazine and replaced with rubberized bitumen matting to waterproof the roof, with a ventilation network of drainage pipes laid underneath. The sand was then put back on top, held down by slabs of turf.

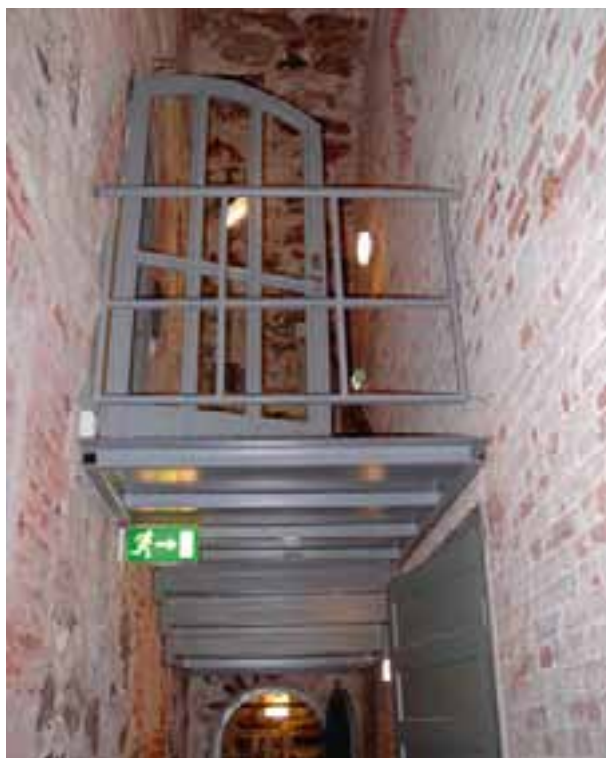
An emergency exit was built on the top floor by enlarging an old ventilator, making an opening in one of the brick walls of the flanking corridor, and building four flights of steps and four landings. KH

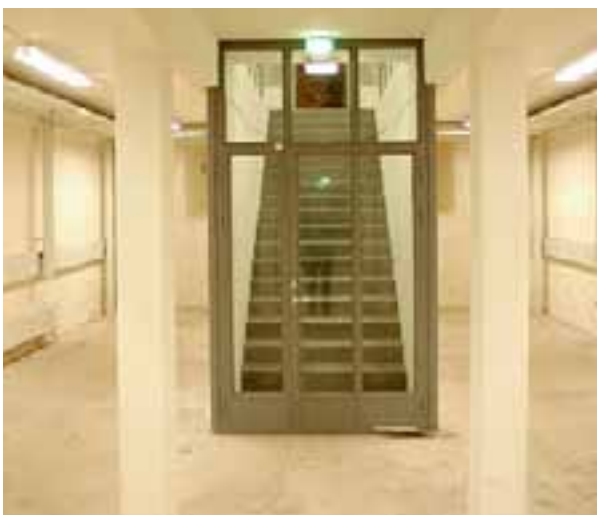
Because of the building's new use, each floor was made into a separate fire compartment. KH

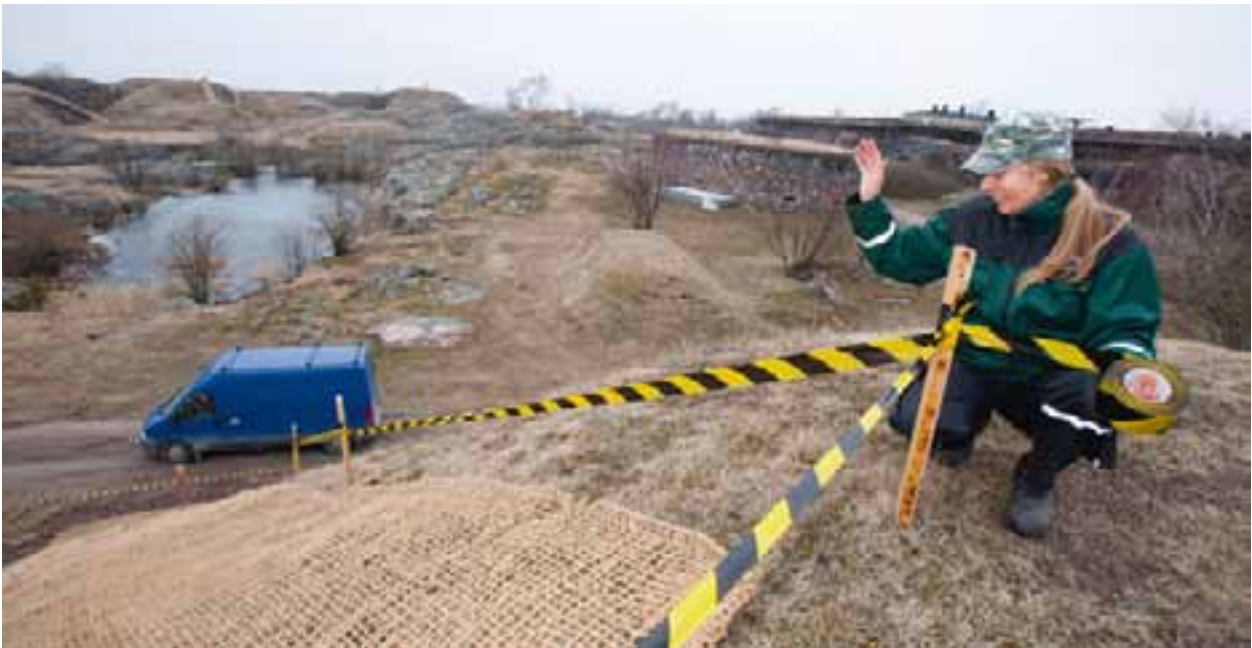
Gardener Iina Johansson repairing erosion damage to the earth covering of a powder magazine on Kustaanmiekka. EJ

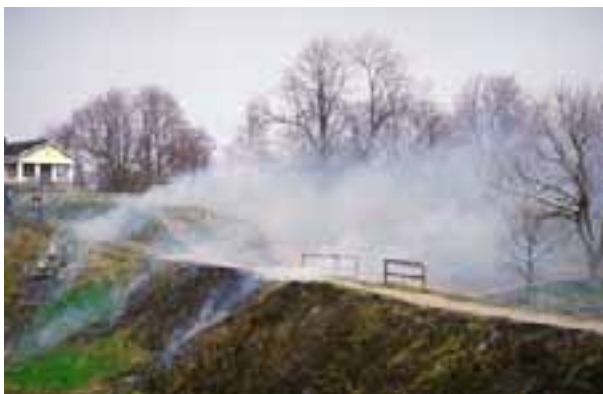
Burning-off dead plants on the earthworks. KH

to restore the original shapes of the earthworks based on their present appearance. Damage to the earthworks and firing platforms are repaired with turf tiles and coconut netting. Undamaged portions are touched as little as possible. Portions of earthworks growing tall grasses or herbs are sometimes burned over in the traditional way to remove dead plants, especially on slopes that are difficult to access.

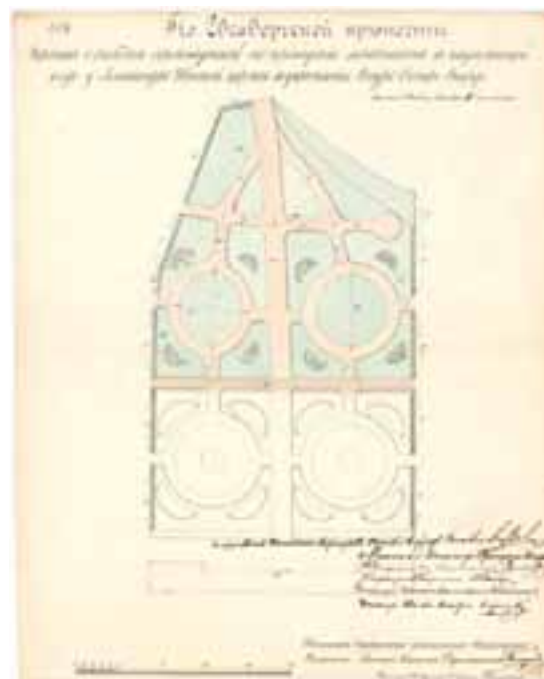
Church park plan, Russian engineering detachment 1873. MV

An Orthodox church was completed on Iso Mustasaari island in 1854, and a church park was laid out around it in 1858. This has two parts: the church knoll, where lilacs were planted, and the area in front of the officers' quarters (C 54, also known as 'Noah's Ark') where a park with circular and crossing pathways was laid out in the 1870s. The circular pathways were later replaced with curved pathways, which also eventually disappeared. In the 1920s, the park was encircled by a low wooden fence with nooks to accommodate benches.

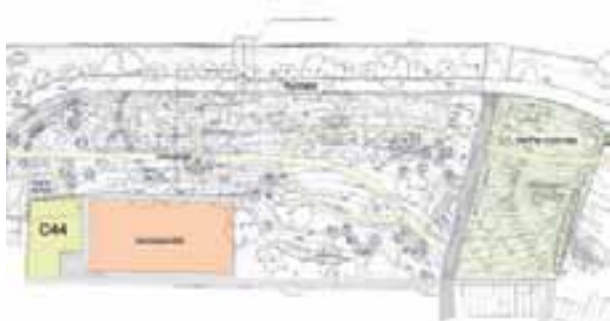
Casino Park reconditioning plan. Drawing: Ark-Viapor Oy / Pekka Nevalainen

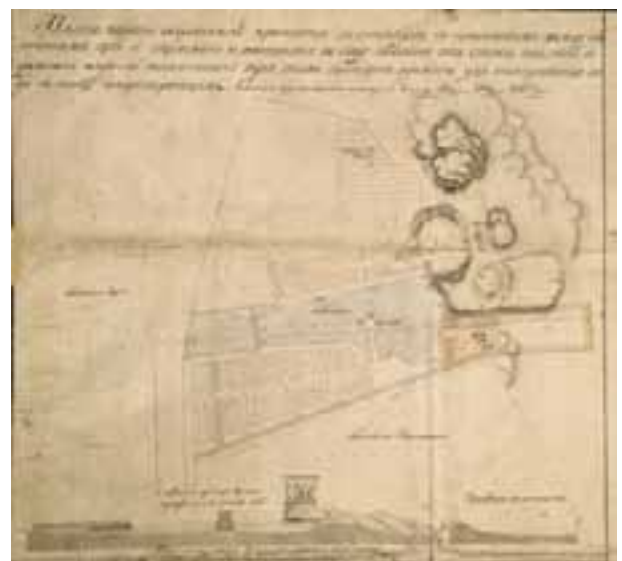
The 1811 plan for alterations to the west end of the pond shows the angular formal garden laid out in the Swedish era. MV

Towards the end of the Swedish era, the vegetable patches, orchards and trimmed hedges were still lined up along straight pathways, in the old formal garden style. By contrast, the newer style of landscape gardening was represented by a naturally shaped pond, a pavilion built on piles on the pond itself and a gazebo perched on the rock high above it. The principal esplanade in the garden was on the shore of the pond, and the unfinished wall lining it formed a perfect 'faux ruins' feature.

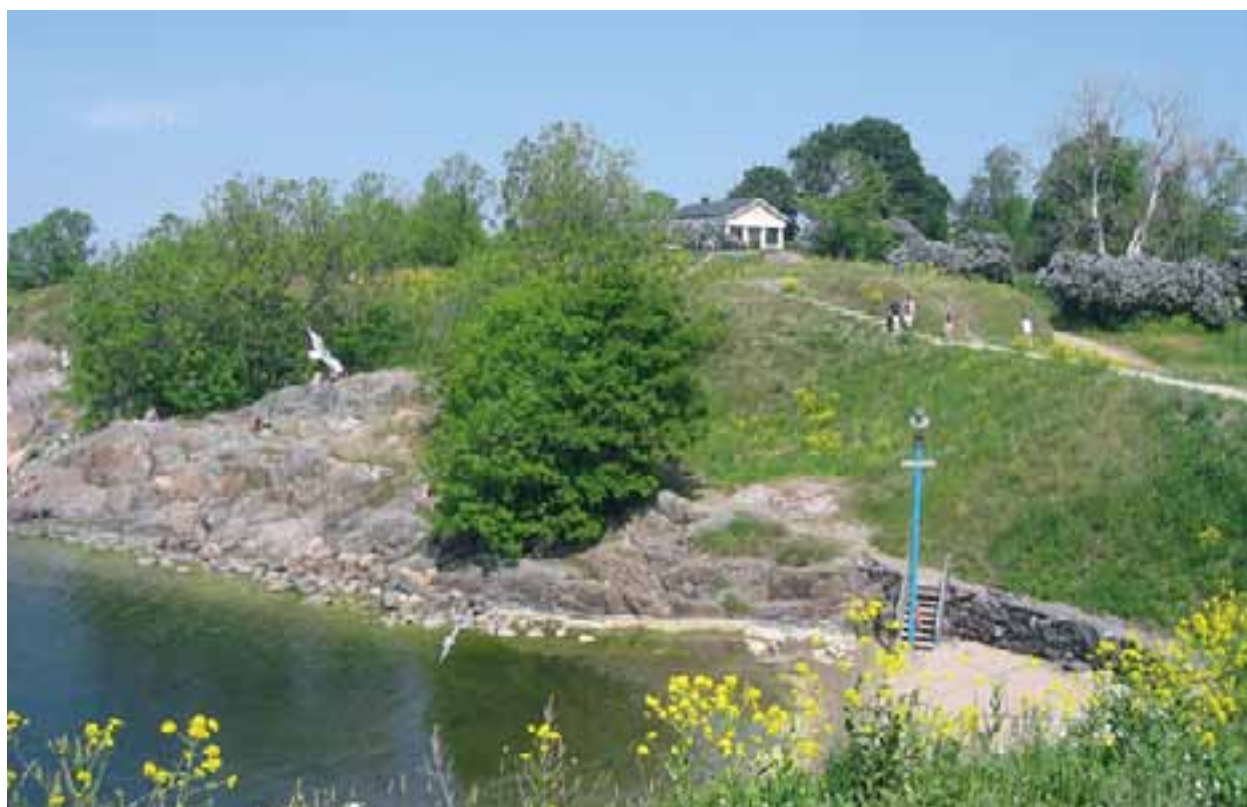
Lilacs in bloom surround the café pavilion in June. To the right is a great ash tree that has dried up as the result of two consecutive summers with practically no rain. LH

Some two dozen trees, typically ash, must be planted to replace those that have died. Traditional shrub and grass species must be re-introduced to broaden the range of flora. The pathway network must be reconditioned and outlined particularly on the southern slopes, where impromptu paths have been trodden.

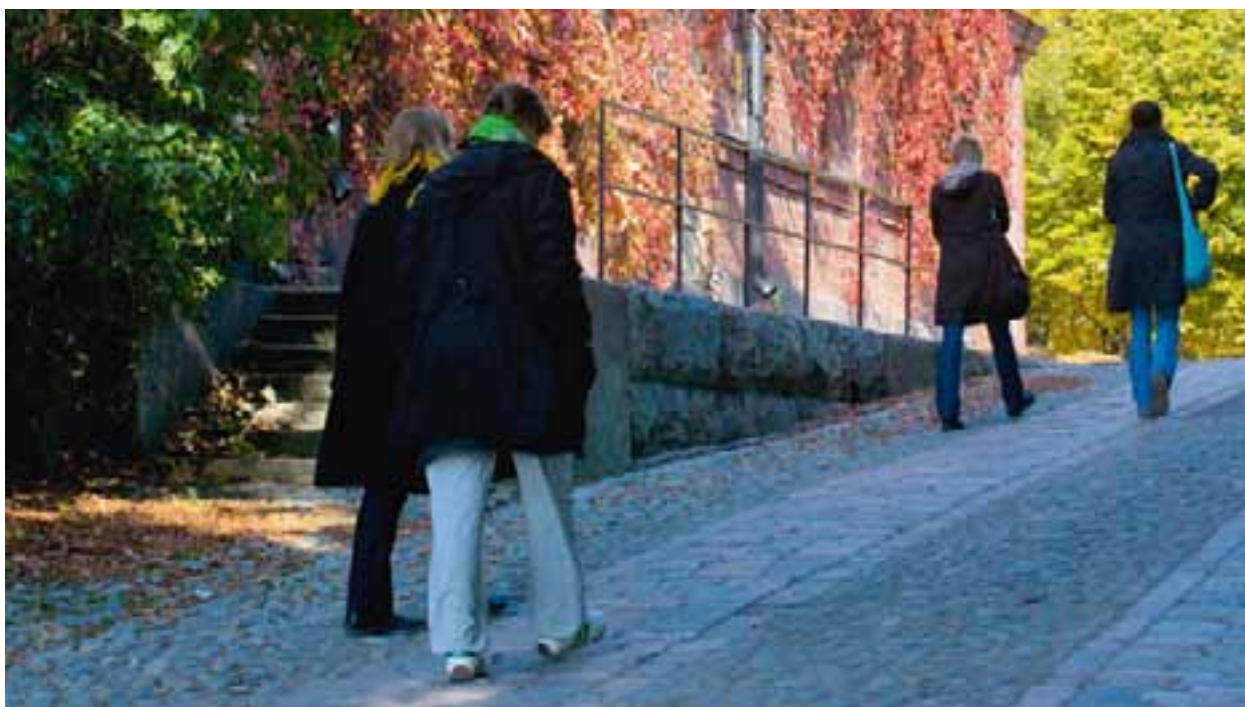
New rubble stone and cobblestone paving on Lennättimenmäki (Telegraph Hill), Iso Mustasaari island. EJ

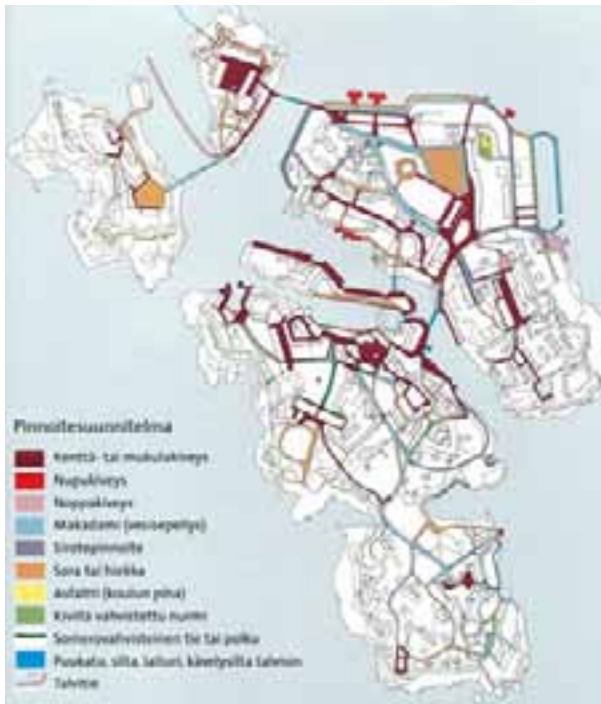
Paving plan from the landscape renovation plan of 1987.

The road network paving plan is included in the landscape renovation plan of 1987, which laid the groundwork for further planning. The purpose of the reconditioning project was to uncover or restore original pavings that had disappeared under layers of sand or had been destroyed in excavation, or to lay new paving resembling the original one as closely as possible. The principal roads from the main quay to the King's Gate were fully reconditioned in 1998, in time for the 250th anniversary of the founding of the fortress.

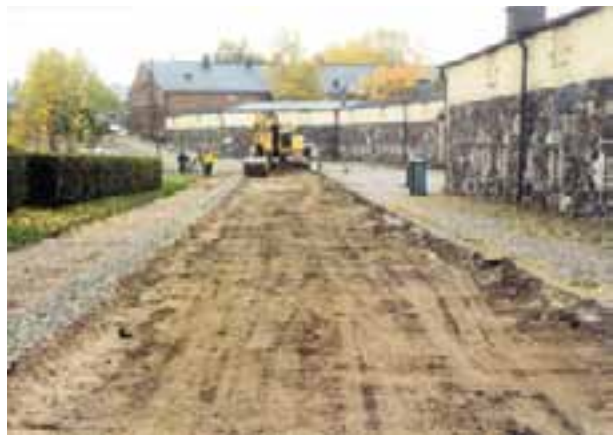
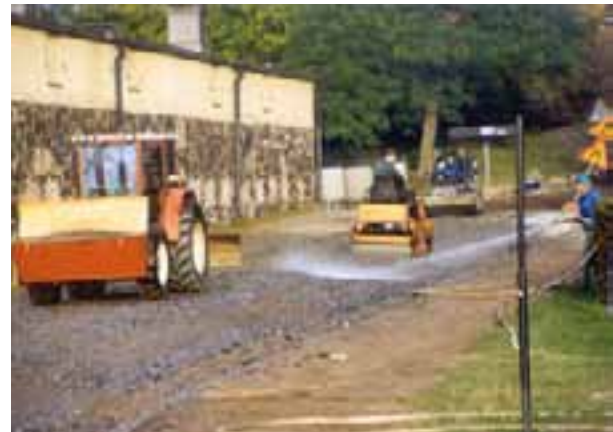
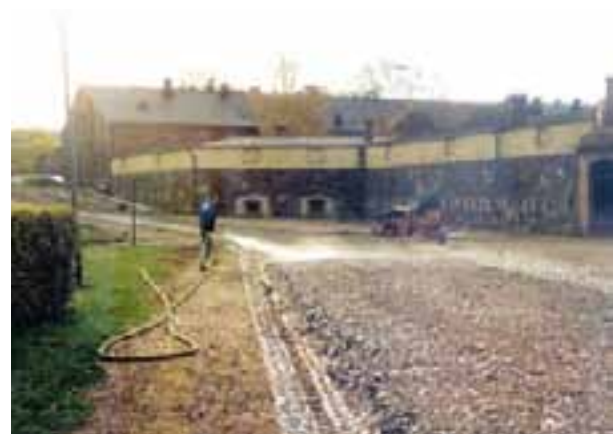
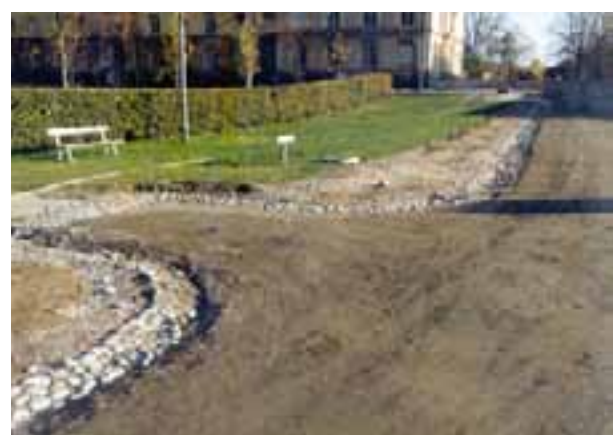
Laying macadam paving in autumn 1996. The aggregate layers are watered and then rolled to compress them into a solid surface. Moraine is spread on top as a binding agent. **PN**

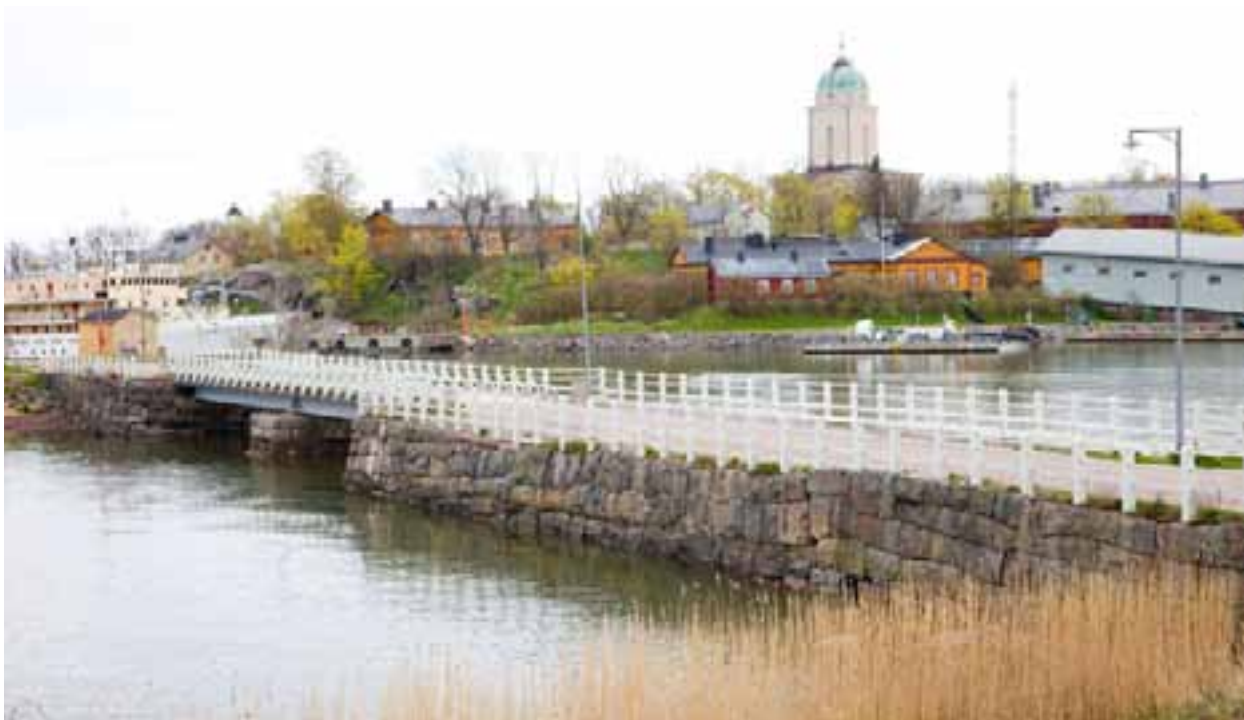
Länsi-Mustasaari island bridge. EJ

The new bridges have foundations made of concrete anchored into the bedrock. The abutments and piers are faced with stone masonry or slabs. The load-bearing structures are in steel and wood. Steel was also used for

the railings on the Länsi-Mustasaari bridge, while on the other bridges the decks and railings are in wood.

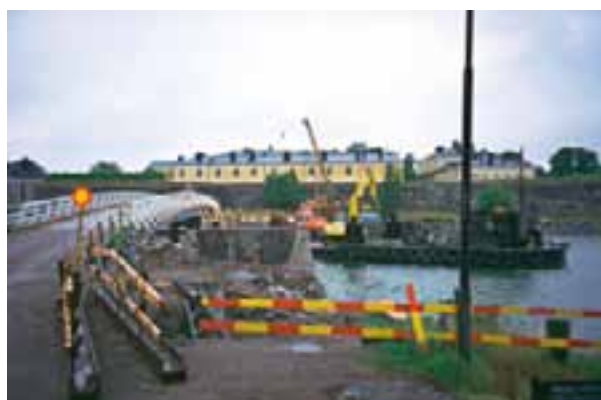
The new Pikku Mustasaari bridge was first built alongside the old bridge, which was then dismantled. New piers were built on the location of the old bridge, and the new bridge was finally moved onto the new piers in the course of a single working day. KH

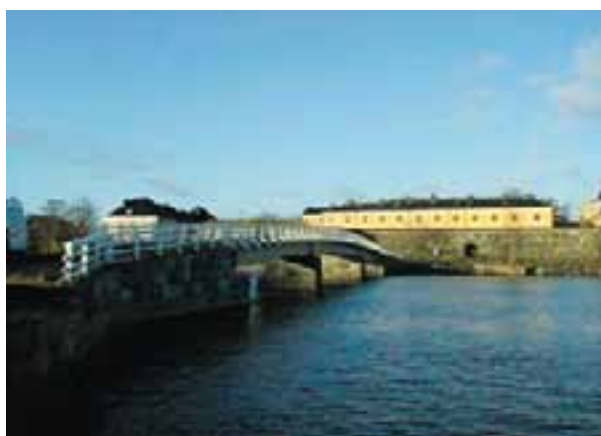
The new Pikku Mustasaari bridge completed. HL

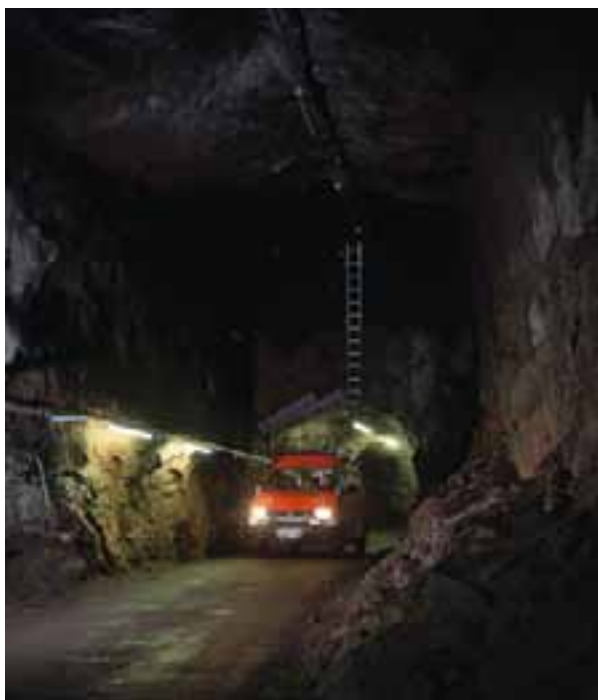
Emergency vehicles, except for the largest fire engines, can access Suomenlinna through the service tunnel. YT

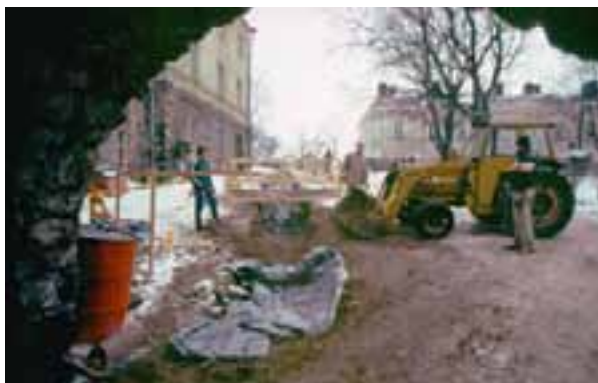
Public utility service excavations in the Great Courtyard in 1980.

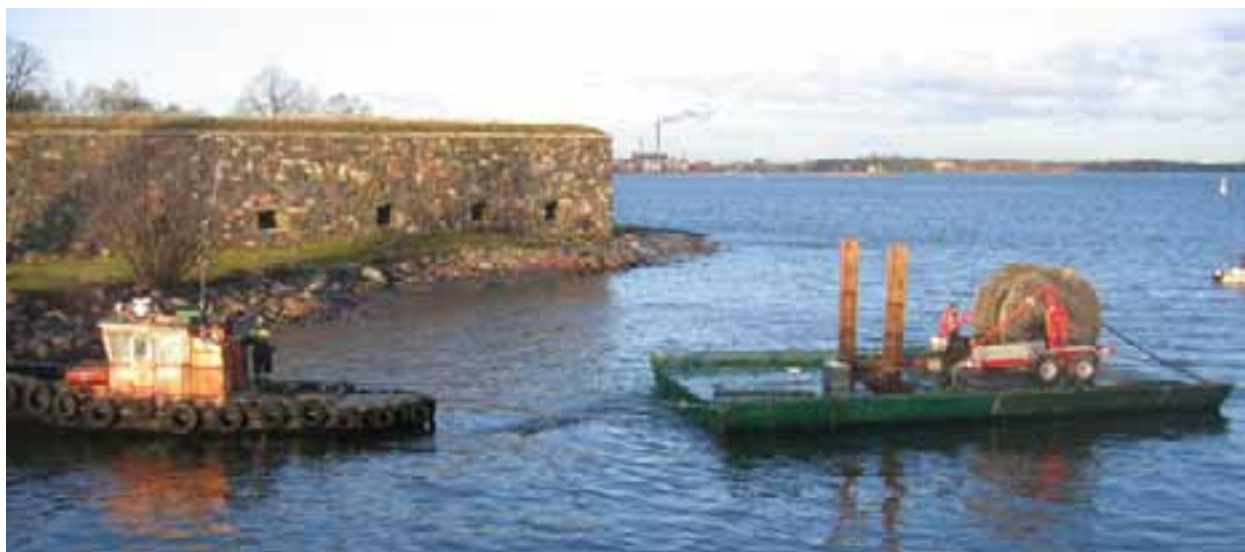
Electrical cable being laid between Lonna and Pikku Mustasaari islands in December 2007.

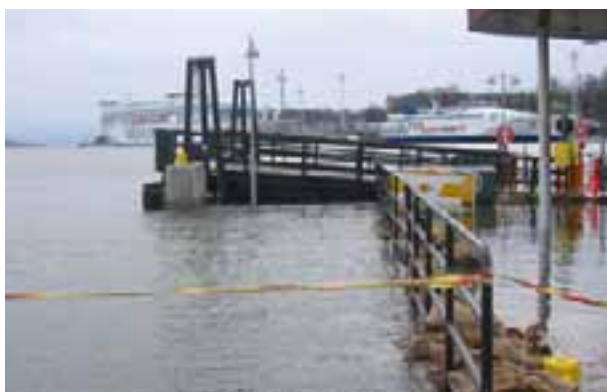
In January 2005, the sea level rose to 1.5 m above normal for a few hours along Market Square and Suomenlinna, almost flooding the dock basins. The ferry service was suspended, and the flood water caused damage along the shore.
